## FIELD INSPECTION REPORT

| <b>Project Name:</b> | Mountain Valley Pipeline | <b>Inspector:</b> | Marshall Willis |
| <b>Spread H:<br/>Montgomery County</b> | STA 12190+85 – 12285+00<br>MVP-MN-276.03<br>MVP-MN-274 | <b>Weather:</b> | Dry |

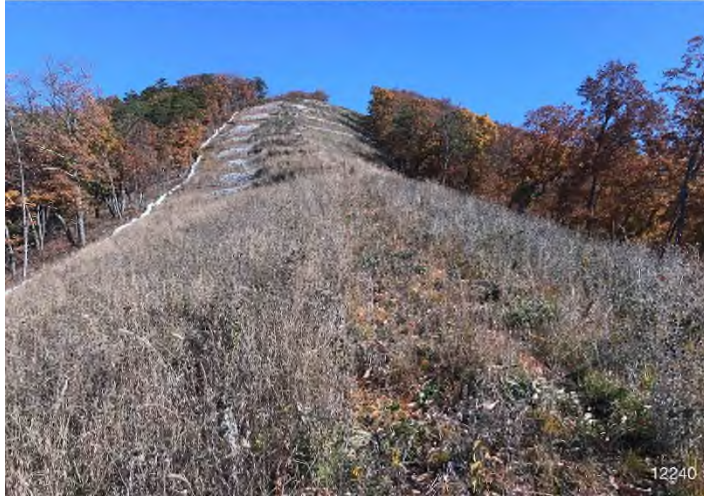
**Figure 1: STA 12240+00** – Controls in place and functioning properly.

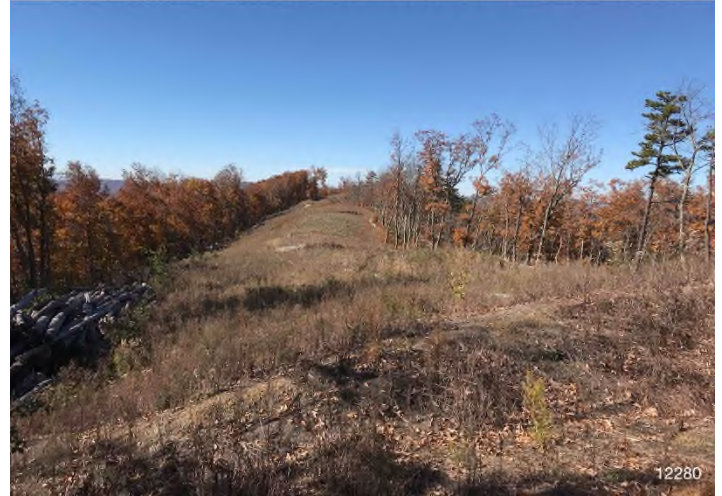
**Figure 2: STA 12280+00** – Controls in place and functioning properly.

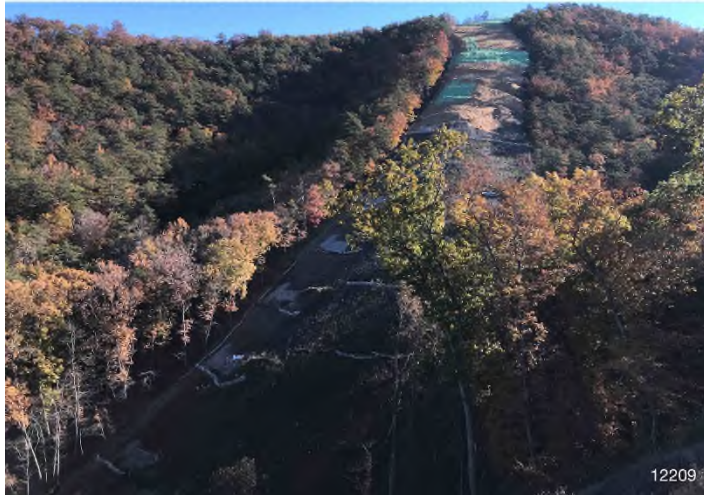
**Figure 3: STA 12209+00** – Controls in place and functioning properly. Area stabilized erosion matting.

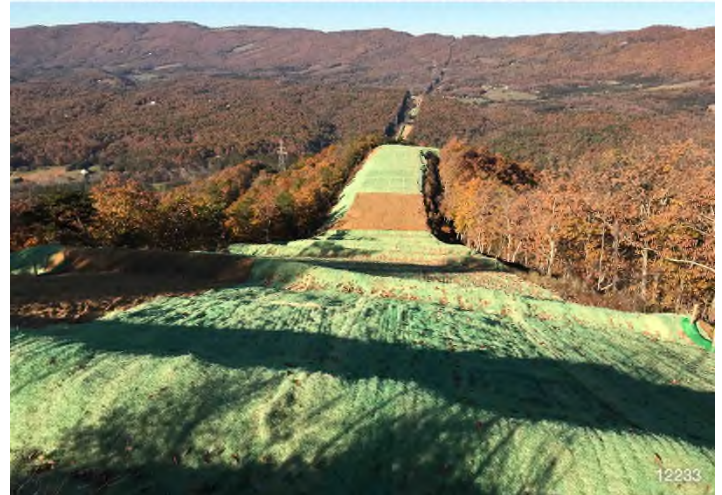
**Figure 4: STA 12233+00** – Controls in place and functioning properly. Area stabilized erosion matting.
