FIELD INSPECTION REPORT

Project Name:	Mountain Valley Pipeline	Inspector:	Marshall Willis
Inspection Date:	Friday, December 10, 2021	Project Contact:	Brian Clauto, Cory Chalmers
Spread I: Franklin County	STA 13415+51 – 13452+38 MVP-FR-293.02	Weather:	Dry

FIELD INSPECTION PHOTO LOG

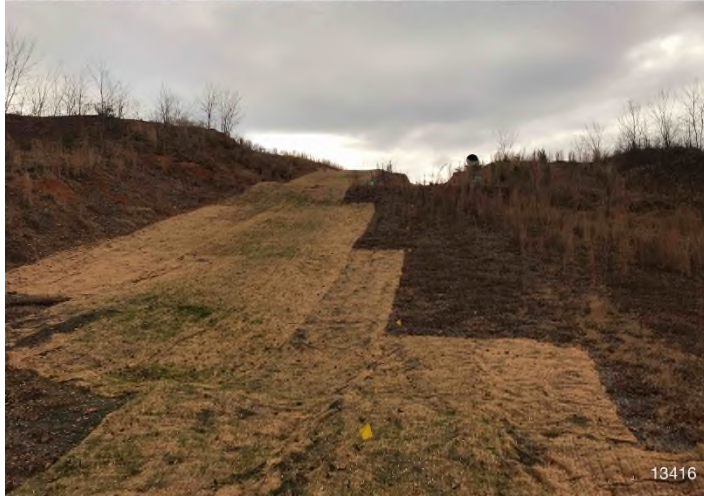
Figure 1: STA 13416+00 – Controls in place and functioning properly. Area stabilized with erosion matting.
BRG: 107°E (T) LAT: 37.092180 LON: -80.027055 ±16ft ALT: 1493ft

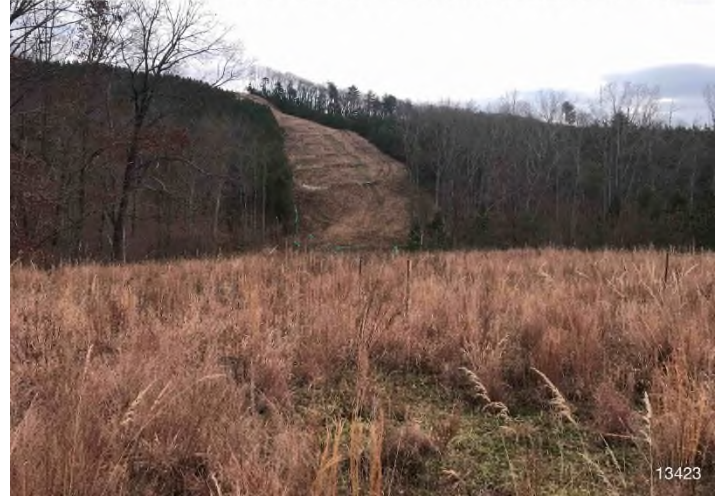
Figure 2: STA 13423+00 – Controls in place and functioning properly.
BRG: 121°SE (T) LAT: 37.091045 LON: -80.025401 ±98ft ALT: 1604ft

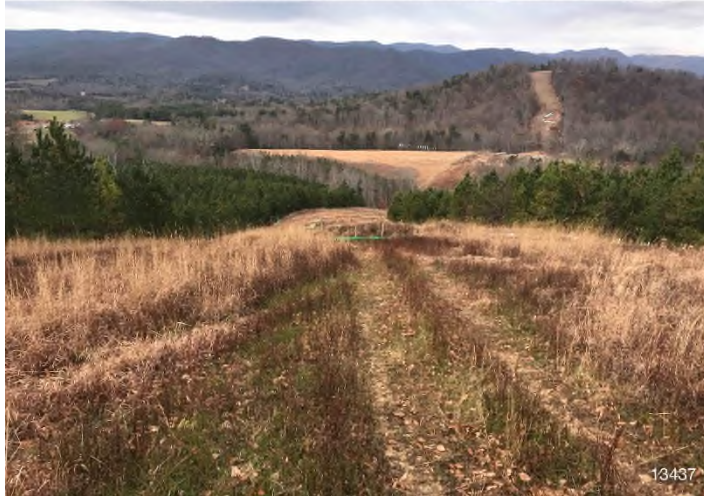
Figure 3: STA 13437+00 – Controls in place and functioning properly.
BRG: 266°W (T) LAT: 37.090363 LON: -80.020600 ±16ft ALT: 1700ft

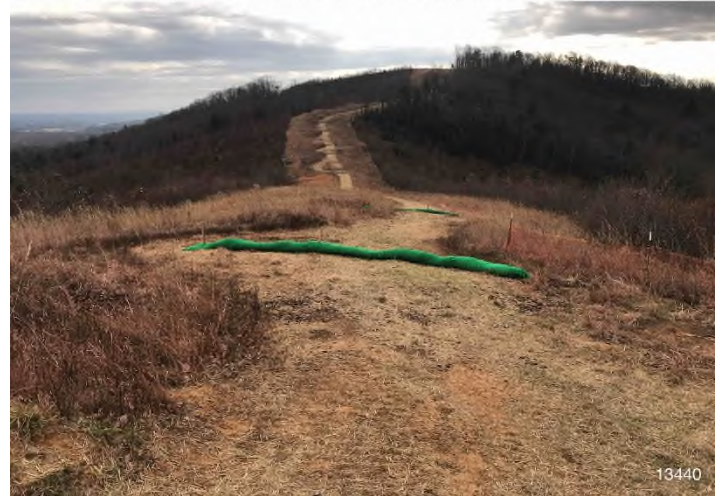
Figure 4: STA 13440+00 – Controls in place and functioning properly.
BRG: 136°SE (T) LAT: 37.090219 LON: -80.019881 ±16ft ALT: 1707ft
