## FIELD INSPECTION REPORT

| Project Name: | Mountain Valley Pipeline | Inspector: | Marshall Willis |
| Inspection Date: | Thursday, December 9, 2021 | Project Contact: | Brian Clauto, Cory Chalmers |
| Spread I:<br>Pittsylvania County | STA 15496+70 – 15584+23 | Weather: | Dry |

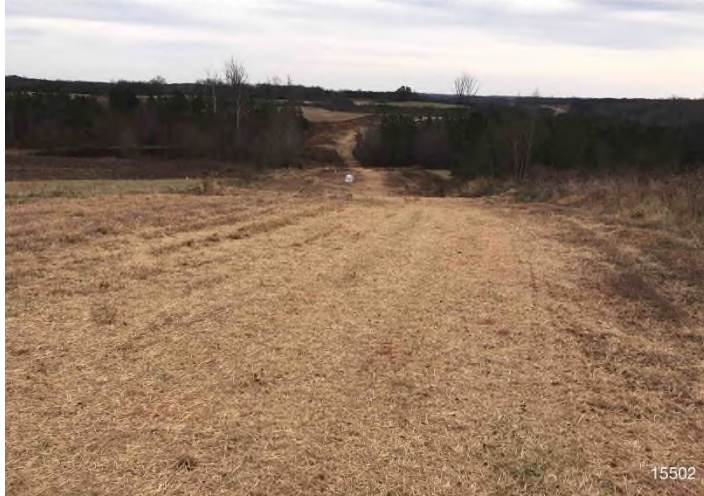
**Figure 1: STA 15502+00** – Controls in place and functioning properly. Area stabilized with straw  
BRG: 97°E (T) LAT: 36.913131 LON: -79.468459 ±11742ft ALT: 918ft

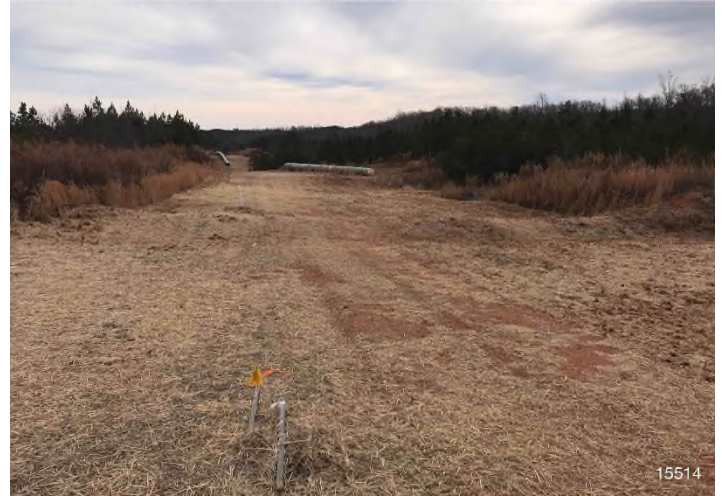
**Figure 2: STA 15514+00** – Controls in place and functioning properly. Area stabilized with straw.  
BRG: 88°E (T) LAT: 36.904874 LON: -79.470921 ±8415ft ALT: 843ft

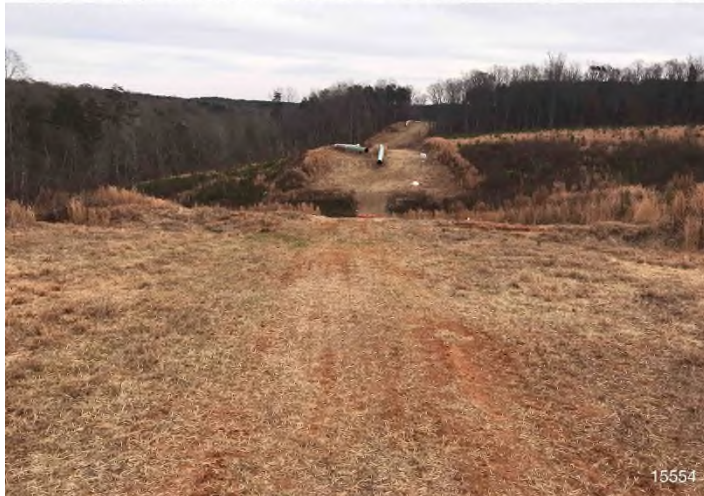
**Figure 3: STA 15554+00** – Controls in place and functioning properly. Area stabilized with straw  
BRG: 98°E (T) LAT: 36.894303 LON: -79.407332 ±12604ft ALT: 789ft

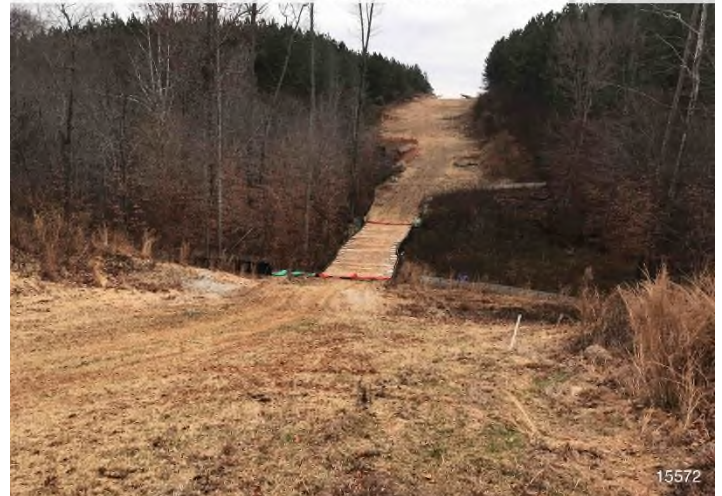
**Figure 4: STA 15572+00** – Controls in place and functioning properly. Area stabilized with straw  
BRG: 98°E (T) LAT: 36.898317 LON: -79.450577 ±16420ft ALT: 849ft
