## FIELD INSPECTION REPORT

| Project Name: | Mountain Valley Pipeline | Inspector: | Marshall Willis |
| Inspection Date: | Wednesday, December 8, 2021 | Project Contact: | Brian Clauto, Cory Chalmers |

## FIELD INSPECTION PHOTO LOG

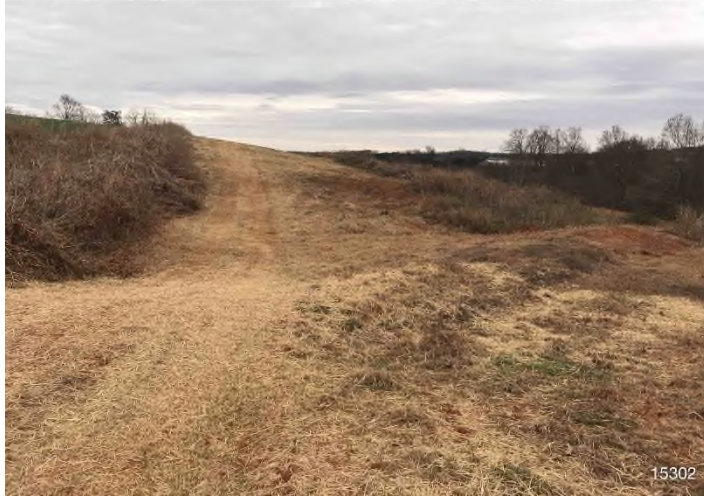
**Figure 1: STA 15302+00** – Controls in place and functioning properly. Area stabilized with straw  
BRG: 149°SE (T) LAT: 36.931038 LON: -79.531548 ±213ft ALT: 774ft

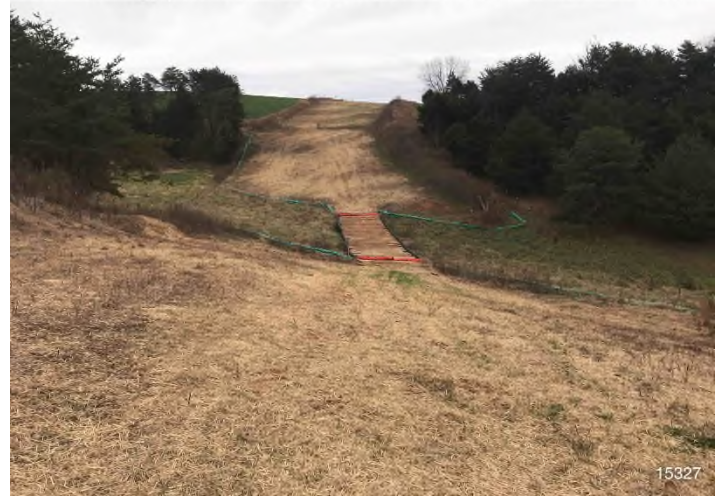
**Figure 2: STA 15327+00** – Controls in place and functioning properly. Area stabilized with straw.  
BRG: 121°SE (T) LAT: 36.928286 LON: -79.522008 ±32ft ALT: 707ft

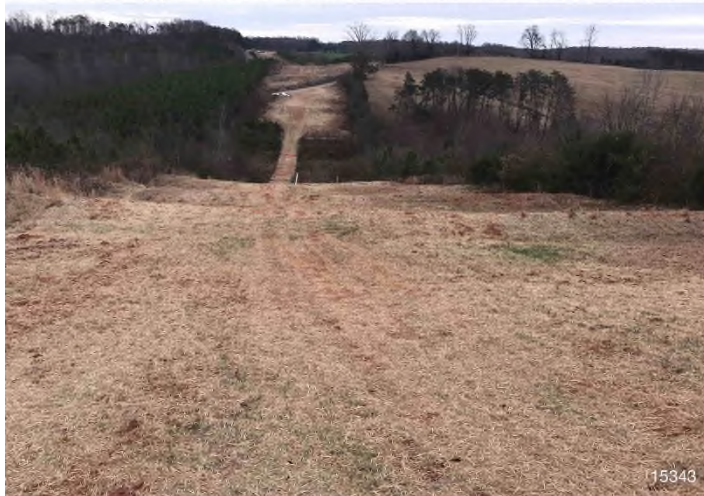
**Figure 3: STA 15343+00** – Controls in place and functioning properly. Area stabilized with straw  
BRG: 126°SE (T) LAT: 36.918542 LON: -79.531105 ±9708ft ALT: 752ft

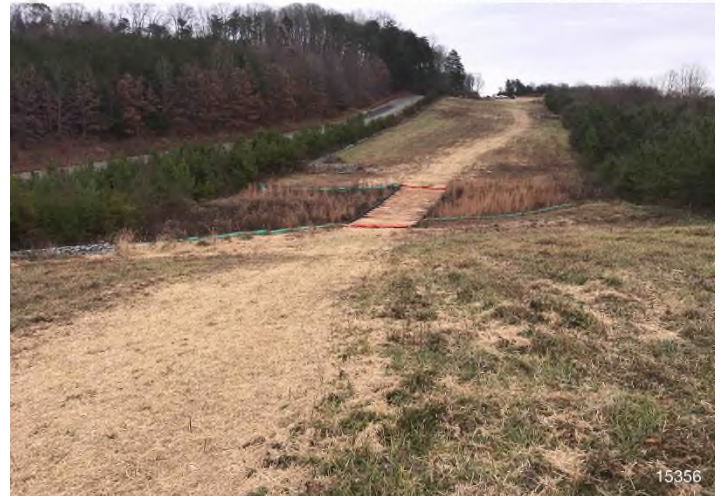
**Figure 4: STA 15356+00** – Controls in place and functioning properly. Area stabilized with straw  
BRG: 97°E (T) LAT: 36.923368 LON: -79.514165 ±16ft ALT: 740ft
