## FIELD INSPECTION REPORT

| <b>Project Name:</b> | Mountain Valley Pipeline | <b>Inspector:</b> | Marshall Willis |
| <b>Spread H:<br/>Franklin County</b> | STA 13115+97 – 13195+79<br>MVP-FR-291<br>MVP-FR-292.01 | <b>Weather:</b> | Dry |

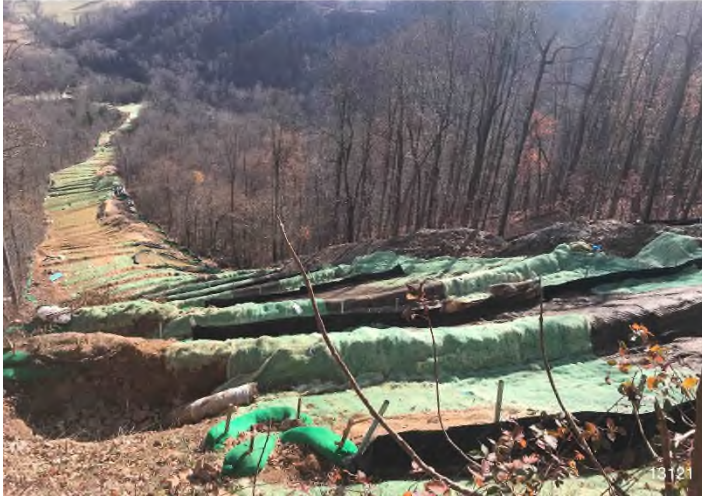
**Figure 1: STA 13121+00** – Controls in place and functioning properly. Area stabilized with erosion matting.  
BRG: 123°SE (T) LAT: 37.121969 LON: -80.094099 ±32ft ALT: 2410ft

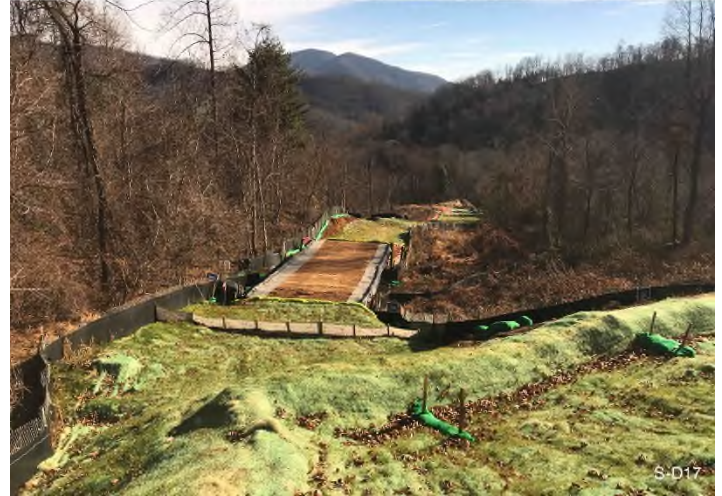
**Figure 2: Stream S-D17** – Controls in place and functioning properly.  
BRG: 94°E (T) LAT: 37.121680 LON: -80.088925 ±32ft ALT: 1792ft

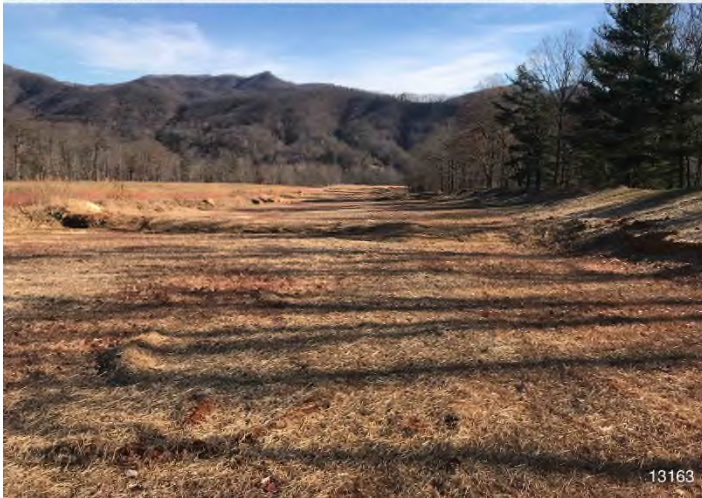
**Figure 3: STA 13163+00** – Controls in place and functioning properly. Area stabilized with straw  
BRG: 70°E (T) LAT: 37.124538 LON: -80.085238 ±10912ft ALT: 1693ft

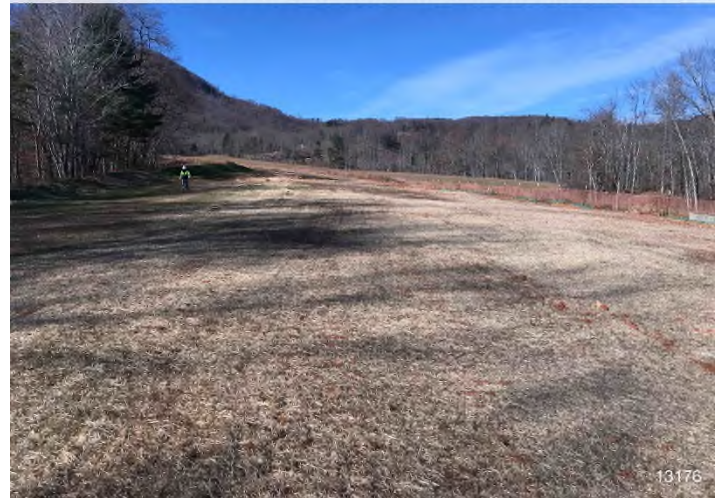
**Figure 4: STA 13176+00** – Controls in place and functioning properly. Area stabilized with straw  
BRG: 289°W (T) LAT: 37.125434 LON: -80.079235 ±16ft ALT: 1612ft
