## FIELD INSPECTION REPORT

<b>Project Name:</b>	Mountain Valley Pipeline	<b>Inspector:</b>	Marshall Willis
<b>Inspection Date:</b>	Tuesday, December 21, 2021	<b>Project Contact:</b>	Brian Clauto, Cory Chalmers
<b>Spread I: Franklin County</b>	STA 13778+00 – 13853+50 MVP-FR-300 MVP-FR-302 MVP-FR-300.01	<b>Weather:</b>	Dry

## FIELD INSPECTION PHOTO LOG

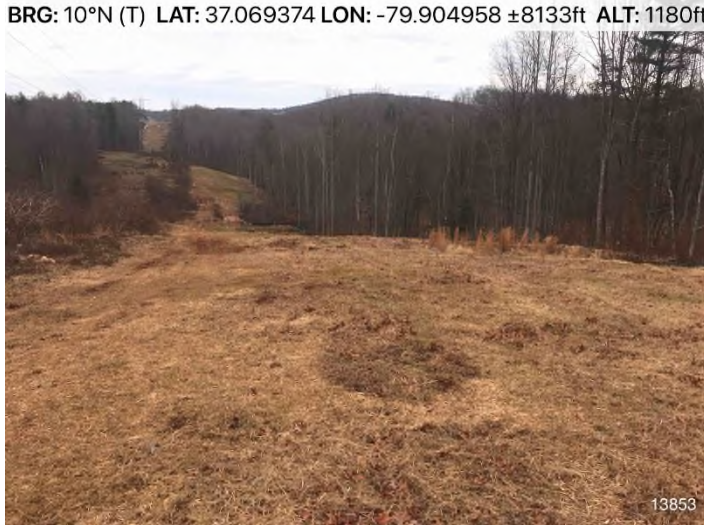
**Figure 1: STA 13853+00** – Controls in place and functioning properly. Area stabilized with straw.  
BRG: 10°N (T) LAT: 37.069374 LON: -79.904958 ±8133ft ALT: 1180ft

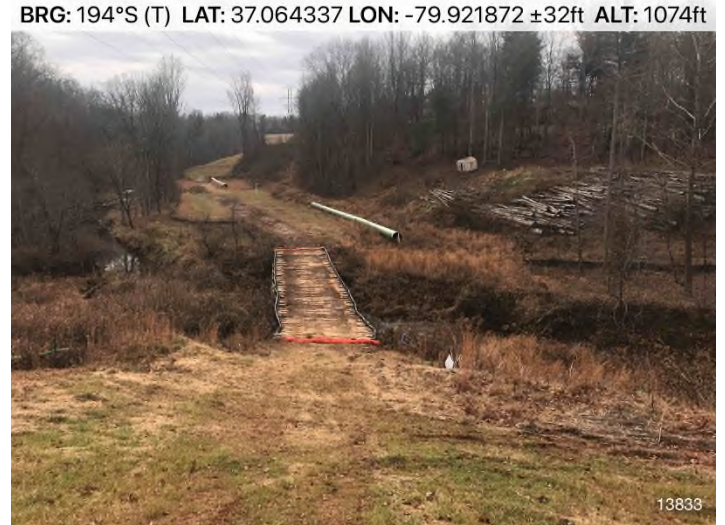
**Figure 2: STA 13833+00** – Controls in place and functioning properly. Area stabilized straw.  
BRG: 194°S (T) LAT: 37.064337 LON: -79.921872 ±32ft ALT: 1074ft

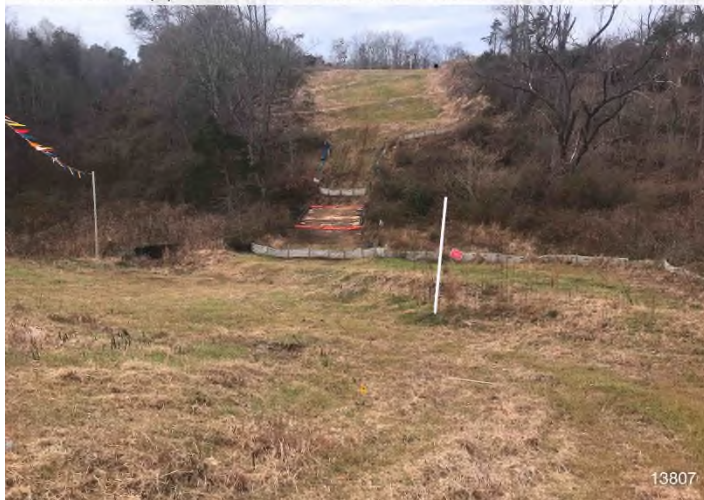
**Figure 3: STA 13807+00** – Controls in place and functioning properly. Area stabilized with straw.  
BRG: 262°W (T) LAT: 37.069612 LON: -79.925718 ±16ft ALT: 1115ft

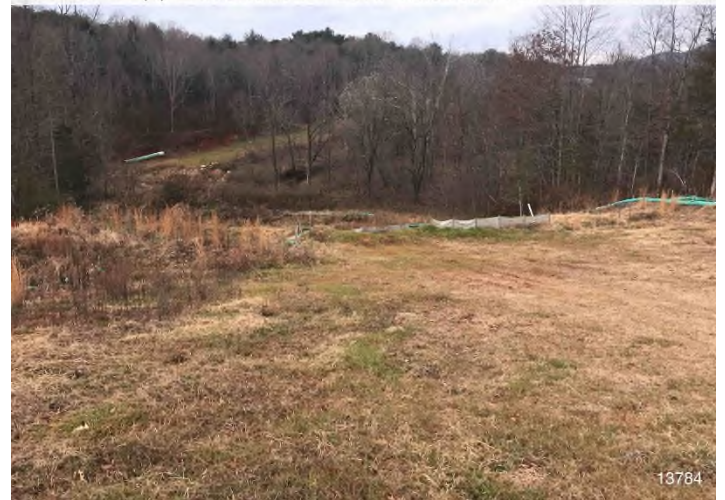
**Figure 4: STA 13784+00** – Controls in place and functioning properly. Area stabilized with straw.  
BRG: 287°W (T) LAT: 37.069237 LON: -79.946694 ±9051ft ALT: 1062ft
