## FIELD INSPECTION REPORT

<b>Project Name:</b>	Mountain Valley Pipeline	<b>Inspector:</b>	Marshall Willis
<b>Inspection Date:</b>	Monday, December 20, 2021	<b>Project Contact:</b>	Brian Clauto, Cory Chalmers
<b>Spread H: Franklin County</b>	STA 13030+00 – 13063+00 MVP-FR-289 MVP-FR-290	<b>Weather:</b>	Dry

## FIELD INSPECTION PHOTO LOG

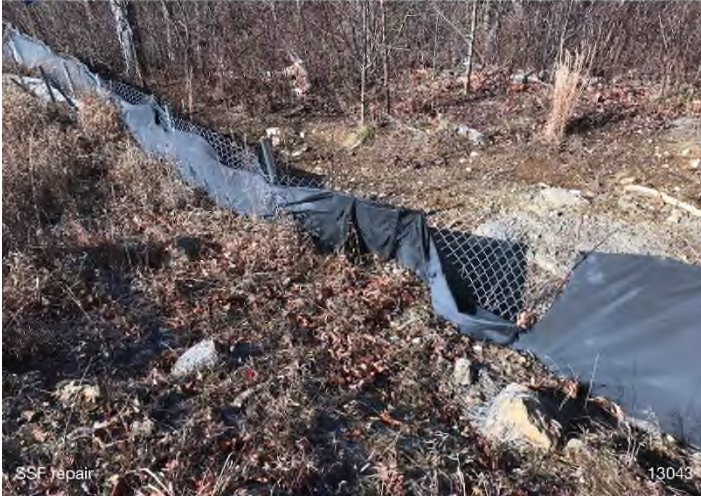
- STA 13043+00: SSF maintenance needed.
- STA 13043+50: P1 maintenance needed.

**Figure 1: STA 13043+00 – SSF maintenance needed.**

**Recommended Corrective Action:** Maintain and install all controls per the approved PSS&S.

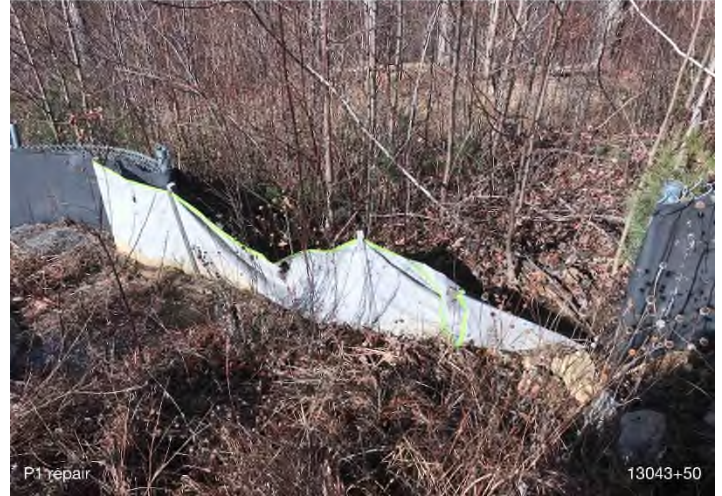
**Figure 2: STA 12043+50 – P1 maintenance needed.**

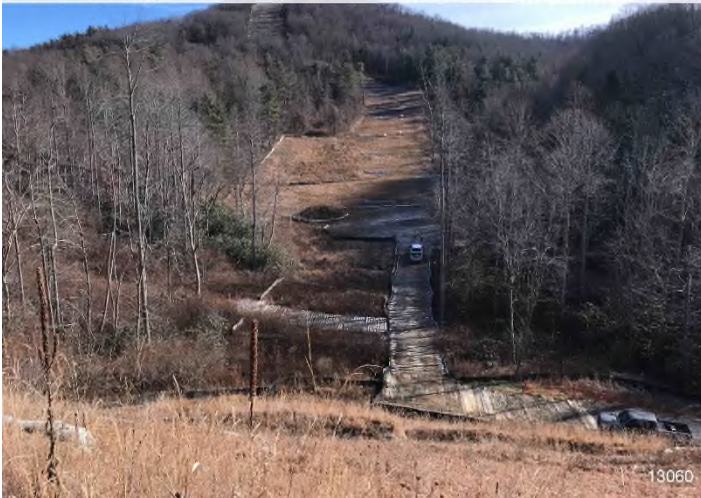
**Figure 3: STA 13060+00 – Controls in place and functioning properly.**

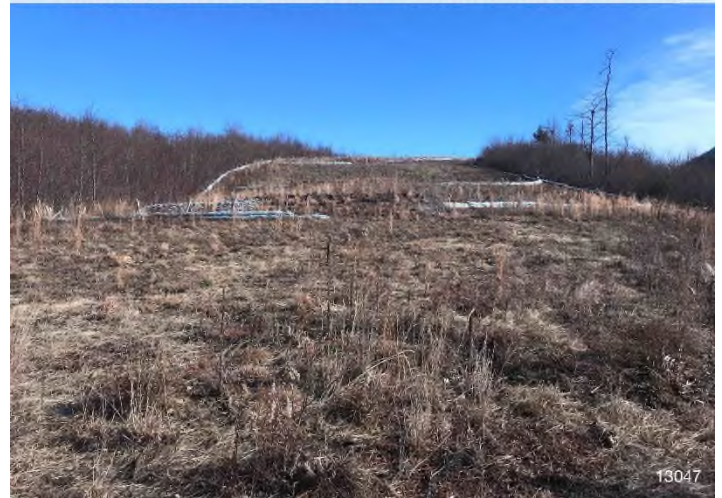
**Figure 4: STA 13047+00 – Controls in place and functioning properly.**
