## FIELD INSPECTION REPORT

Project Name:	Mountain Valley Pipeline	Inspector:	Marshall Willis
Inspection Date:	Friday, December 17, 2021	Project Contact:	Brian Clauto, Cory Chalmers
Spread I: Franklin County	STA 13575+21 – 13644+82	Weather:	Dry

## FIELD INSPECTION PHOTO LOG

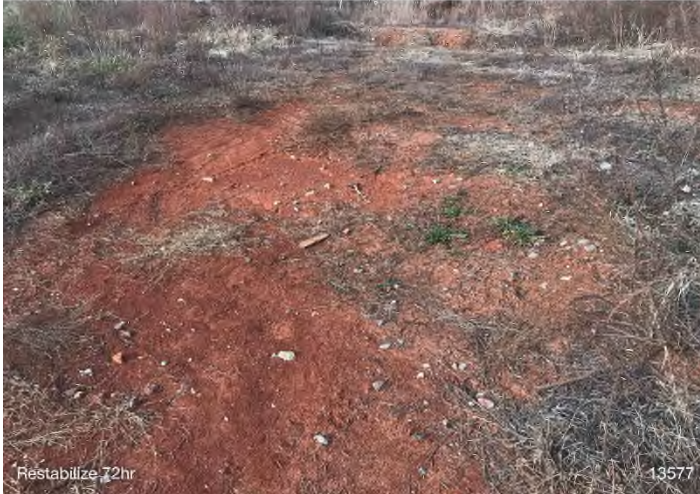
**Figure 1: STA 13577+50 – Re-stabilization needed.**

- STA 13577+00: Re-stabilize area.
- STA 13627+00: Re-stabilize area.

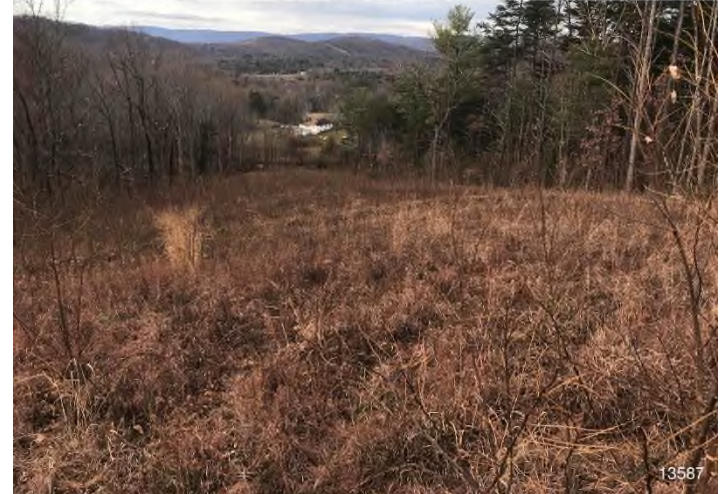
**Figure 2: STA 13587+00 – Controls in place and functioning properly.**

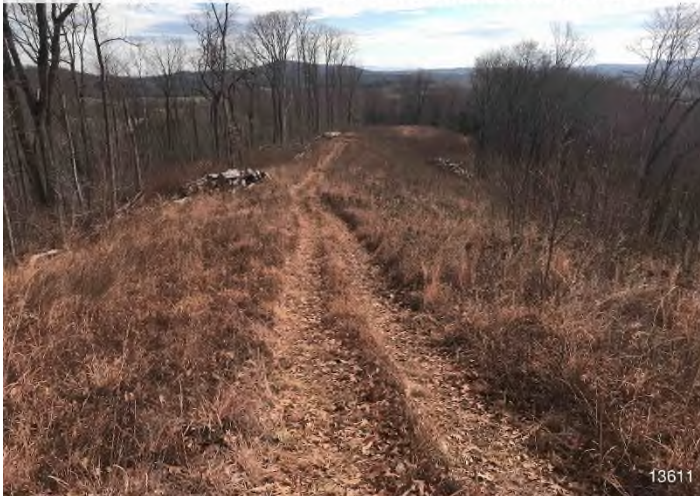
**Figure 3: STA 13611+00 – Controls in place and functioning properly.**

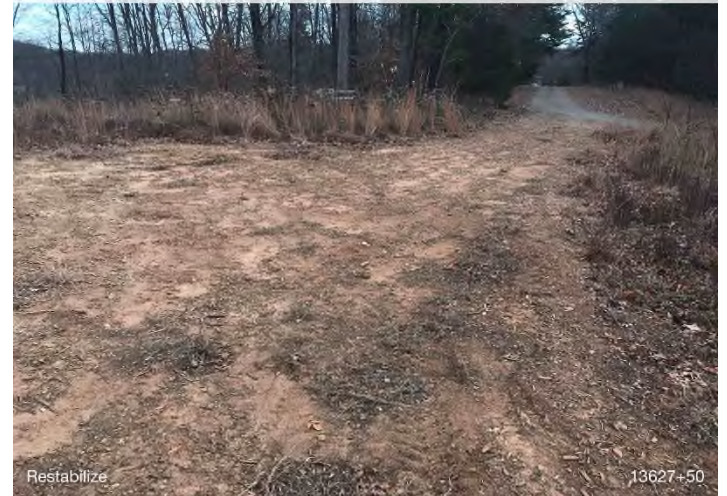
**Figure 4: STA 13627+50 – Re-stabilization needed.**
