FIELD INSPECTION REPORT

Project Name:	Mountain Valley Pipeline	Inspector:	Marshall Willis
Inspection Date:	Thursday, December 16, 2021	Project Contact:	Brian Clauto, Cory Chalmers
Spread H: Roanoke County	STA 12866+36 – 12915+20 MVP-RO-286	Weather:	Dry

FIELD INSPECTION PHOTO LOG

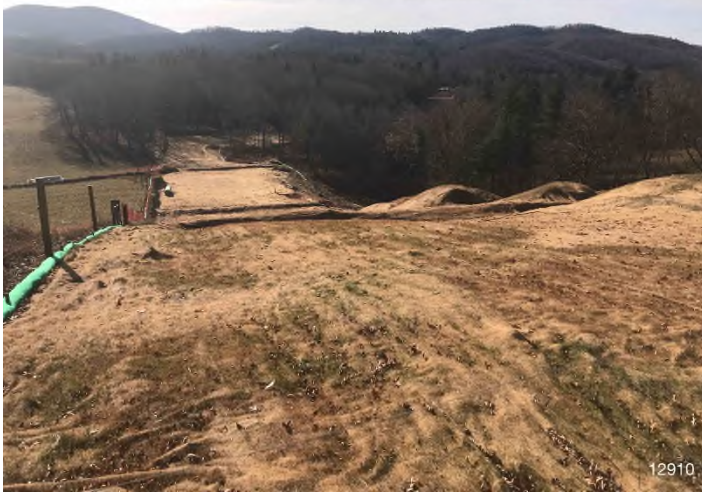
Figure 1: STA 12910+00 – Controls in place and functioning properly. Area stabilized with erosion matting.
BRG: 184°S (T) LAT: 37.135368 LON: -80.136183 ±17762ft ALT: 2723ft

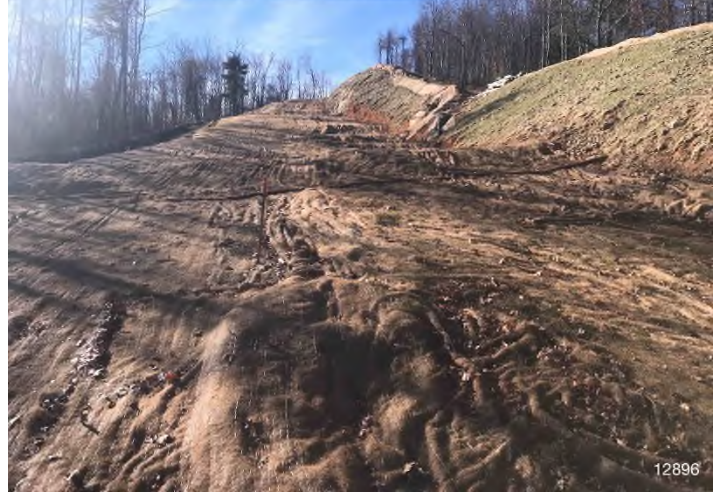
Figure 2: STA 12896+00 – Controls in place and functioning properly. Area stabilized with erosion matting.
BRG: 212°SW (T) LAT: 37.148069 LON: -80.134009 ±32ft ALT: 2624ft

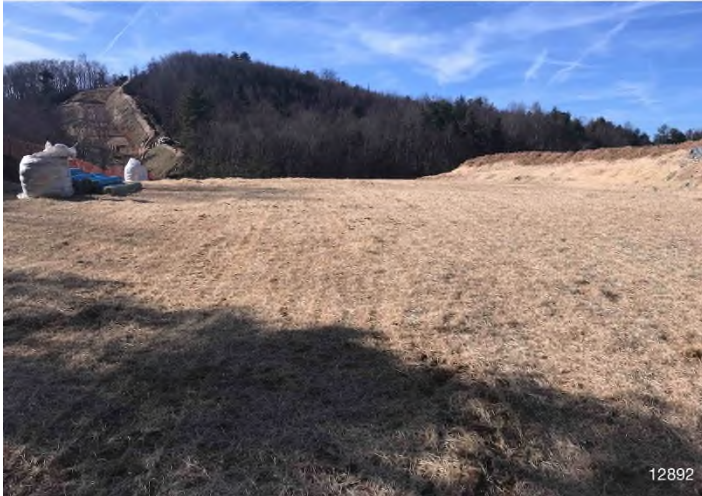
Figure 3: STA 12892+00 – Controls in place and functioning properly. Area stabilized with straw.
BRG: 220°SW (T) LAT: 37.149909 LON: -80.133341 ±328ft ALT: 2737ft

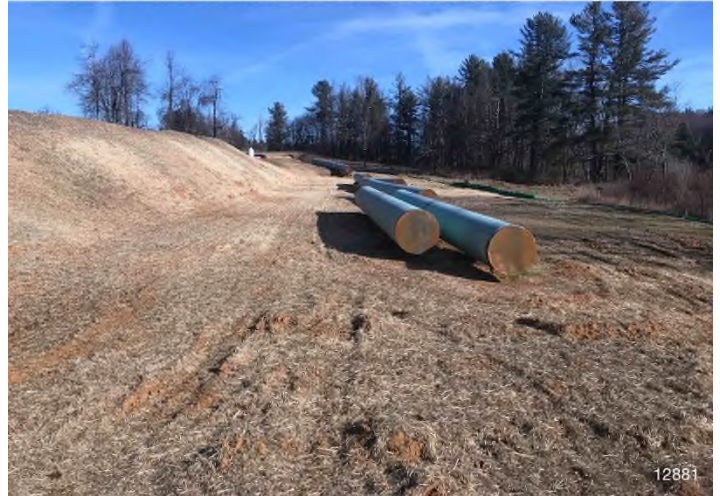
Figure 4: STA 12881+00 – Controls in place and functioning properly. Area stabilized with straw.
BRG: 45°NE (T) LAT: 37.148881 LON: -80.119800 ±10121ft ALT: 2659ft
