## FIELD INSPECTION REPORT

| <b>Project Name:</b> | Mountain Valley Pipeline | <b>Inspector:</b> | Marshall Willis |
| <b>Spread H:<br/>Roanoke County</b> | STA 12690+00 – 12730+00<br>MVP-RO-280<br>MVP-RO-281 | <b>Weather:</b> | Dry |

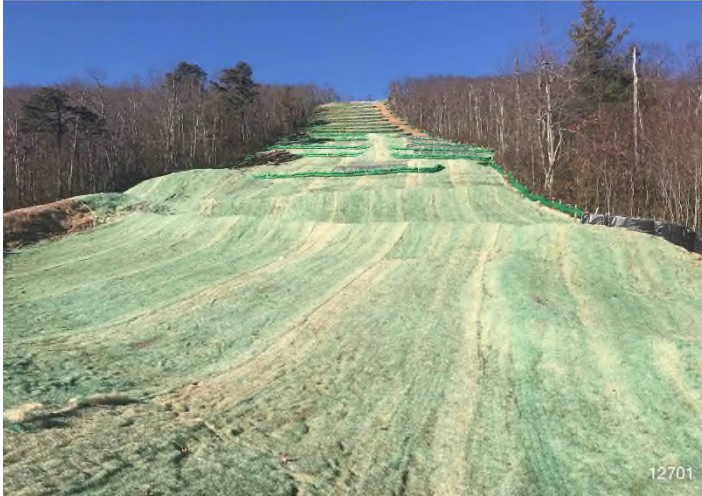
**Figure 1: STA 12701+00** – Controls in place and functioning properly. Area stabilized with erosion matting.  
BRG: 302°NW (T) LAT: 37.190745 LON: -80.153811 ±16ft ALT: 3353ft

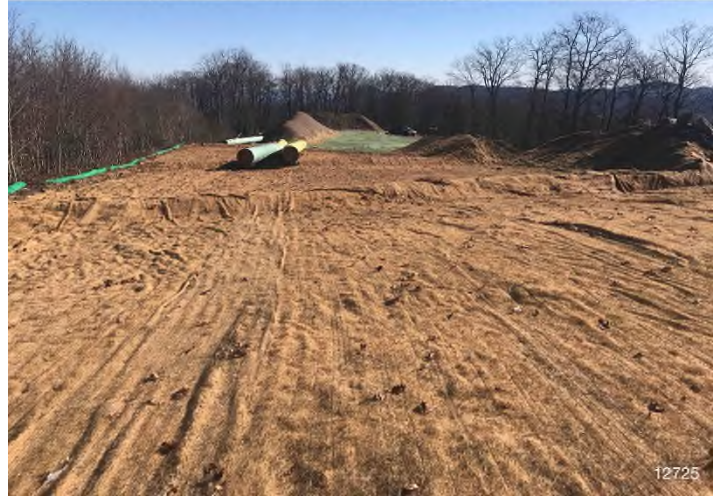
**Figure 2: STA 12725+00** – Controls in place and functioning properly. Area stabilized with erosion matting.  
BRG: 114°SE (T) LAT: 37.185484 LON: -80.149804 ±16ft ALT: 3397ft

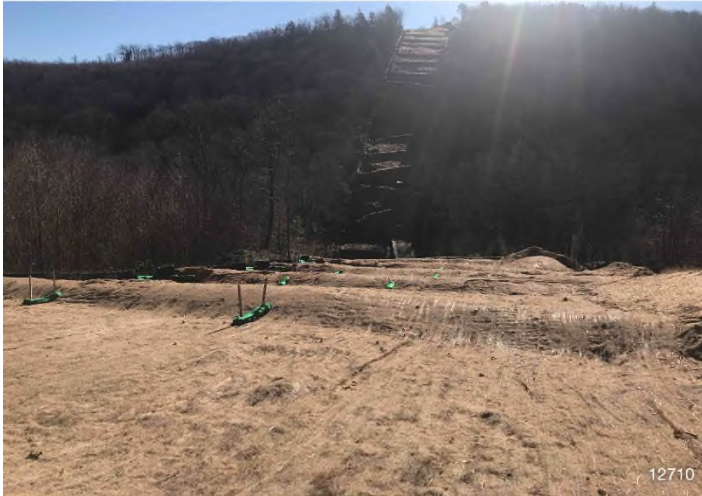
**Figure 3: STA 12710+00** – Controls in place and functioning properly. Area stabilized with erosion matting.  
BRG: 144°SE (T) LAT: 37.188799 LON: -80.151953 ±164ft ALT: 2997ft

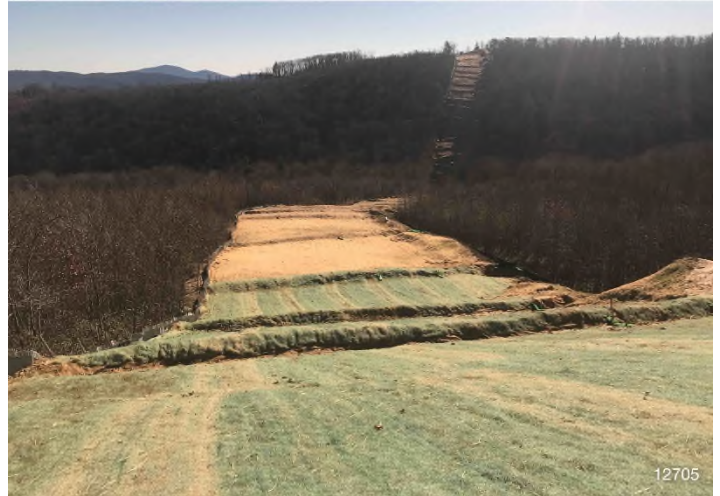
**Figure 4: STA 12705+00** – Controls in place and functioning properly. Area stabilized with erosion matting.  
BRG: 149°SE (T) LAT: 37.190526 LON: -80.153287 ±164ft ALT: 3341ft
