FIELD INSPECTION REPORT

| Project Name: | Mountain Valley Pipeline | Inspector: | Marshall Willis | | | |
| Inspection Date: | Thursday, February 3, 2022 | Project Contact: | Brian Clauto, Cory Chalmers | | | |
| Spread I: Franklin County | STA 13562+00 - 13575+00 STA 13535+00 - 13545+00 | Weather: | Rainy | | | |

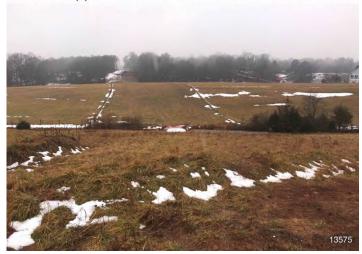
<u>Figure 1</u>: **STA 13575+00** – Controls in place and functioning properly.

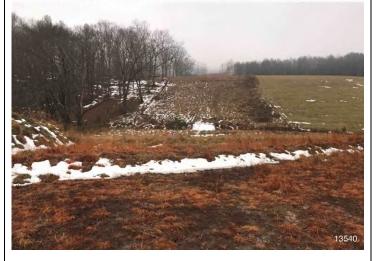
<u>Figure 3</u>: **STA 13540+00** – Controls in place and functioning properly.
