# FIELD INSPECTION REPORT

<b>Project Name:</b>	Mountain Valley Pipeline	<b>Inspector:</b>	Matthew Grant
<b>Inspection Date:</b>	Wednesday, February 2, 2022	<b>Project Contact:</b>	Brian Clauto
<b>Spread I: Franklin</b>	St13785-13750 ATWS 569A, 1444 AR-FR-30	<b>Weather:</b>	Wet

# FIELD INSPECTION PHOTO LOG

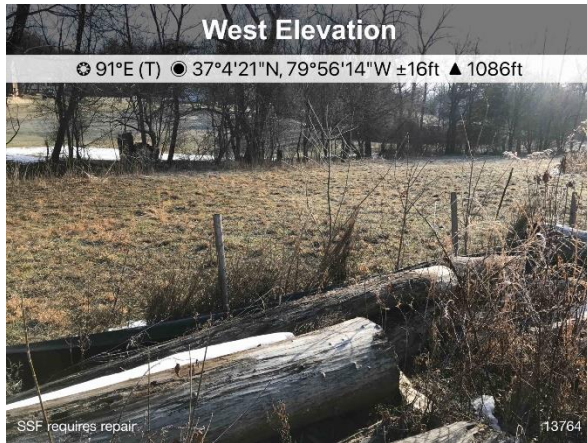
- St13764 SSF is down and requires repair.

- Figure 1: St 13764 SSF is down and requires repair.

**Recommended Corrective Action:** Maintain and install all controls per the approved PSS&S.

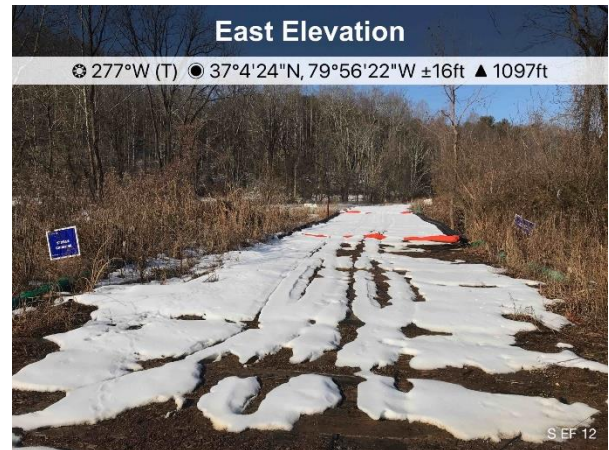
- Figure 2: ESC's are in place at designated crossing S-EF12.

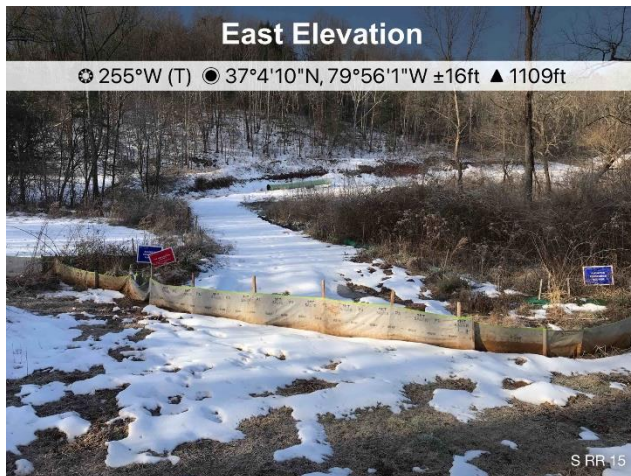
- Figure 3: ESC's are in place at designated crossing S-RR15.

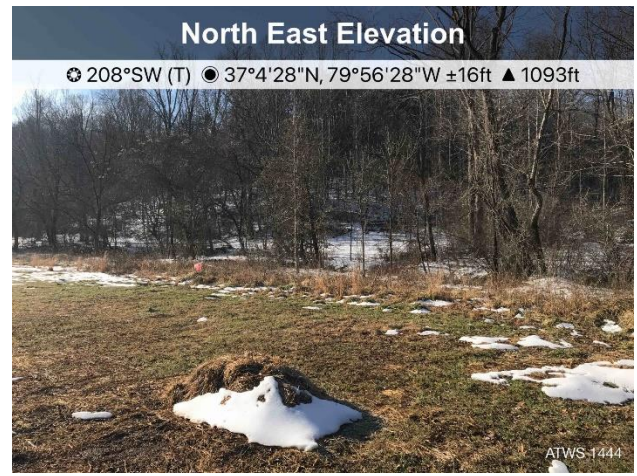
- Figure 4: ATWS 1444 remains dormant, ESC's are in place.
