## COMPLAINT INVESTIGATION REPORT

<b>Project Name:</b>	<b>Mountain Valley Pipeline</b>	<b>Inspector:</b>	<b>Marshall Willis</b>
<b>Inspection Date:</b>	<b>Wednesday, February 2, 2022</b>	<b>Project Contact:</b>	<b>Brian Clauto, Cory Chalmers</b>
<b>Spread I: Franklin County</b>	<b>MVP-MLV-AR-32</b>	<b>Weather:</b>	<b>Dry</b>

## FIELD INSPECTION PHOTO LOG

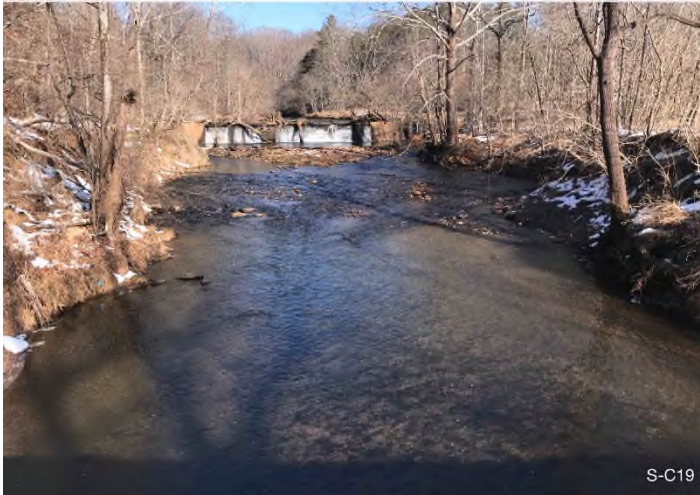
1. The "Arrington's Mill" dam in question is located approximately 250 feet upstream of the planned MVP ROW crossing of Maggodee Creek (See Figure 1).
2. Access Road MVP-MLV-AR-32 is also located downstream of the dam and runs parallel with Maggodee Creek for 150 feet before entering the ROW (See Figures 7 and 8).
3. Significant amount of woody debris was present on the dam (See Figures 1 and 2).
4. Bank subsidence was evident upstream of the scour area (See Figure 3).
5. Erosion control devices within the MVP limits of disturbance and along MVP-MLV-AR-32 were installed per the approved plans and appeared to be functioning as designed (See Figures 7 and 8).
6. No erosion was observed in the area where runoff from rock construction entrance flows to the stream bank.
7. At the time of inspection, there was no evidence of sediment discharge from MVP ROW.

**Figure 1: STA 14233+50** – Looking N upstream towards the Arrington Mill Dam from the Maggodee Creek ROW crossing.

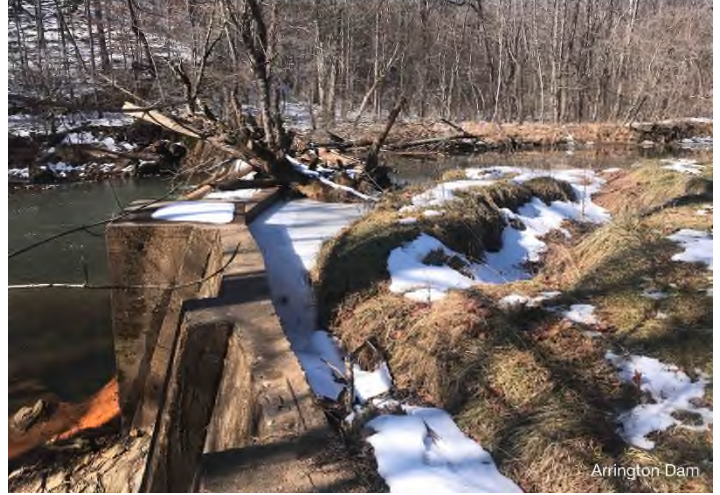
**Figure 2: Arrington Mill Dam** – Looking W at Arrington Mill Dam.

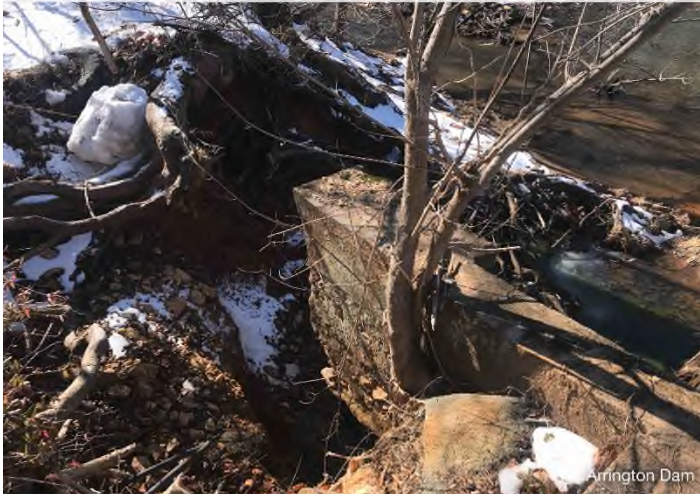
1. MVP construction appears to be in compliance with the approved plans. No requirement for corrective actions was noted during this inspection.
2. The bank scour observed on the east side of the dam does not appear to be the result of runoff from the MVP construction.
3. The bank scour is likely caused by combination of recent significant rainfall events, upstream land use practices and the age and disrepair of the dam itself.
4. DEQ staff recommended that Mr. Hale obtain an assessment and recommendation for maintenance and repairs to the dam from a qualified Professional Engineer with experience dealing with dams.

**Figure 3: Arrington Mill Dam** – Looking SW from the dam at the location of bank scour.

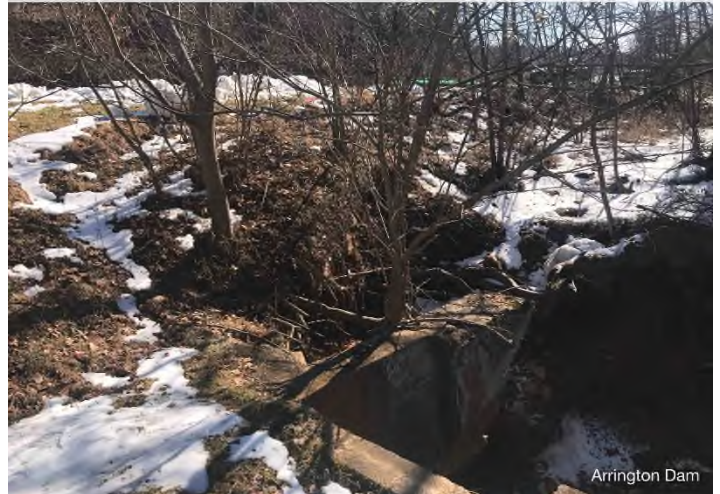
**Figure 4: Arrington Mill Dam** – Looking E towards start of access road MVP-MLV-AR-32 from the location of bank scour.

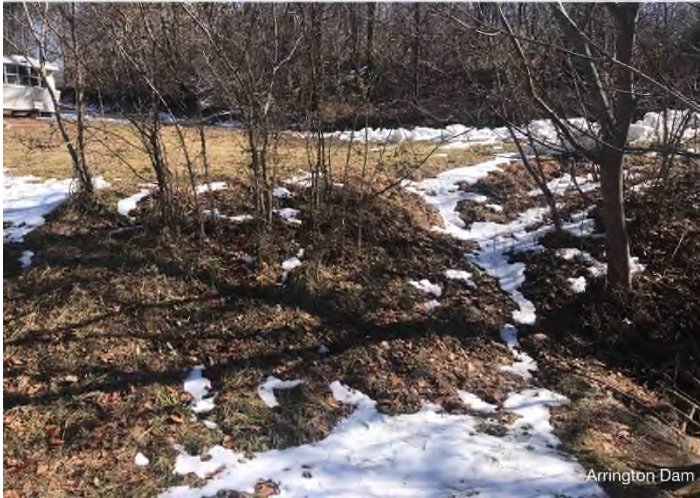
**Figure 5: Arrington Mill Dam** – Looking E towards start of access road MVP-MLV-AR-32.

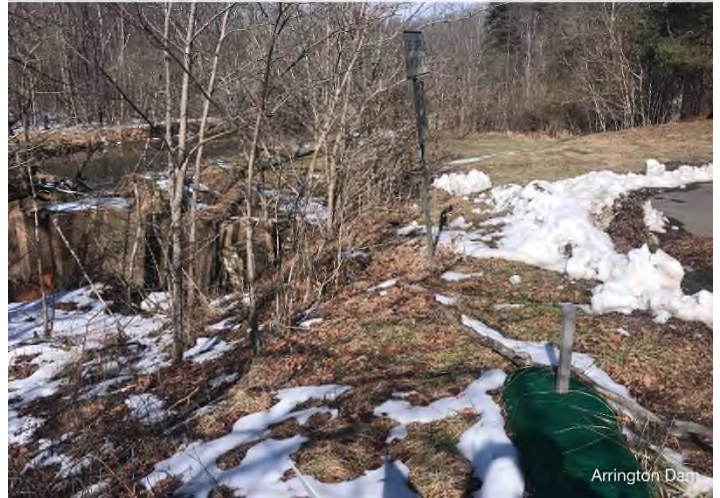
**Figure 6: MVP-MLV-AR-32** – Looking NW towards Arrington Mill dam from start of access road MVP-MLV-AR-32.

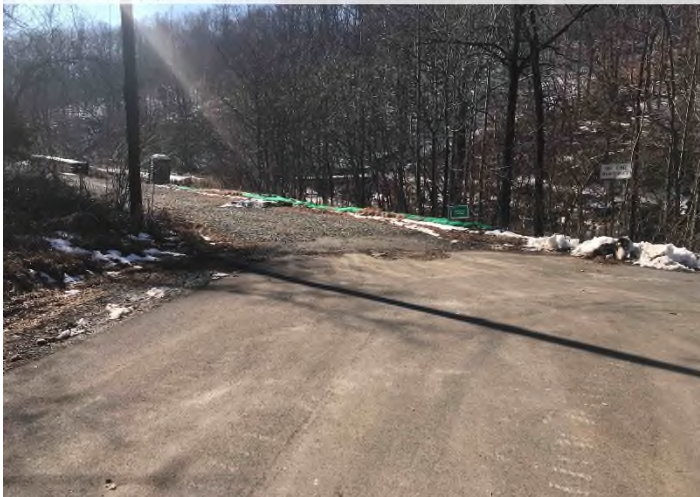
**Figure 7: MVP-MLV-AR-32** – Looking SSW towards Arrington Mill dam and start of access road MVP-MLV-AR-32.

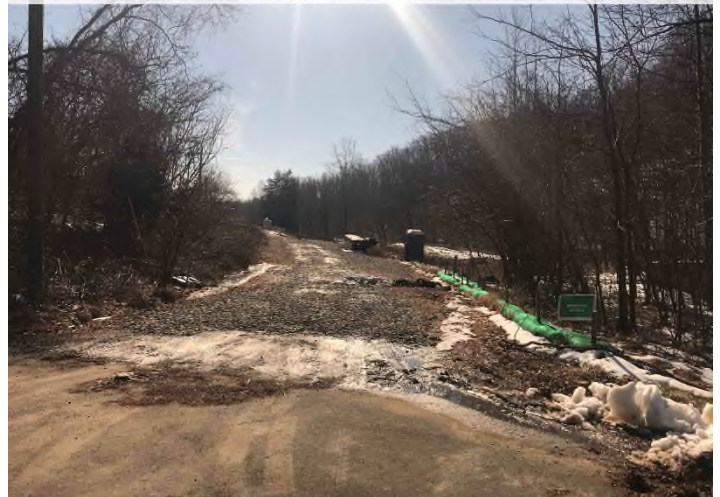
**Figure 8: MVP-MLV-AR-32** – Looking south down MVP access road at the RCE. Controls in place and functioning properly.
