## FIELD INSPECTION REPORT

Project Name:	Mountain Valley Pipeline	Inspector:	Marshall Willis
Inspection Date:	Tuesday, February 1, 2022	Project Contact:	Brian Clauto, Cory Chalmers
Spread I: Franklin County	STA 13892+45 – 14009+86 MVP-FR-306.02/306.03	Weather:	Wet

## FIELD INSPECTION PHOTO LOG

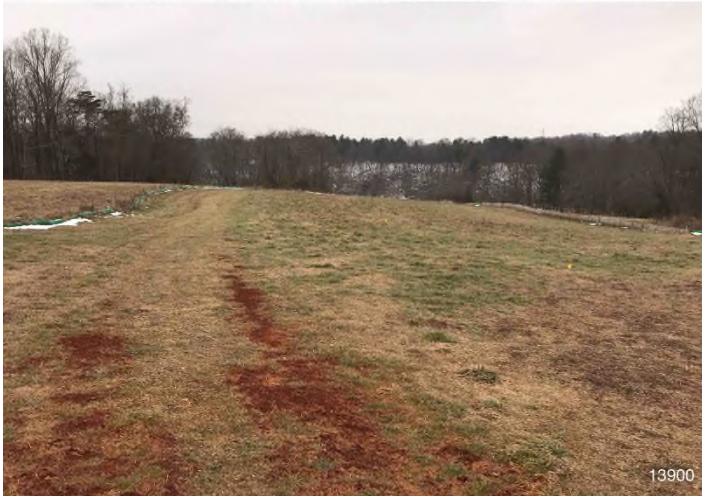
**Figure 1: STA 13900+00** – Controls in place and functioning properly.  
BRG: 204°SW (T) LAT: 37.053320 LON: -79.910466 ±643ft ALT: 1093ft

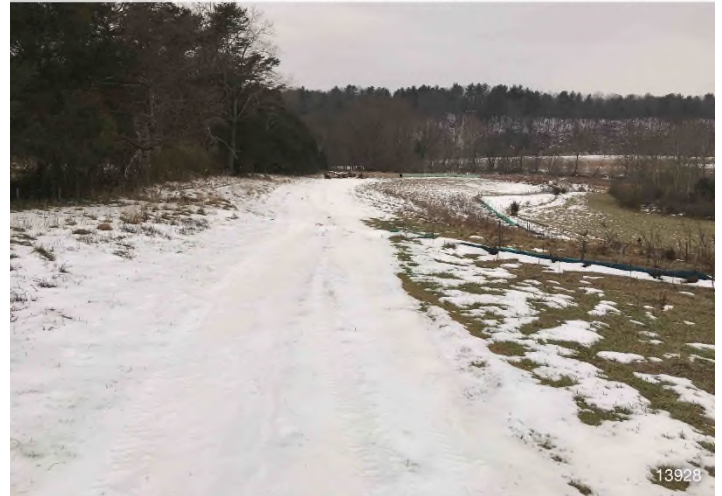
**Figure 2: STA 13928+00** – Controls in place and functioning properly.  
BRG: 249°W (T) LAT: 37.049708 LON: -79.905202 ±32ft ALT: 1057ft

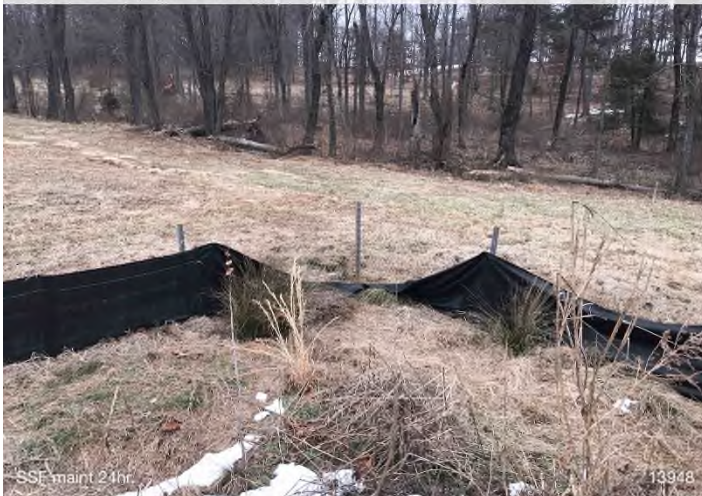
- STA 13948+00: SSF repair needed.

**Figure 3: STA 13948+00** – SSF repair needed.  
BRG: 50°NE (T) LAT: 37.047815 LON: -79.898022 ±98ft ALT: 1042ft

**Recommended Corrective Action:** Maintain and install all controls per the approved PSS&S.

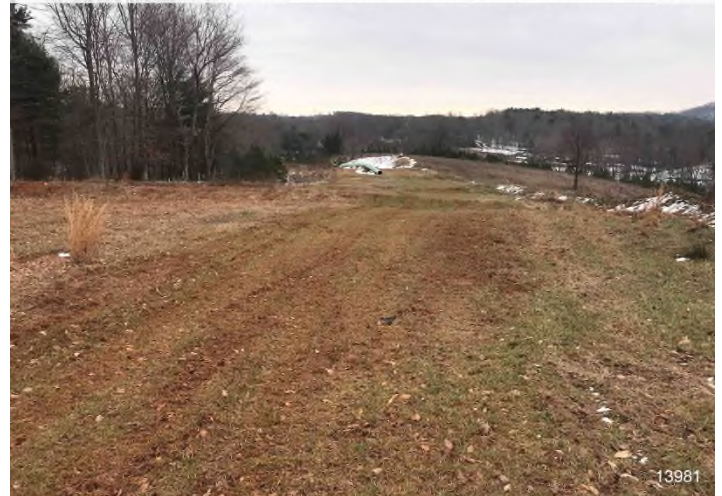
**Figure 4: STA 13981+00** – Controls in place and functioning properly.  
BRG: 112°E (T) LAT: 37.053989 LON: -79.911300 ±9724ft ALT: 1089ft
