Project Name:	Mountain Valley Pipeline	Inspector:	Matthew Grant		
Inspection Date:	Tuesday, February 1, 2022	Project Contact:	Brian Clauto		
Spread I: Franklin	St13958-14010 ATWS 1299, 1466 AR-FR-306.02	Weather:	Wet

## FIELD INSPECTION PHOTO LOG

**Project Name:** Mountain Valley Pipeline

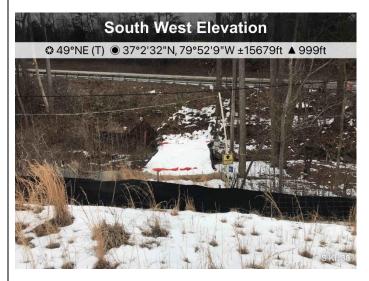
Figure 3: ESC's are in place at designated crossing S-KL38.

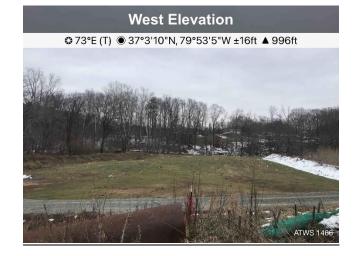
<u>Figure 4</u>: ATWS 1466 remains dormant with ESC and stabilization in place.
