FIELD INSPECTION REPORT

Project Name:	Mountain Valley Pipeline	Inspector:	Marshall Willis
Inspection Date:	Thursday, January 27, 2022	Project Contact:	Brian Clauto, Cory Chalmers
Spread I: Pittsylvania County	STA 15942+00 – 16026+00 Transco Station H-602/H603 Lines	Weather:	Wet

FIELD INSPECTION PHOTO LOG

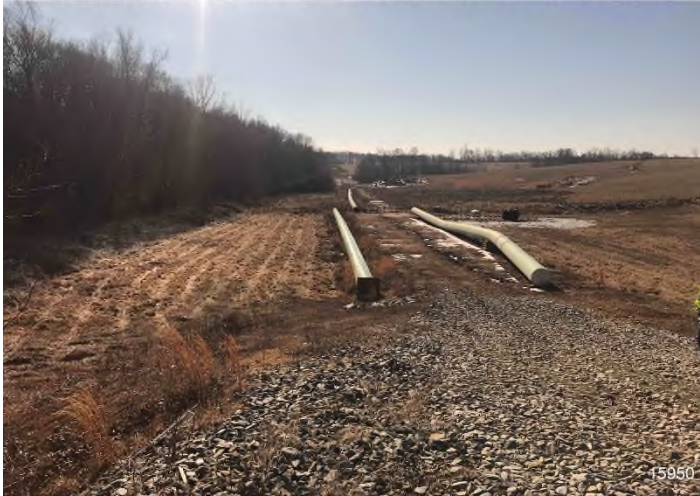
Figure 1: STA 15950+00 – Controls in place and functioning properly.

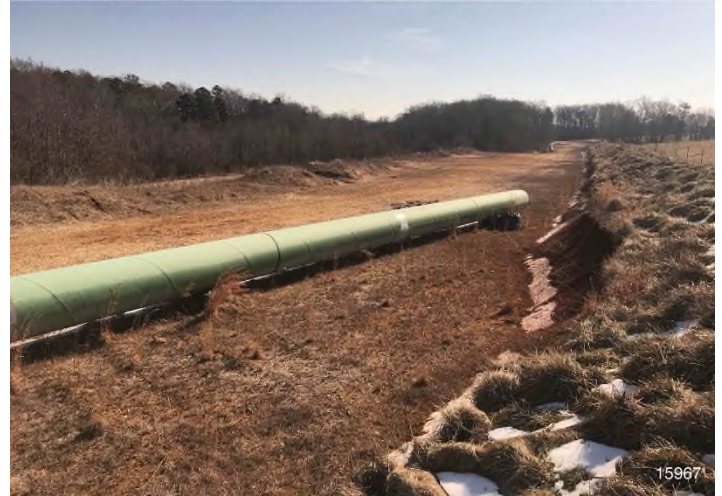
Figure 2: STA 15967+00 – Controls in place and functioning properly. Area stabilized with straw.

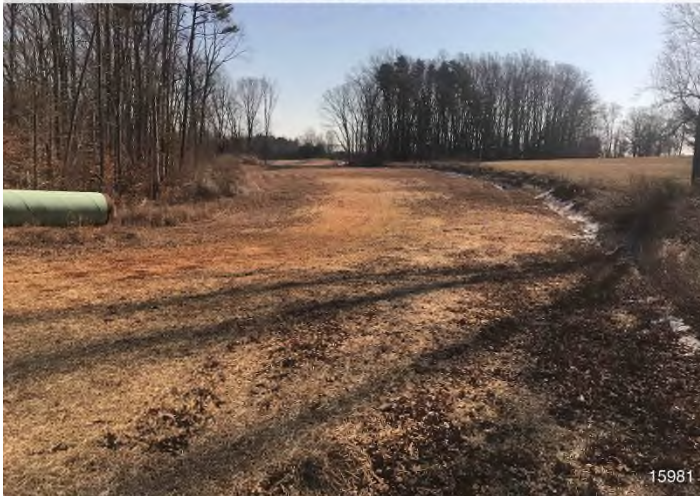
Figure 3: STA 15981+00 – Controls in place and functioning properly. Area stabilized with straw.

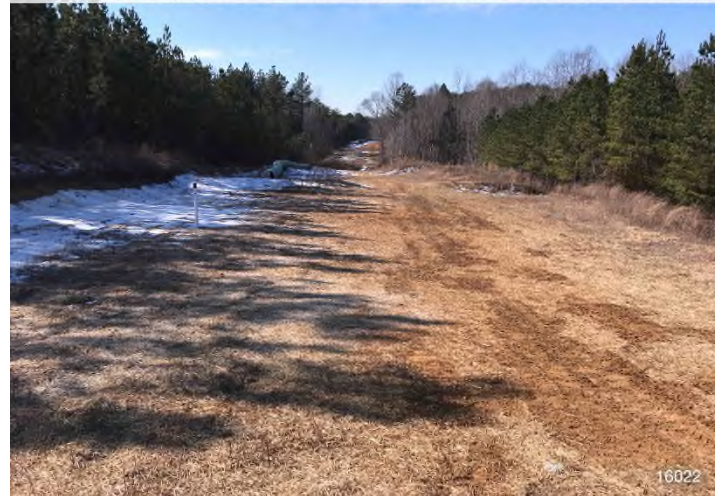
Figure 4: STA 16022+00 – Controls in place and functioning properly. Area stabilized with straw.
