## FIELD INSPECTION REPORT

| <b>Project Name:</b> | Mountain Valley Pipeline | <b>Inspector:</b> | Marshall Willis |
| <b>Spread H:<br/>Roanoke County</b> | STA 12945+00 – 12982+00<br>MVP-RO-287<br>MVP-RO-288 | <b>Weather:</b> | Snow |

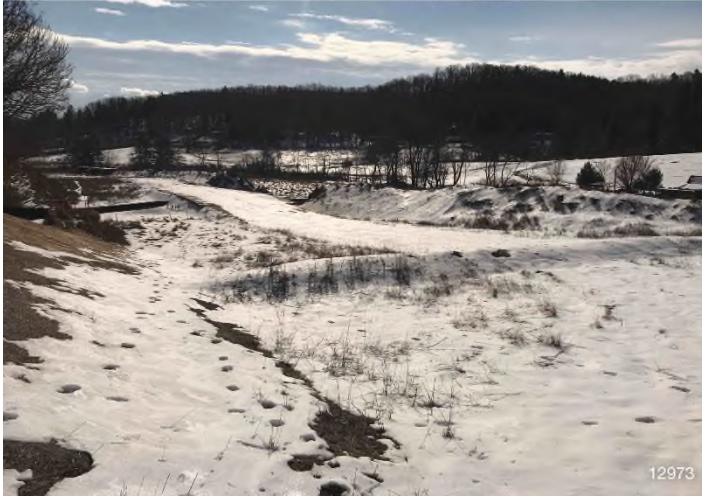
**Figure 1: STA 12973+00** – Controls in place and functioning properly.  
BRG: 109°E (T) LAT: 37.126278 LON: -80.138236 ±3343ft ALT: 2707ft

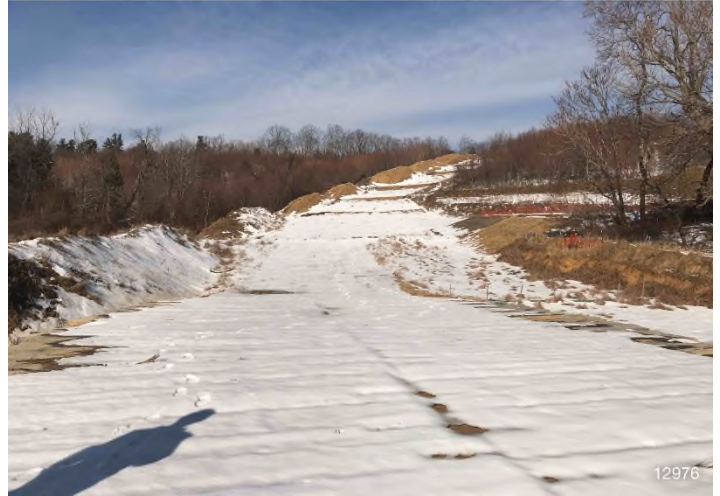
**Figure 2: STA 12976+00** – Controls in place and functioning properly.  
BRG: 314°NW (T) LAT: 37.130091 LON: -80.136250 ±98ft ALT: 2693ft

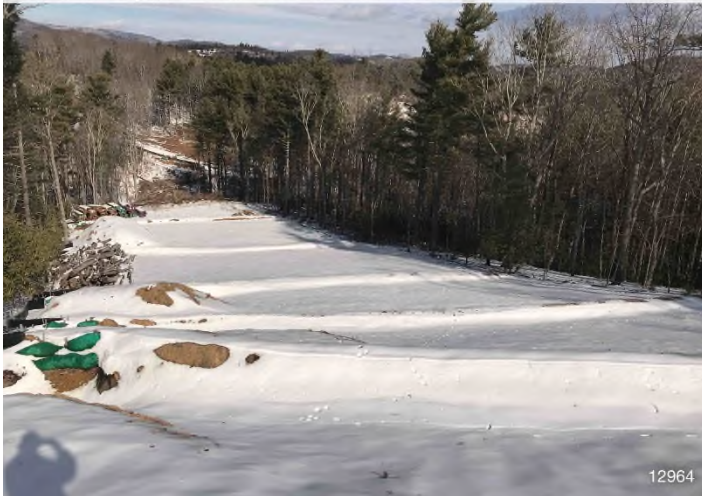
**Figure 3: STA 12964+00** – Controls in place and functioning properly.  
BRG: 13°N (T) LAT: 37.132743 LON: -80.137531 ±98ft ALT: 2653ft

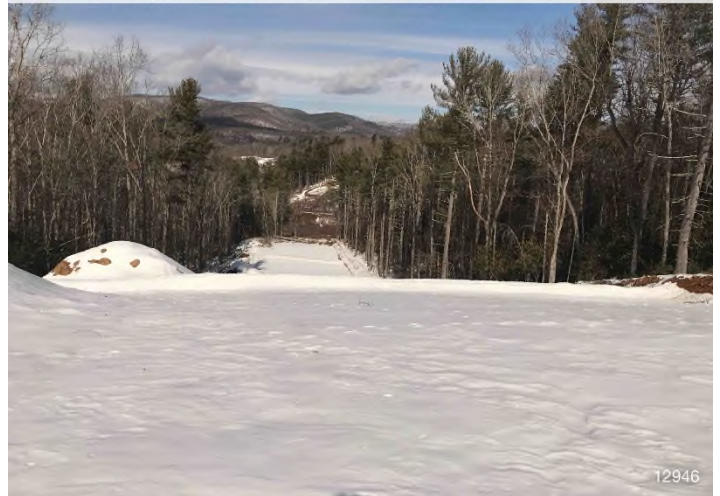
**Figure 4: STA 12946+00** – Controls in place and functioning properly.  
BRG: 353°N (T) LAT: 37.136174 LON: -80.138652 ±32ft ALT: 2718ft
