## FIELD INSPECTION REPORT

| Project Name: | Mountain Valley Pipeline | Inspector: | Marshall Willis |
| Spread H:<br>Franklin County | STA 13141+00 – 13196+00<br>MVP-FR-292/292.01 | Weather: | Snow |

## FIELD INSPECTION PHOTO LOG

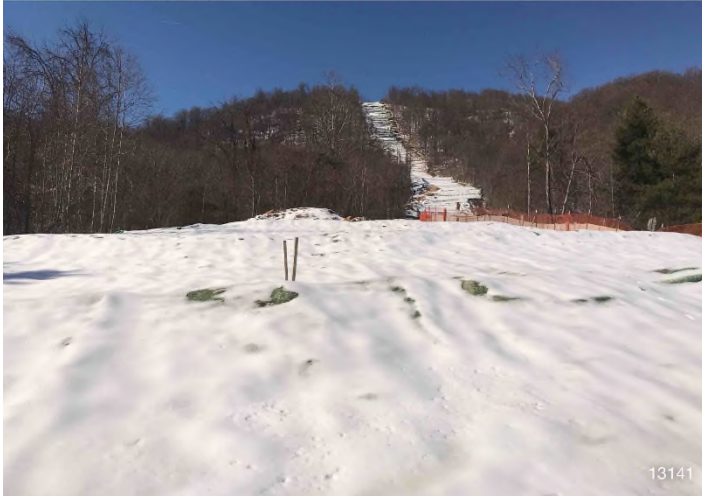
13141

**Figure 1: STA 13141+00** – Controls in place and functioning properly.

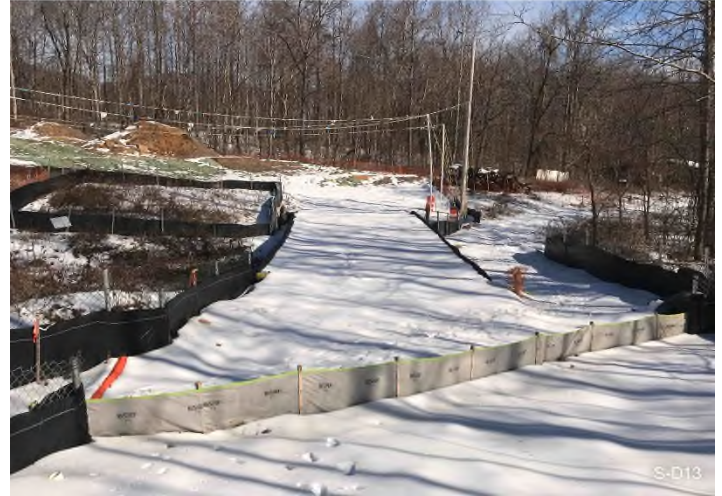
S-D13

**Figure 2: Stream S-D13** – Controls in place and functioning properly along stream crossing.

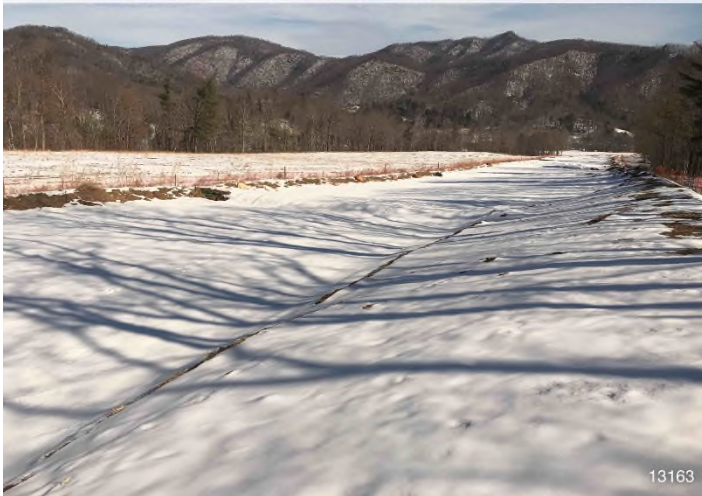
13163

**Figure 3: STA 13163+00** – Controls in place and functioning properly.

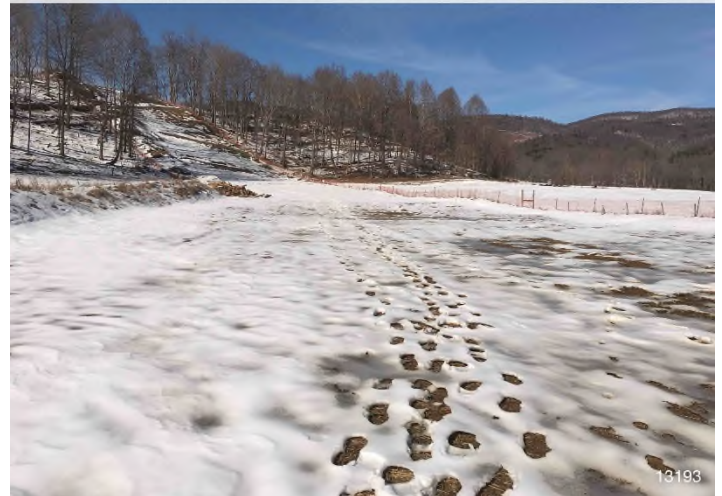
13193

**Figure 4: STA 13193+00** – Controls in place and functioning properly.
