## FIELD INSPECTION REPORT

Project Name:	Mountain Valley Pipeline	Inspector:	Marshall Willis
Inspection Date:	Wednesday, January 12, 2022	Project Contact:	Brian Clauto, Cory Chalmers
Spread I: Pittsylvania County	STA 15496+75 – 15584+25	Weather:	Dry

## FIELD INSPECTION PHOTO LOG

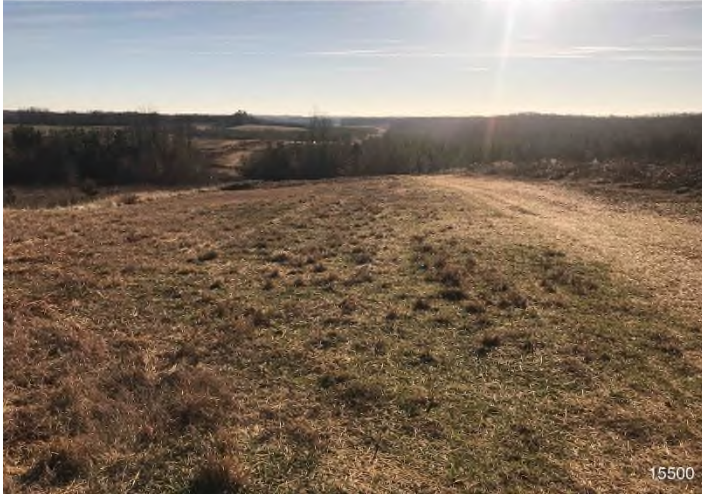
**Figure 1: STA 15500+00** – Controls in place and functioning properly. Area stabilized with straw.  
BRG: 123°SE (T) LAT: 36.906035 LON: -79.474116 ±32ft ALT: 952ft

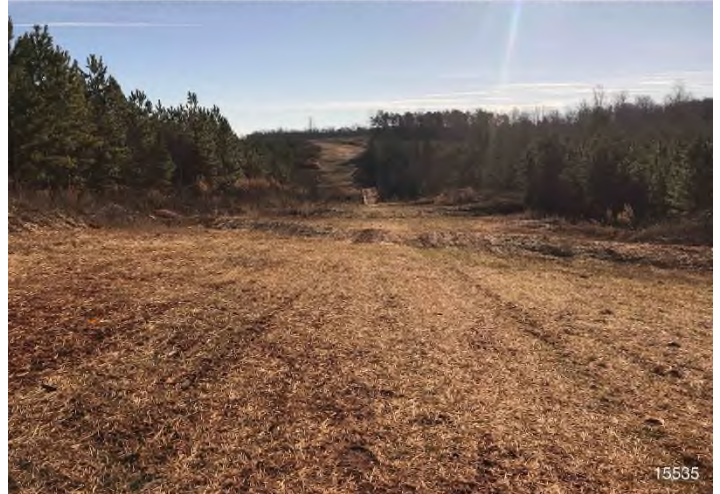
**Figure 2: STA 15535+00** – Controls in place and functioning properly. Area stabilized with straw.  
BRG: 95°E (T) LAT: 36.900461 LON: -79.464243 ±16ft ALT: 832ft

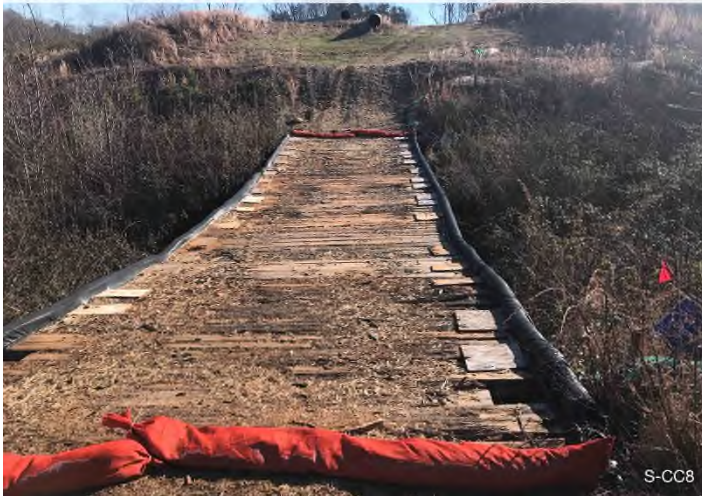
**Figure 3: Stream S-CC8** – Controls in place and functioning properly.  
BRG: 118°SE (T) LAT: 36.897904 LON: -79.458298 ±32ft ALT: 823ft

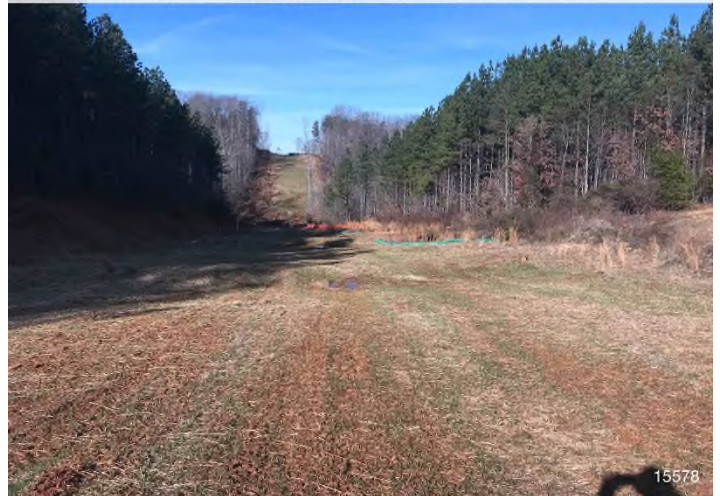
**Figure 4: STA 15578+00** – Controls in place and functioning properly. Area stabilized with straw.  
BRG: 307°NW (T) LAT: 36.892059 LON: -79.439800 ±21738ft ALT: 756ft
