FIELD INSPECTION REPORT

Project Name:	Mountain Valley Pipeline	Inspector:	Marshall Willis
Inspection Date:	Monday, January 10, 2022	Project Contact:	Brian Clauto, Cory Chalmers
Spread H: Montgomery County	STA 12414+00 – 12485+00 MVP-MLV-AR-28 MVP-MN-279.02	Weather:	Dry

FIELD INSPECTION PHOTO LOG

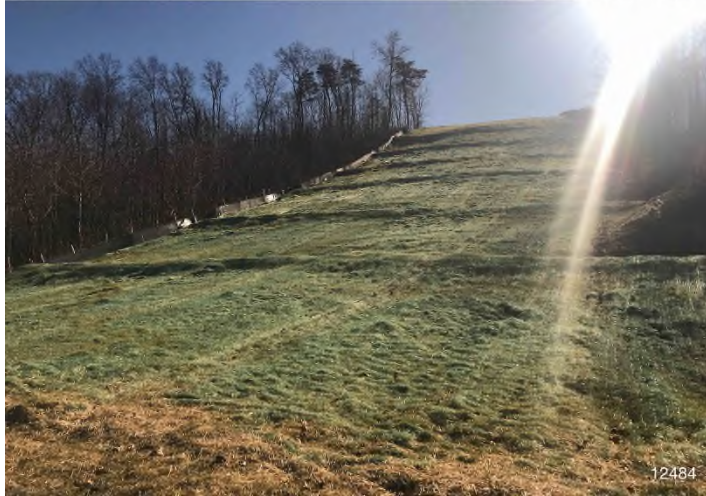
Figure 1: STA 12484+00 – Controls in place and functioning properly. Area stabilized with erosion matting.
BRG: 136°SE (T) **LAT:** 37.223450 **LON:** -80.202113 ±16ft **ALT:** 1483ft

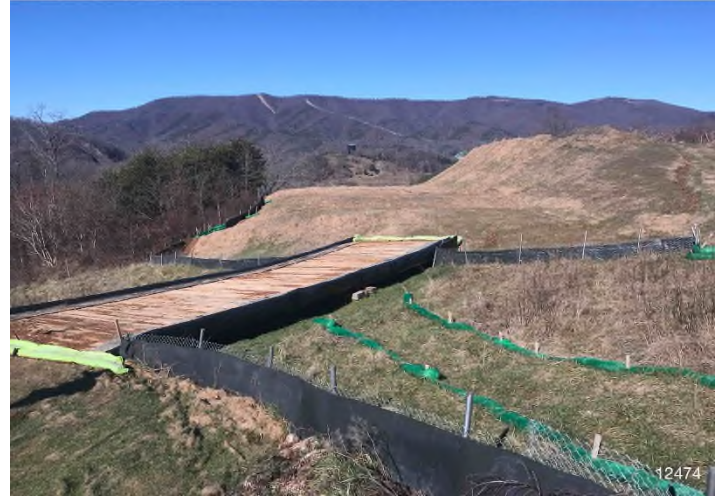
Figure 2: STA 12474+00 – Controls in place and functioning properly. Area stabilized with erosion matting.
BRG: 334°NW (T) **LAT:** 37.226016 **LON:** -80.202059 ±32ft **ALT:** 1380ft

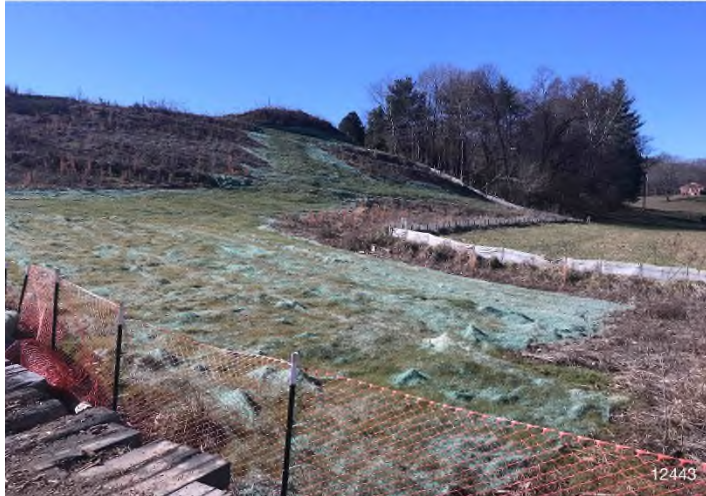
Figure 3: STA 12443+00 – Controls in place and functioning properly. Area stabilized with erosion matting.
BRG: 295°NW (T) **LAT:** 37.233211 **LON:** -80.198265 ±958ft **ALT:** 1161ft

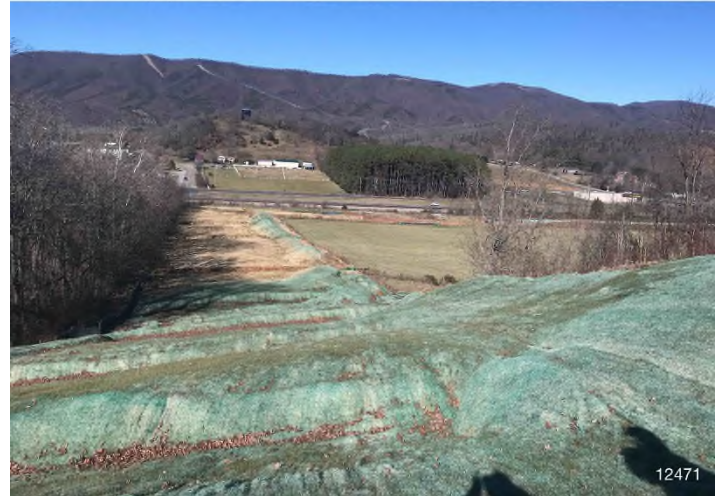
Figure 4: STA 12471+00 – Controls in place and functioning properly. Area stabilized with erosion matting.
BRG: 353°N (T) **LAT:** 37.227036 **LON:** -80.202321 ±32ft **ALT:** 1322ft
