## FIELD INSPECTION REPORT

| Project Name: | Mountain Valley Pipeline | Inspector: | Marshall Willis |
| Inspection Date: | Thursday, February 17, 2022 | Project Contact: | Brian Clauto, Cory Chalmers |
| Spread H:<br>Roanoke County | STA 12760+00 – 12797+00<br>MVP-RO-282 | Weather: | Dry |

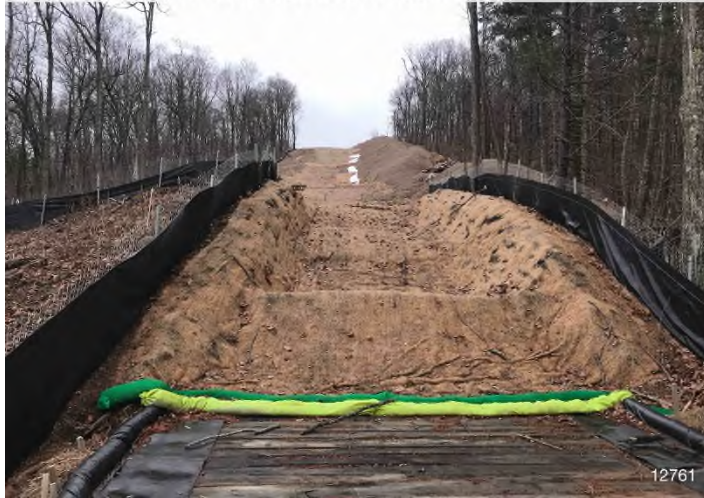
**Figure 1: STA 12761+00** – Controls in place and functioning properly. Area stabilized with erosion matting.  
BRG: 147°SE (T) LAT: 37.179111 LON: -80.141374 ±164ft ALT: 2904ft

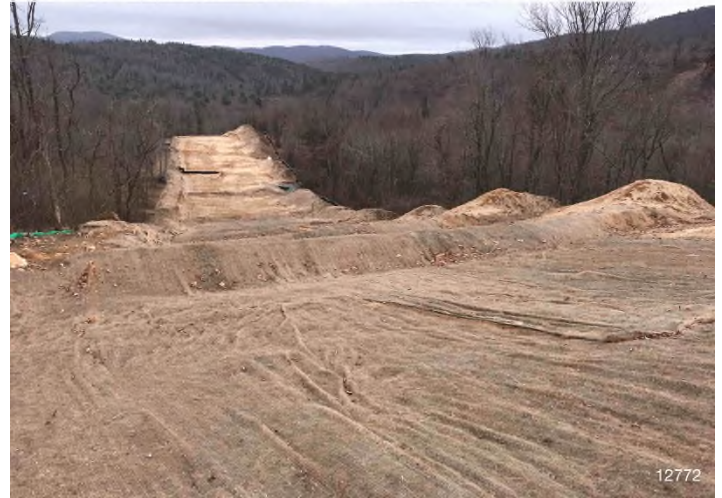
**Figure 2: STA 12772+00** – Controls in place and functioning properly. Area stabilized with erosion matting.  
BRG: 193°S (T) LAT: 37.181551 LON: -80.133599 ±6896ft ALT: 2981ft

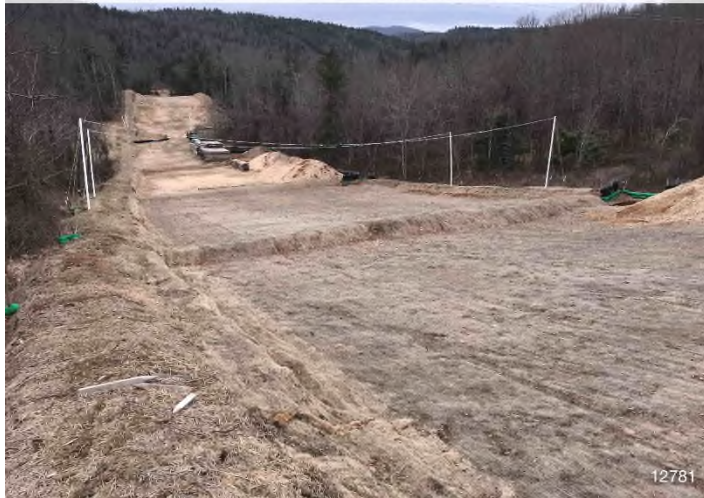
**Figure 3: STA 12781+00** – Controls in place and functioning properly. Area stabilized with erosion matting.  
BRG: 179°S (T) LAT: 37.178437 LON: -80.135868 ±6614ft ALT: 2870ft

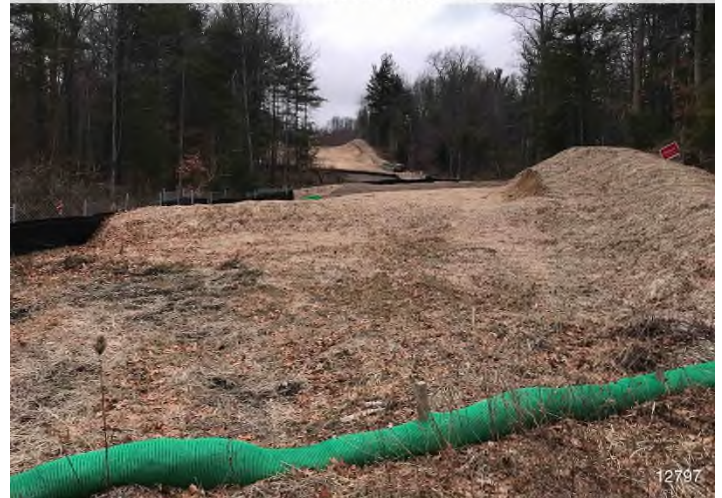
**Figure 4: STA 12797+00** – Controls in place and functioning properly.  
BRG: 21°N (T) LAT: 37.178961 LON: -80.134189 ±6040ft ALT: 2717ft
