## FIELD INSPECTION REPORT

| <b>Project Name:</b> | Mountain Valley Pipeline | <b>Inspector:</b> | Marshall Willis |
| <b>Spread H:<br/>Roanoke County</b> | STA 12700+00 – 12730+00<br>MVP-RO-280<br>MVP-RO-281 | <b>Weather:</b> | Dry |

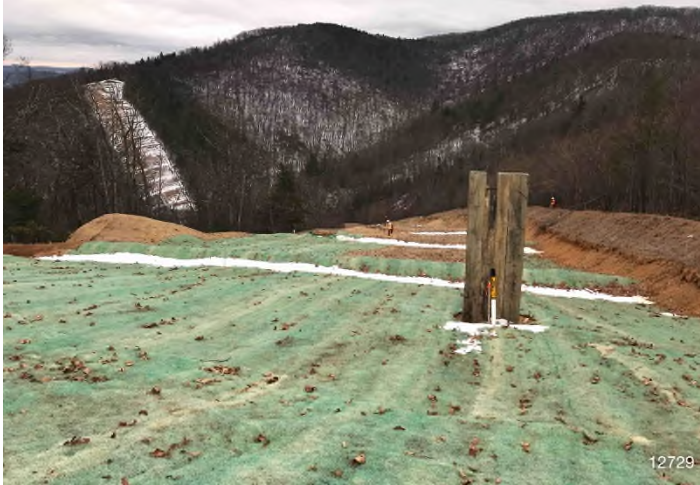
**Figure 1: STA 12729+00** – Controls in place and functioning properly.  
BRG: 174°S (T) LAT: 37.182598 LON: -80.132383 ±6896ft ALT: 3495ft

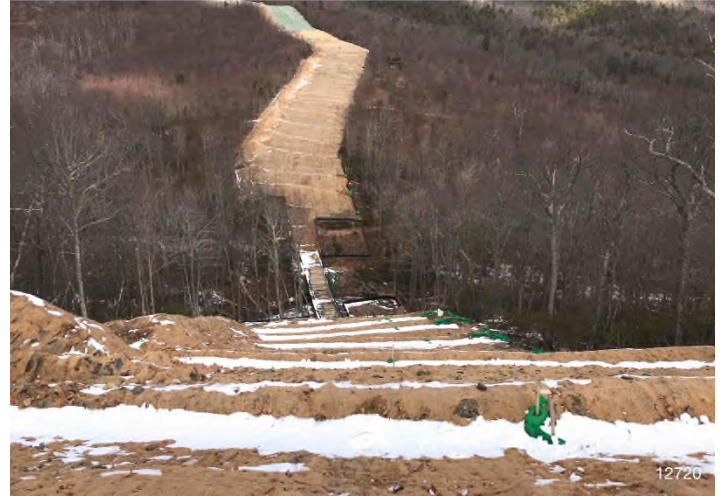
**Figure 2: STA 12720+00** – Controls in place and functioning properly.  
BRG: 350°N (T) LAT: 37.186471 LON: -80.150607 ±164ft ALT: 3262ft

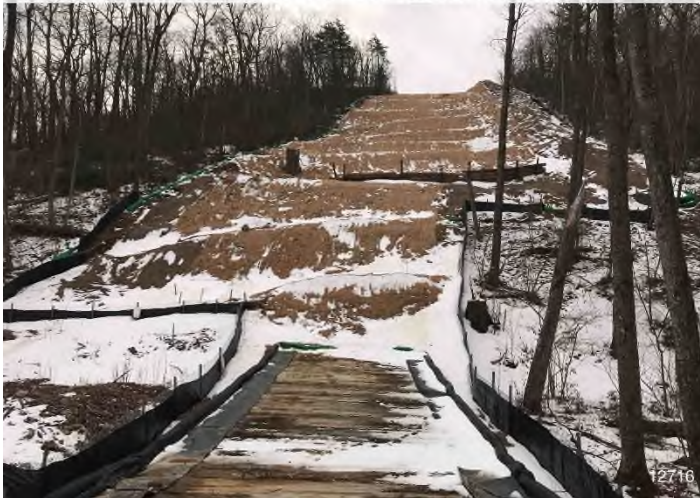
**Figure 3: STA 12716+00** – Controls in place and functioning properly.  
BRG: 56°NE (T) LAT: 37.187703 LON: -80.151183 ±32ft ALT: 3106ft

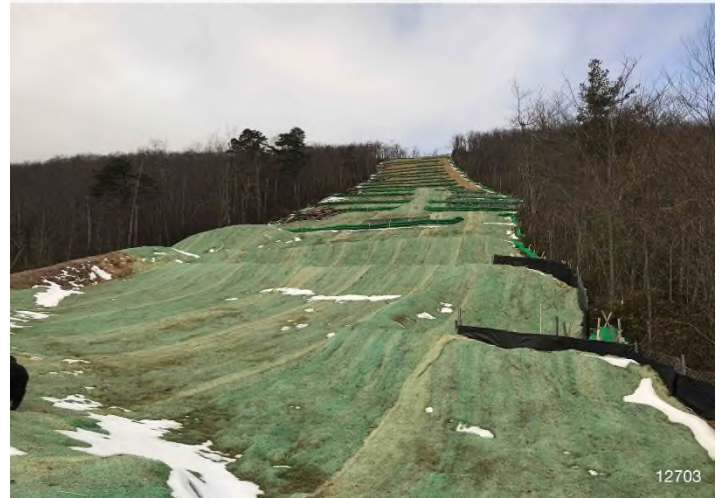
**Figure 4: STA 12703+00** – Controls in place and functioning properly.  
BRG: 294°NW (T) LAT: 37.191014 LON: -80.153724 ±32ft ALT: 3396ft
