FIELD INSPECTION REPORT

Project Name:	Mountain Valley Pipeline	Inspector:	Marshall Willis
Inspection Date:	Thursday, February 10, 2022	Project Contact:	Brian Clauto, Cory Chalmers
Spread I: Franklin County	STA 14861+31 – 14981+55	Weather:	Wet

FIELD INSPECTION PHOTO LOG

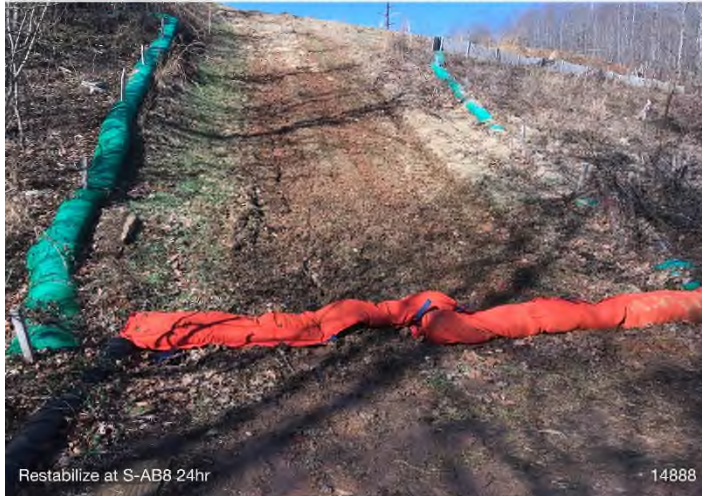
14888

Figure 1: STA 14888+00 – Re-stabilization needed adjacent to S-AB8.

Restabilize at S-AB8 24hr

- STA 14888+00: Re-stabilization needed adjacent to S-AB8.

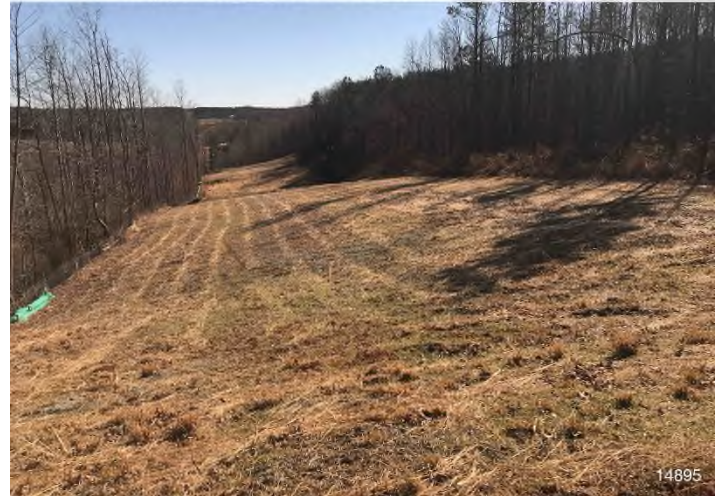
14895

Figure 2: STA 14895+00 – Controls in place and functioning properly.

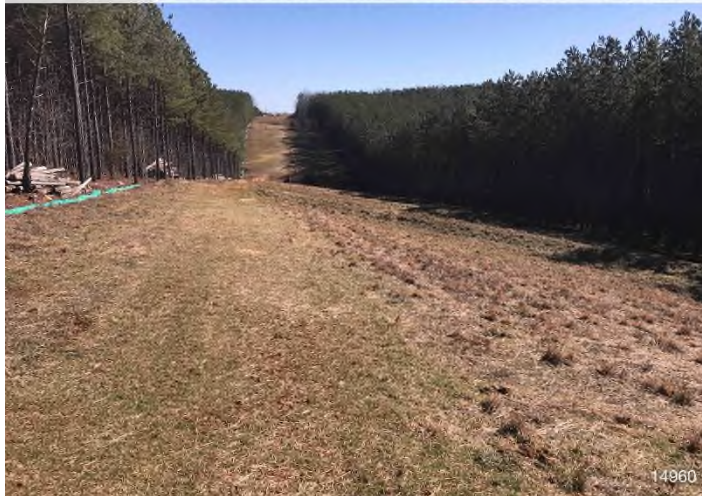
14960

Figure 3: STA 14960+00 – Controls in place and functioning properly.

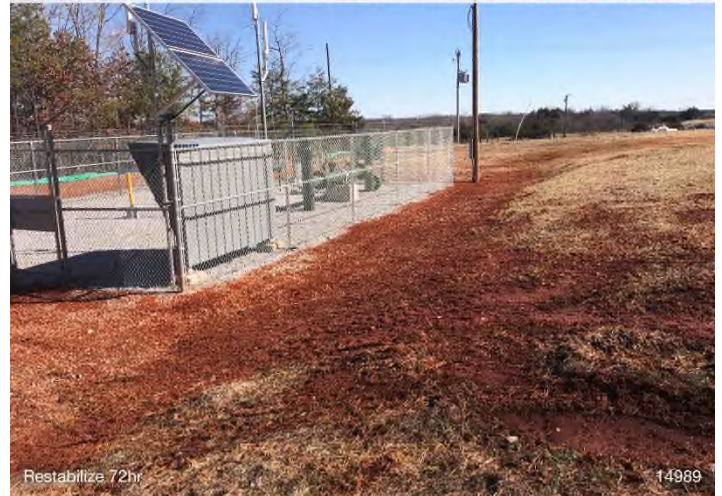
14989

Figure 4: STA 14989+00 – Re-stabilization needed.

Restabilize 72hr

- STA 14989+00: Re-stabilization needed.
