FIELD INSPECTION REPORT

Project Name:	Mountain Valley Pipeline	Inspector:	Marshall Willis
Inspection Date:	Monday, February 7, 2022	Project Contact:	Brian Clauto, Cory Chalmers
Spread H: Montgomery County	STA 12072+00 – 12103+00 STA 12234+00 – 12285+00 MVP-MN-270/270.01/276.03	Weather:	Rainy

FIELD INSPECTION PHOTO LOG

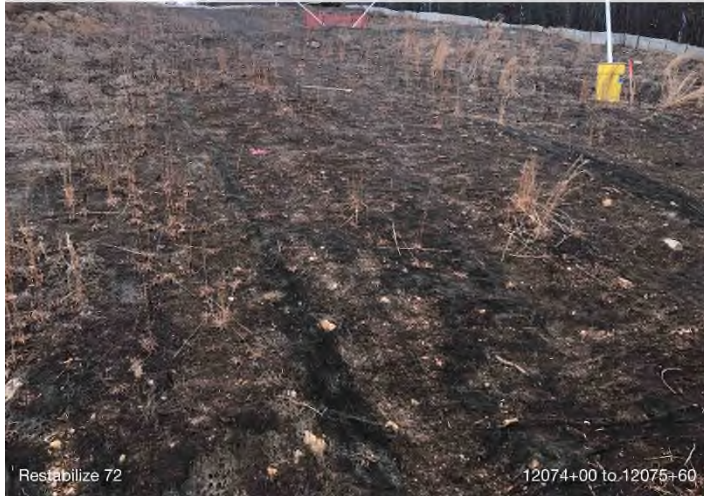
Figure 1: STA 12074+00 to 12075+60 – Re-stabilization needed.
Erosion control matting deteriorated.

Recommended Corrective Action: Maintain and install all controls per the approved PSS&S.

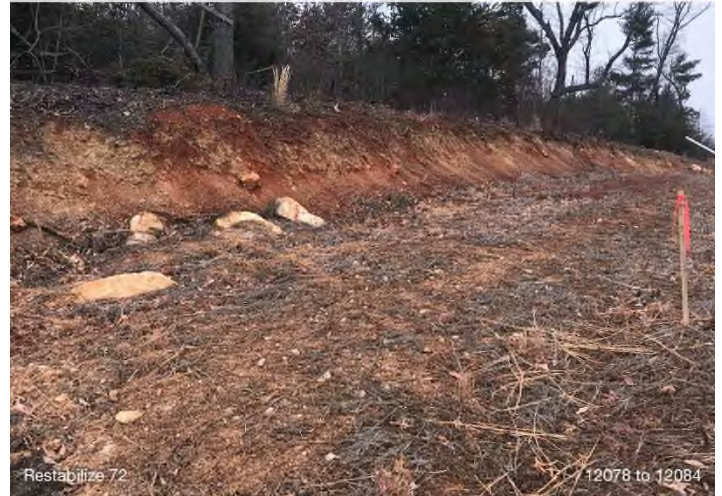
Figure 2: STA 12078+00 to 12084+00 – Re-stabilization needed.
Erosion control matting deteriorated.

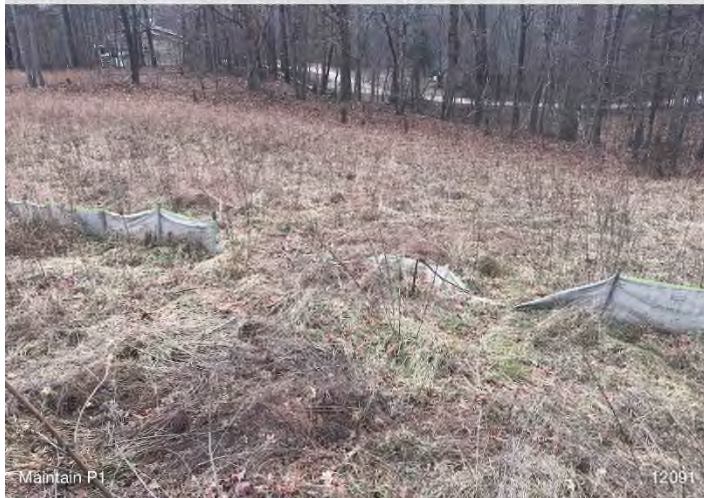
Figure 3: STA 12091+00 – P1 maintenance needed.

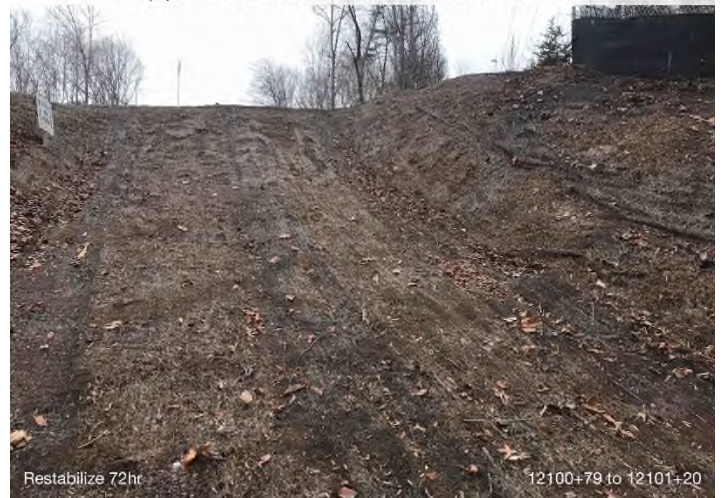
Figure 4: STA 12100+70 to 12101+20 – Re-stabilization needed.
Erosion control matting deteriorated.
