Project Name:	Mountain Valley Pipeline	Inspector:	Matthew Grant		
Inspection Date:	Tuesday, February 22, 2022	Project Contact:	Brian Clauto		
Spread H: Montgomery	St1298-12300, 12154-12150, 12120, 12100-12112 ATWS 1374, 1216, 1217, 1167, 1168 AR-MN276.03, 273, 270.01, 271	Weather:	Wet

FIELD INSPECTION PHOTO LOG

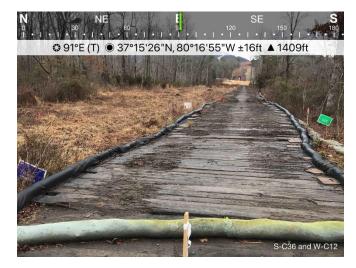
Figure 1: Designated crossing S-C12 & W-C12, ESC's are in place and functioning.

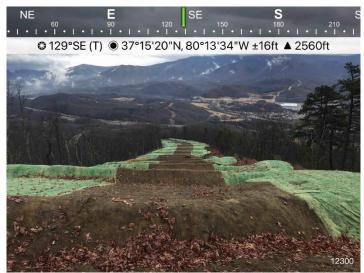
Figure 2: St12300, ESC controls were in place.
