Project Name:	Mountain Valley Pipeline	Inspector:	Matthew Grant
Inspection Date:	Wednesday, March 9, 2022	Project Contact:	Brian Clauto
Spread H: Montgomery	St12914-12867+08 ATWS 1236, 1326 AR-Fr	Weather:	Wet

FIELD INSPECTION PHOTO LOG

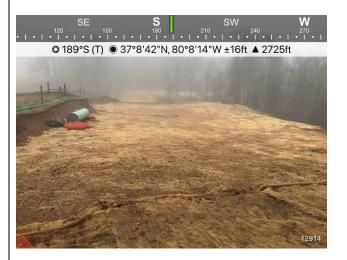
Figure 2: St12914, ESC controls were in place.
