## FIELD INSPECTION REPORT

Project Name:	Mountain Valley Pipeline	Inspector:	Marshall Willis
Inspection Date:	Monday, March 7, 2022	Project Contact:	Brian Clauto, Cory Chalmers
Spread I: Franklin County	STA 13748+30 – 13826+95 MVP-FR-300/302	Weather:	Dry

## FIELD INSPECTION PHOTO LOG

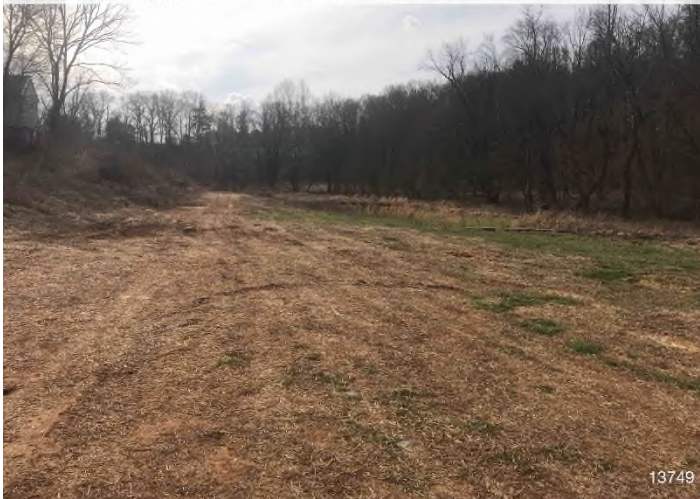
**Figure 1: STA 13749+00** – Controls in place and functioning properly.

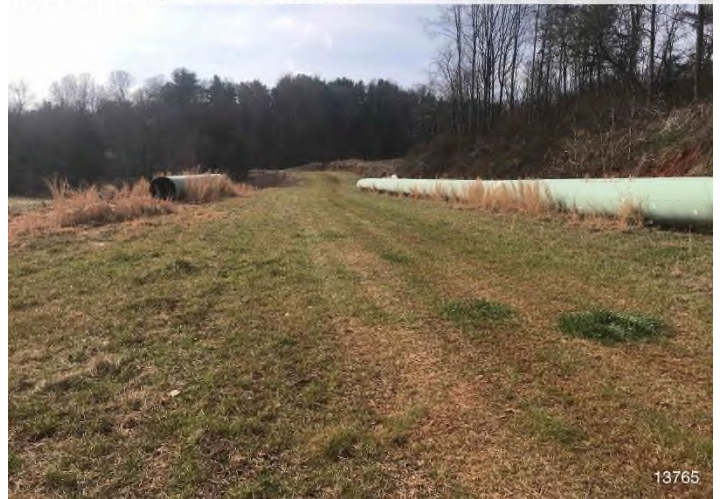
**Figure 2: STA 13765+00** – Controls in place and functioning properly.

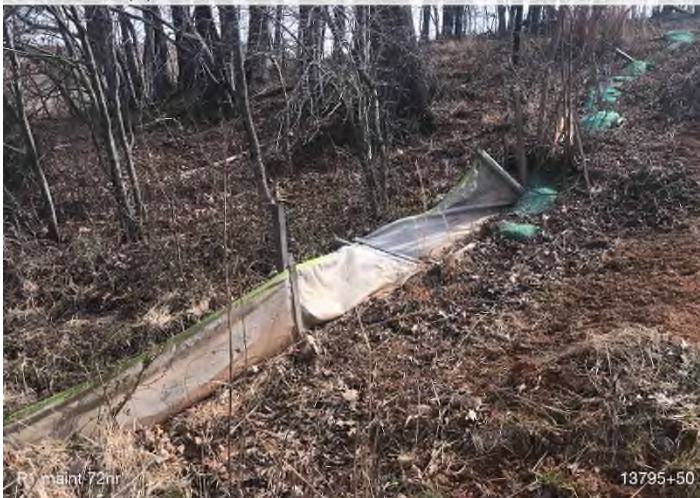
- STA 13795+50: P1 maintenance needed.

**Figure 3: STA 13795+50** – P1 maintenance needed.

**Recommended Corrective Action:** Maintain and install all controls per the approved PSS&S.

**Deadline:** Within 72-Hour of Notification

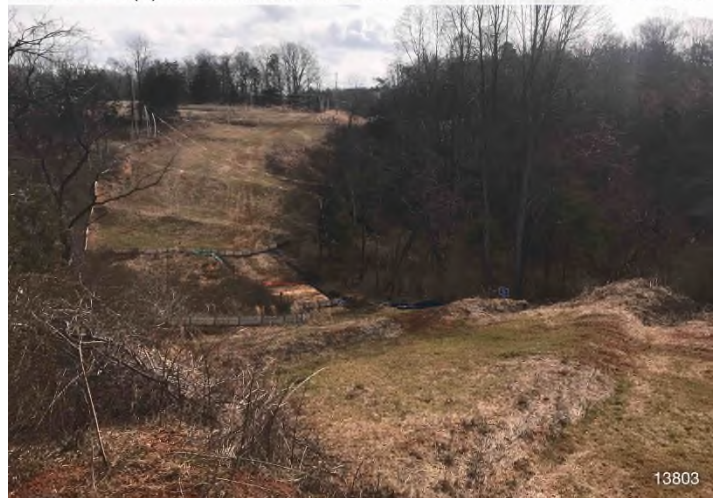
**Figure 4: STA 13803+00** – Controls in place and functioning properly.
