## FIELD INSPECTION REPORT

| Project Name: | Mountain Valley Pipeline | Inspector: | Marshall Willis |
| Inspection Date: | Wednesday, March 2, 2022 | Project Contact: | Brian Clauto, Cory Chalmers |
| Spread I:<br>Franklin County | STA 13415+00 – 13438+00<br>MVP-FR-293.02 | Weather: | Dry |

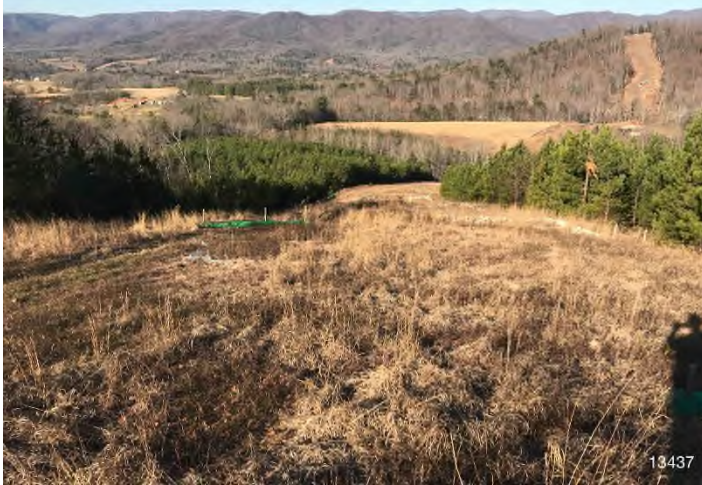
**Figure 1: STA 13437+00** – Controls in place and functioning properly.

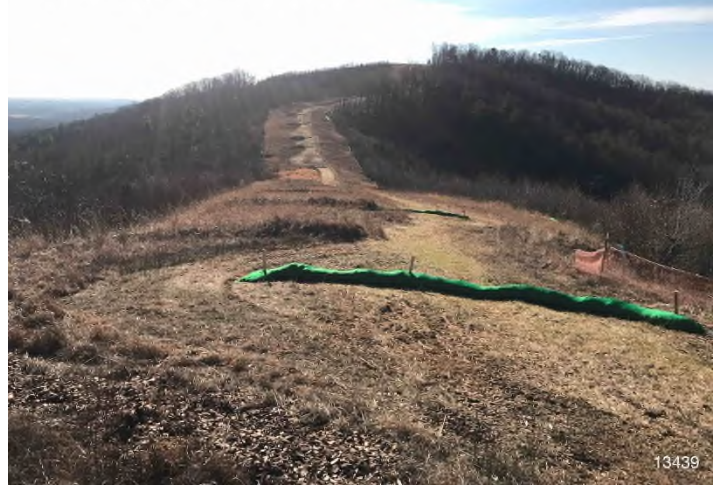
**Figure 2: STA 13439+00** – Controls in place and functioning properly.
