FIELD INSPECTION REPORT

Project Name:	Mountain Valley Pipeline	Inspector:	Marshall Willis
Inspection Date:	Wednesday, March 9, 2022	Project Contact:	Brian Clauto, Cory Chalmers
Spread H: Roanoke County	STA 12866+36 – 12915+15 MVP-RO-286	Weather:	Wet

FIELD INSPECTION PHOTO LOG

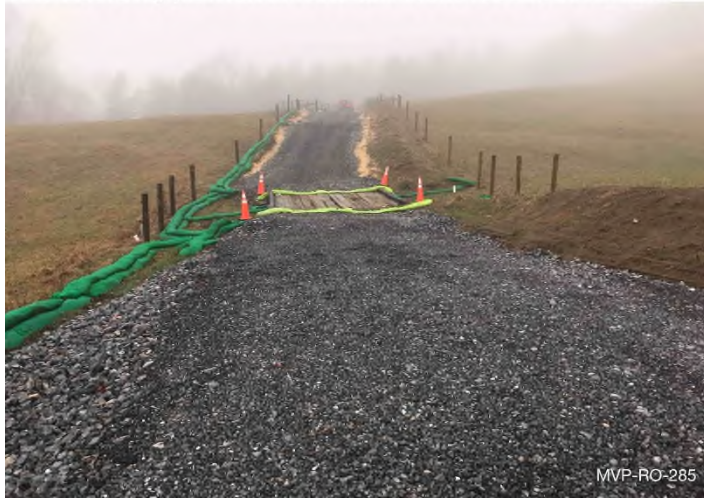
Figure 1: MVP-RO-286 – Controls in place and functioning properly.
BRG: 230°SW (T) LAT: 37.144918 LON: -80.135892 ±32ft ALT: 2665ft

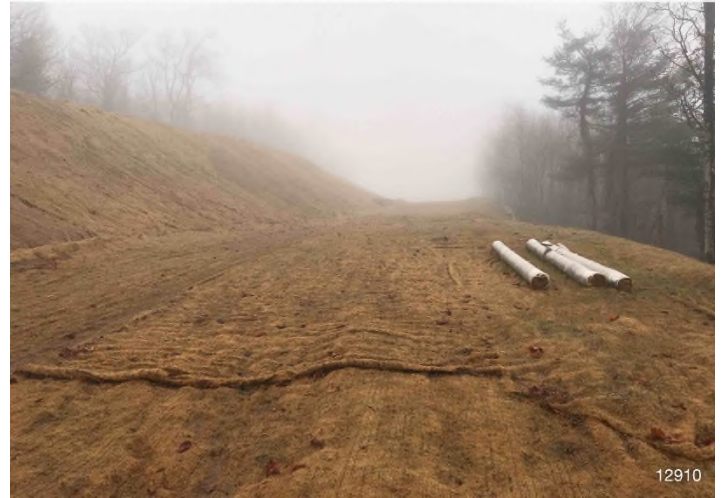
Figure 2: STA 12910+00 – Controls in place and functioning properly. Area stabilized with erosion matting.
BRG: 85°E (T) LAT: 37.119516 LON: -80.137216 ±21305ft ALT: 2686ft

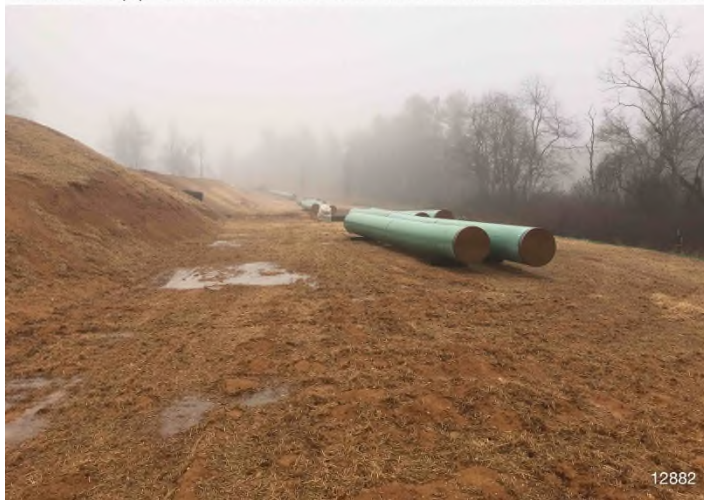
Figure 3: STA 12882+00 – Controls in place and functioning properly. Area stabilized with straw.
BRG: 16°N (T) LAT: 37.153809 LON: -80.124527 ±13661ft ALT: 2628ft

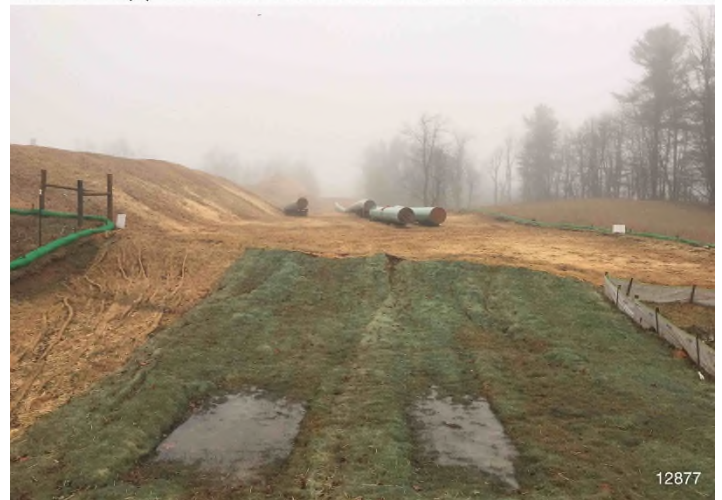
Figure 4: STA 12877+00 – Controls in place and functioning properly. Area stabilized with erosion matting and straw.
BRG: 17°N (T) LAT: 37.154295 LON: -80.125023 ±7391ft ALT: 2617ft
