## FIELD INSPECTION REPORT

Project Name:	Mountain Valley Pipeline	Inspector:	Marshall Willis
Inspection Date:	Friday, March 4, 2022	Project Contact:	Brian Clauto, Cory Chalmers
Spread H: Roanoke County	STA 12971+84 – 13013+53 MVP-RO-288	Weather:	Dry

## FIELD INSPECTION PHOTO LOG

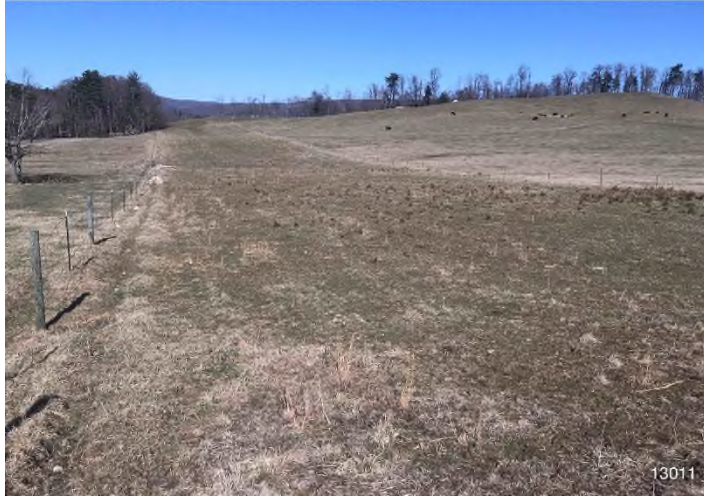
**Figure 1: STA 13011+00** – Controls in place and functioning properly.

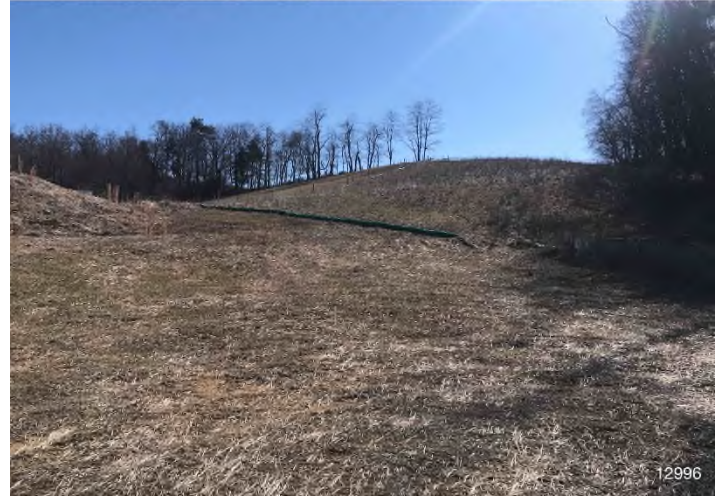
**Figure 2: STA 12996+00** – Controls in place and functioning properly.

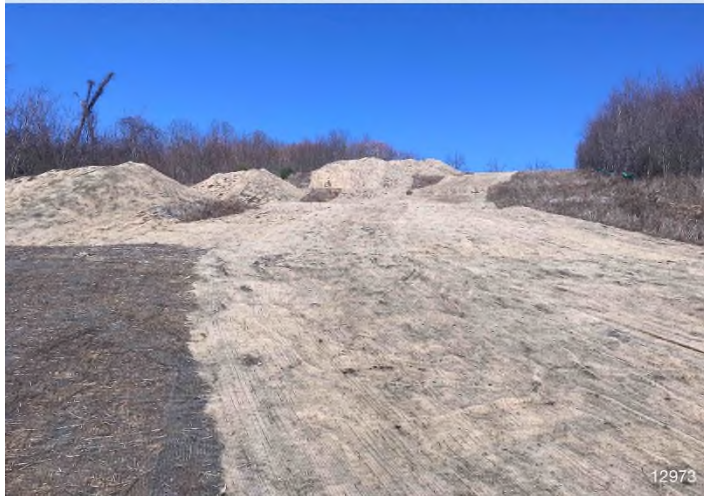
**Figure 3: STA 12973+00** – Controls in place and functioning properly.

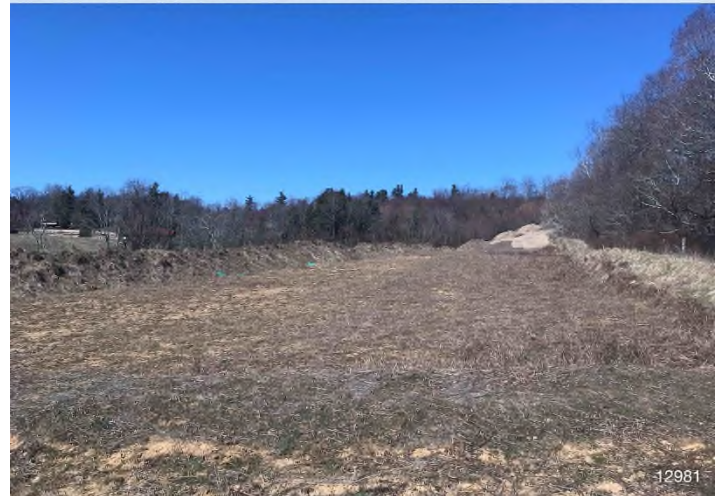
**Figure 4: STA 12981+00** – Controls in place and functioning properly.
