## FIELD INSPECTION REPORT

<b>Project Name:</b>	Mountain Valley Pipeline	<b>Inspector:</b>	Marshall Willis
<b>Inspection Date:</b>	Wednesday, March 2, 2022	<b>Project Contact:</b>	Brian Clauto, Cory Chalmers
<b>Spread H:</b> Roanoke County Franklin County	STA 13260+00 – 13263+00 STA 13060+00 – 13070+00 STA 12680+00 – 12692+00 MVP-FR-290/293.01	<b>Weather:</b>	Dry

## FIELD INSPECTION PHOTO LOG

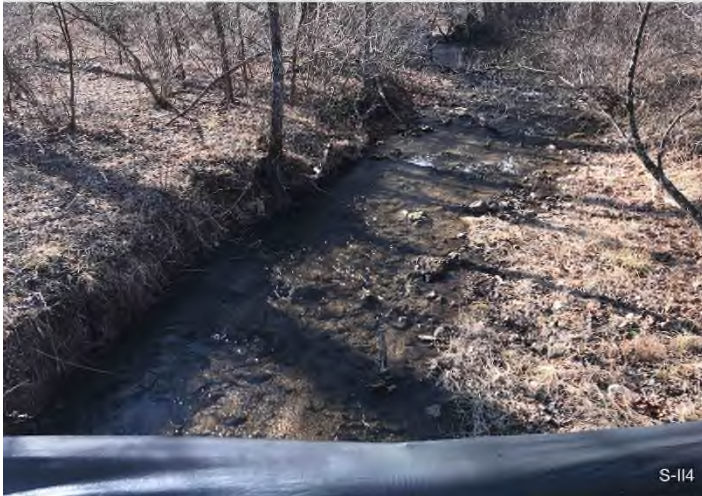
**Figure 1: Stream S-II4** – Controls in place and functioning properly around S-II4 crossing.

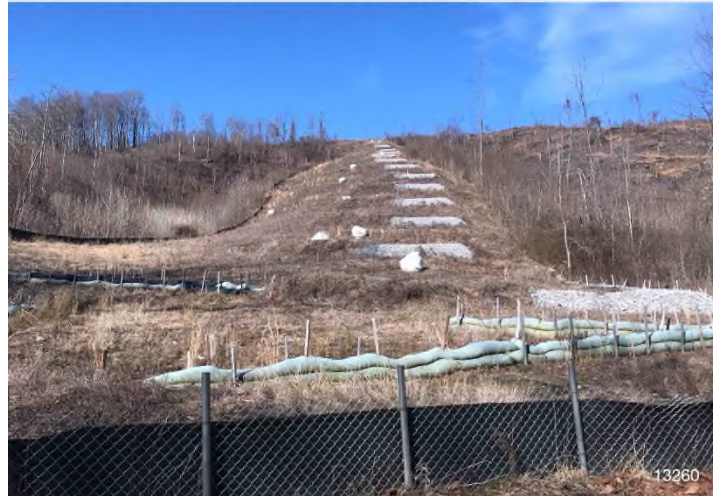
**Figure 2: STA 13260+00** – Controls in place and functioning properly.

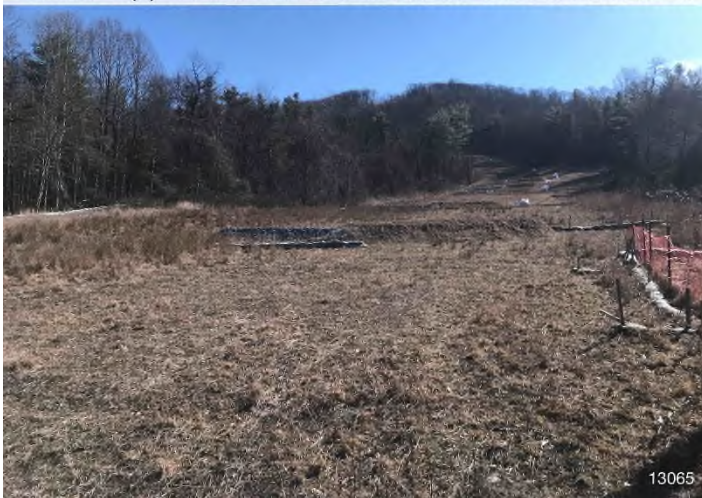
**Figure 3: STA 13065+00** – Controls in place and functioning properly.

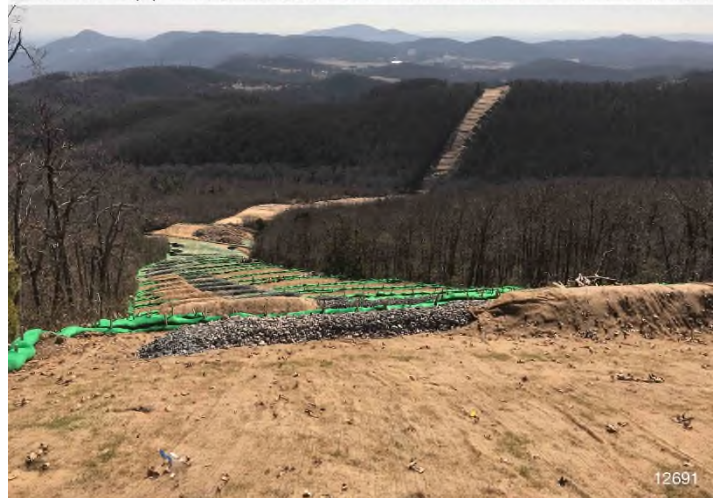
**Figure 4: STA 12691+00** – Controls in place and functioning properly. Area stabilized with erosion matting.
