Project Name:	Mountain Valley Pipeline	Inspector:	Matthew Grant
Inspection Date:	Wednesday, March 30, 2022	Project Contact:	Brian Clauto
Spread I: Franklin	St 13960-13851 ATWS 1299, 1299A, 1040, 1041	Weather:	Dry

FIELD INSPECTION PHOTO LOG

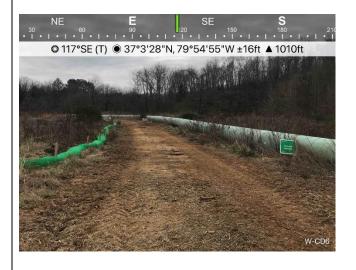
Figure 3: Designated crossing W-CD6, ESC controls were in place.

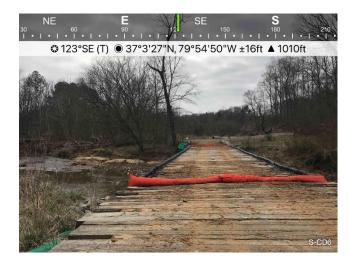
<u>Figure 4</u>: Designated crossing S-CD6, ESC controls were in place.
