Project Name:	Mountain Valley Pipeline	Inspector:	Matthew Grant		
Inspection Date:	Monday, March 28, 2022	Project Contact:	Brian Clauto		
Spread H: Montgomery	St12072+84-12119 ATWS 1162, 1163 AR-MN270	Weather:	Dry

FIELD INSPECTION PHOTO LOG

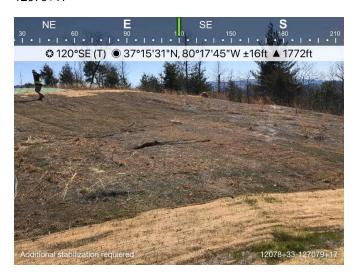
Figure 1: ROW lacks adequate stabilization between St 12078+33-12079+17

<u>Deadline:</u> Within 72-Hour of Notification

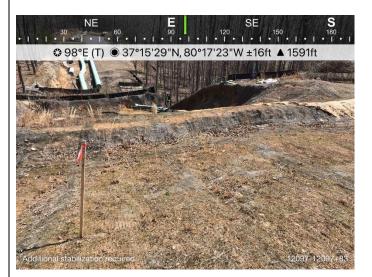
Figure 2: ROW lacks adequate stabilization between St 12097-12097+83

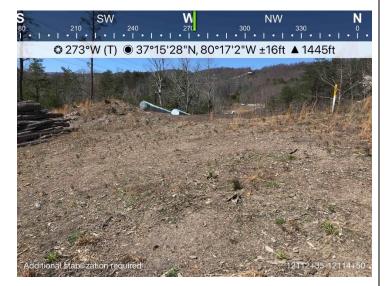
Figure 3: ROW lacks adequate stabilization between St 12112+35-12114+50

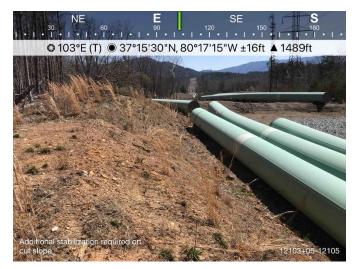
Figure 4: Cut slope lacks adequate stabilization between St 12103+05-12105
