FIELD INSPECTION REPORT

Project Name:	Mountain Valley Pipeline	Inspector:	Marshall Willis
Inspection Date:	Friday, March 18, 2022	Project Contact:	Brian Clauto, Cory Chalmers
Spread I: Franklin County	STA 14131+21 – 14235+38 MVP-FR-309 MVP-MLV-AR-32	Weather:	Wet

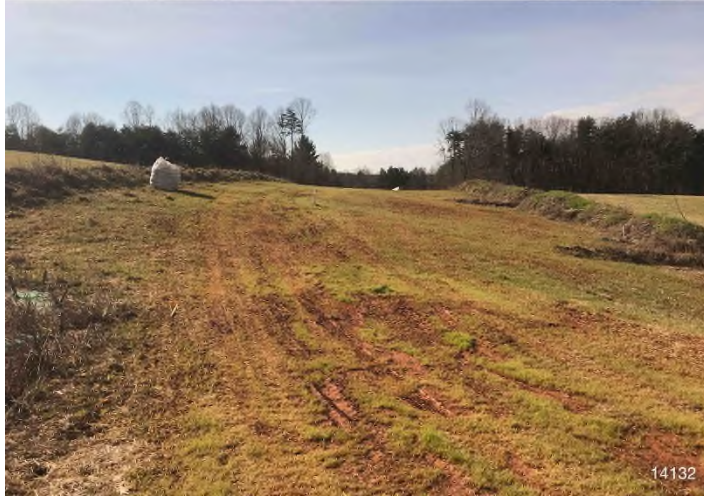
Figure 1: STA 14132+00 – Controls in place and functioning properly.

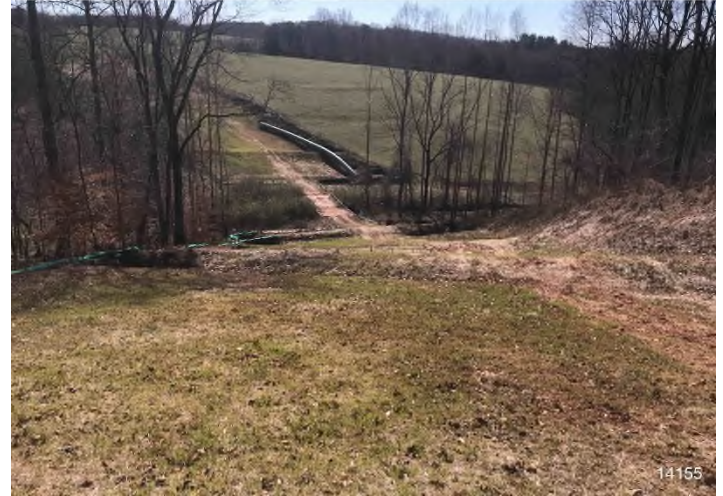
Figure 2: STA 14155+00 – Controls in place and functioning properly.

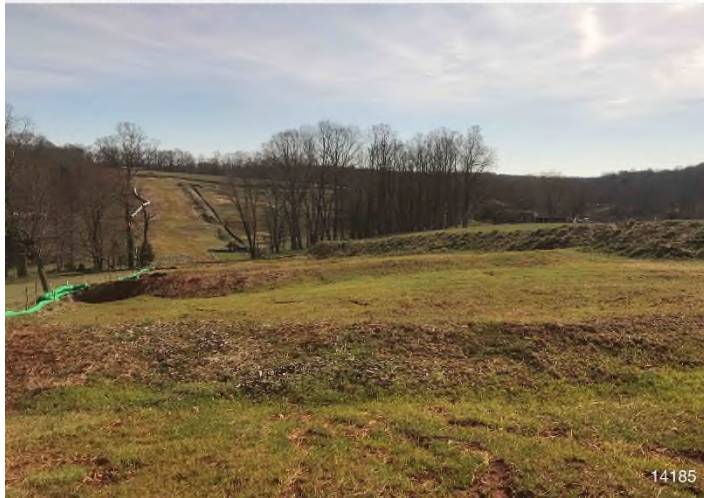
Figure 3: STA 14185+00 – Controls in place and functioning properly.

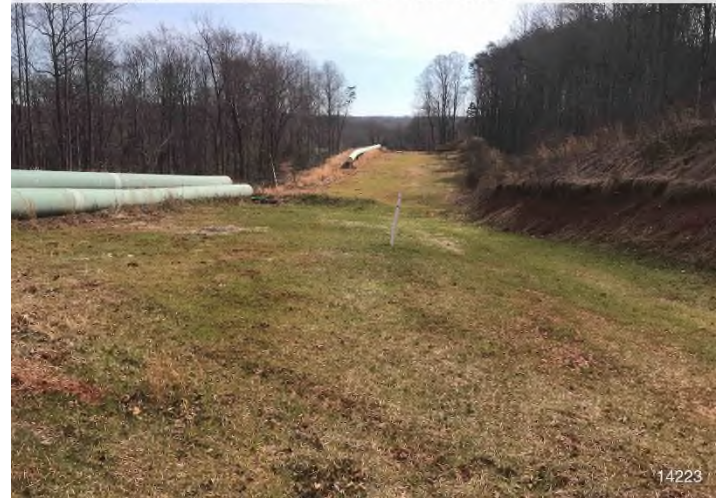
Figure 4: STA 14223+00 – Controls in place and functioning properly.
