## FIELD INSPECTION REPORT

<b>Project Name:</b>	<b>Mountain Valley Pipeline</b>	<b>Inspector:</b>	<b>Marshall Willis</b>
<b>Inspection Date:</b>	<b>Wednesday, March 16, 2022</b>	<b>Project Contact:</b>	<b>Brian Clauto, Cory Chalmers</b>
<b>Spread I: Franklin County</b>	<b>STA 14758+16 – 14845+68</b>	<b>Weather:</b>	<b>Dry</b>

## FIELD INSPECTION PHOTO LOG

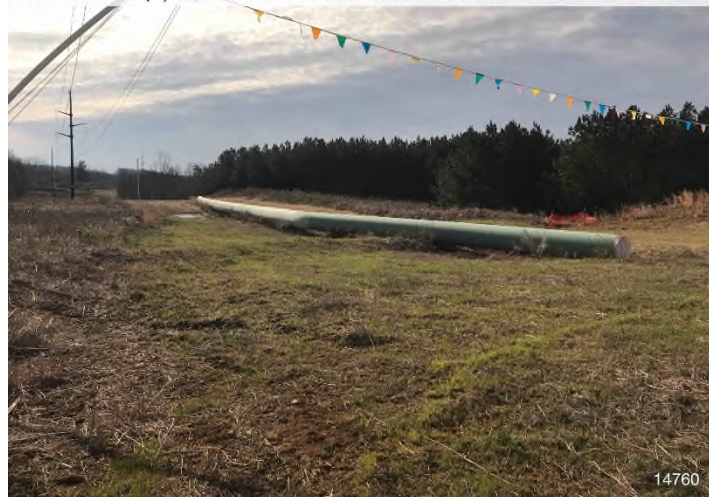
**Figure 1: STA 14760+00** – Controls in place and functioning properly.

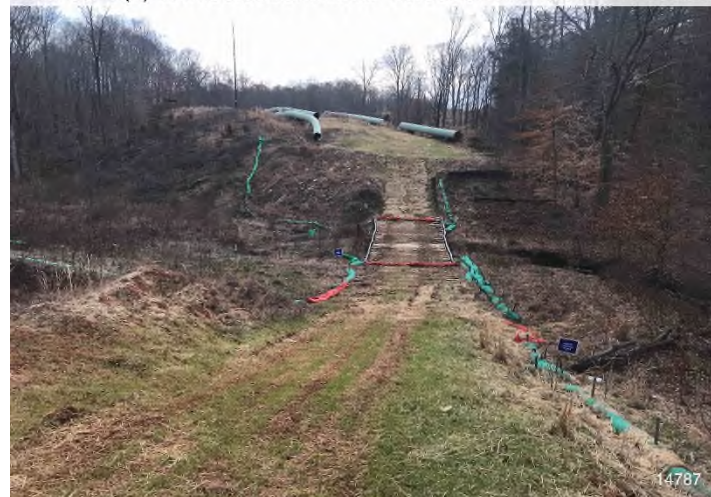
**Figure 2: STA 14787+00** – Controls in place and functioning properly.

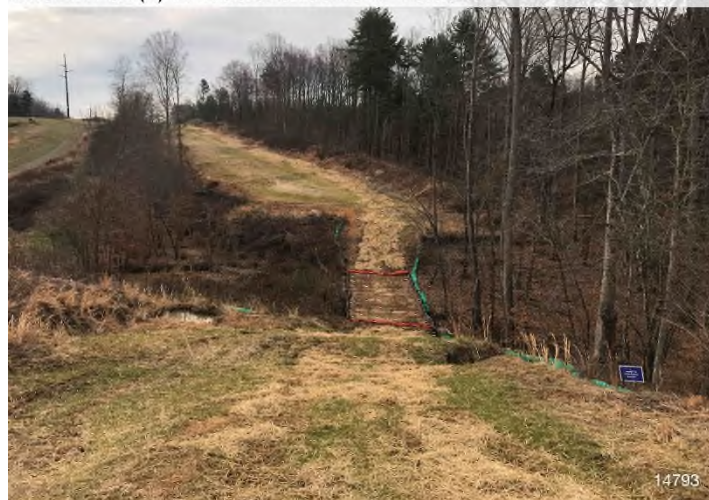
**Figure 3: STA 14793+00** – Controls in place and functioning properly.

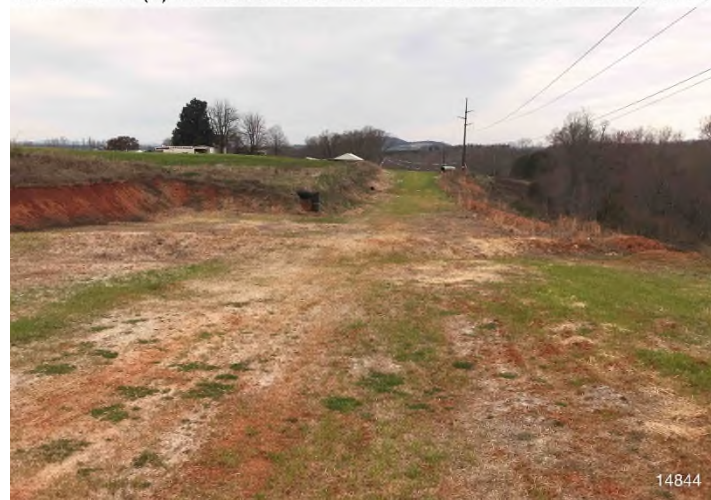
**Figure 4: STA 14844+00** – Controls in place and functioning properly.
