FIELD INSPECTION REPORT

Project Name:	Mountain Valley Pipeline	Inspector:	Marshall Willis
Inspection Date:	Monday, March 28, 2022	Project Contact:	Brian Clauto, Cory Chalmers
Spread H: Montgomery County	STA 12071+80 - 12190+85 MVP-MN-270	Weather:	Dry

FIELD INSPECTION PHOTO LOG

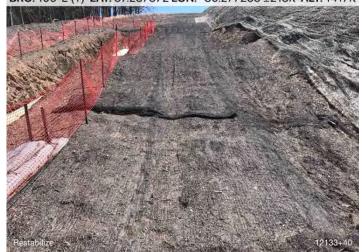
Figure 1: STA 12133+40 to 12134+70 - Re-stabilization needed.

Deadline: Within 72-Hour of Notification

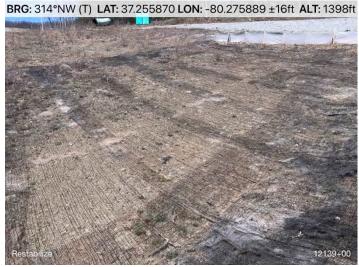
Figure 2: STA 12139+00- Re-stabilization needed.

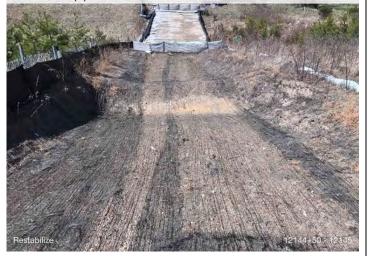
Figure 3: **STA 12144+50 to 12145+00** – Re-stabilization needed.
