FIELD INSPECTION REPORT

Project Name:	Mountain Valley Pipeline	Inspector:	Marshall Willis
Inspection Date:	Friday, March 25, 2022	Project Contact:	Brian Clauto, Cory Chalmers
Spread H: Roanoke County	STA 12994+02 – 13012+63 STA 12940+97 – 12973+43 MVP-RO-287/288	Weather:	Dry

FIELD INSPECTION PHOTO LOG

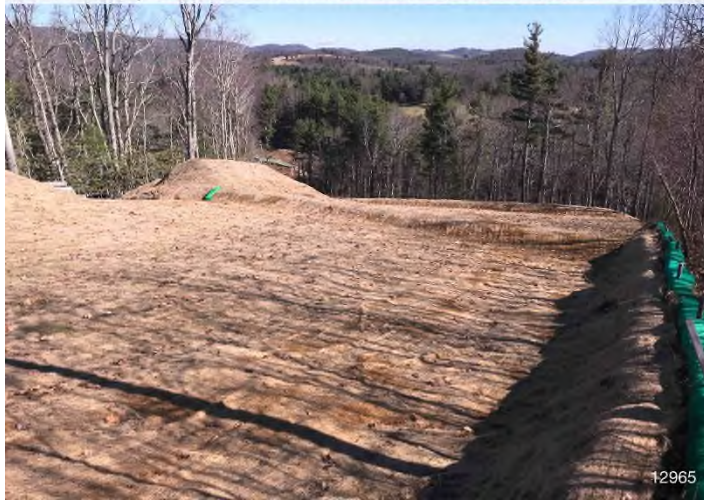
Figure 1: STA 12965+00 – Controls in place and functioning properly. Area stabilized with erosion matting.
BRG: 12°N (T) LAT: 37.124623 LON: -80.142293 ±17962ft ALT: 2701ft

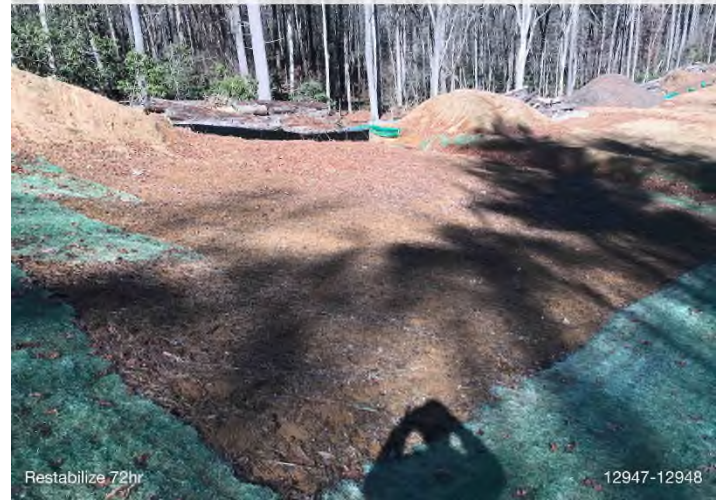
- STA 12947+00 to 12948+00: Re-stabilization needed.
- STA 12943+00 to 12945+00: Re-stabilization needed.
- STA 12953+00 to 12953+50: Re-stabilization needed.

Figure 2: STA 12947+00 to 12948+00 – Re-stabilization needed.
BRG: 300°NW (T) LAT: 37.136997 LON: -80.138890 ±16ft ALT: 2677ft

Recommended Corrective Action: Maintain and install all controls per the approved PSS&S.

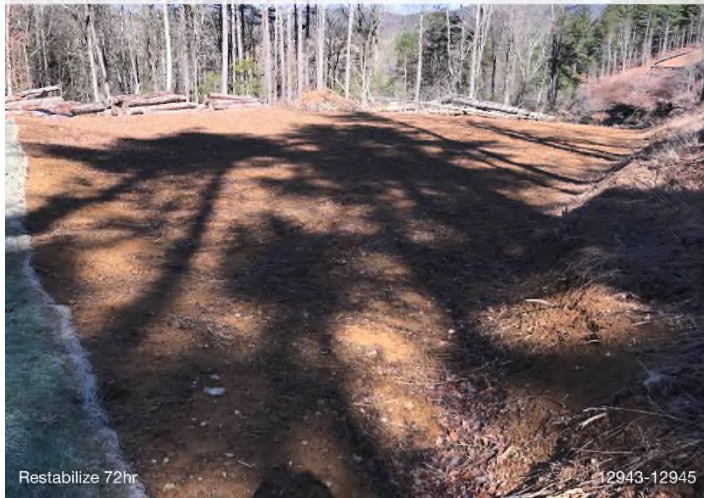
Figure 3: STA 12943+00 to 12945+00 – Re-stabilization needed.

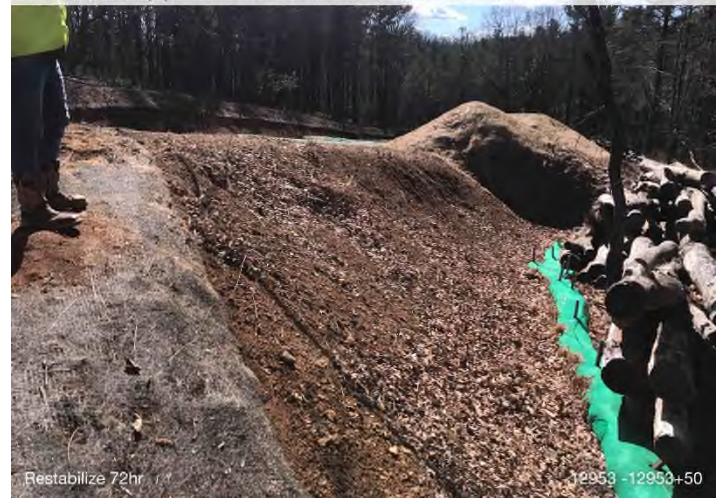
Figure 4: STA 12953+00 to 12953+50 – Re-stabilization needed.
