## FIELD INSPECTION REPORT

| Project Name: | Mountain Valley Pipeline | Inspector: | Marshall Willis |
| Spread H:<br>Montgomery County | STA 12446+00 – 12485+00<br>MVP-MLV-AR-28 | Weather: | Dry |

## FIELD INSPECTION PHOTO LOG

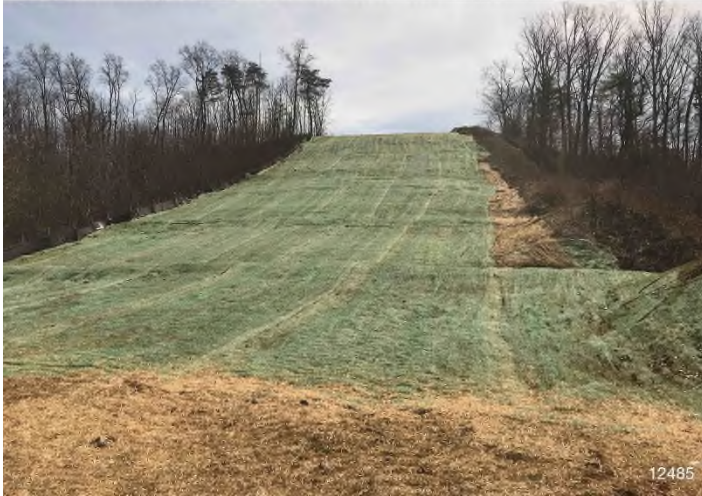
**Figure 1: STA 12485+00** – Controls in place and functioning properly. Area stabilized with erosion matting.  
BRG: 153°SE (T) LAT: 37.223296 LON: -80.213922 ±541ft ALT: 1272ft

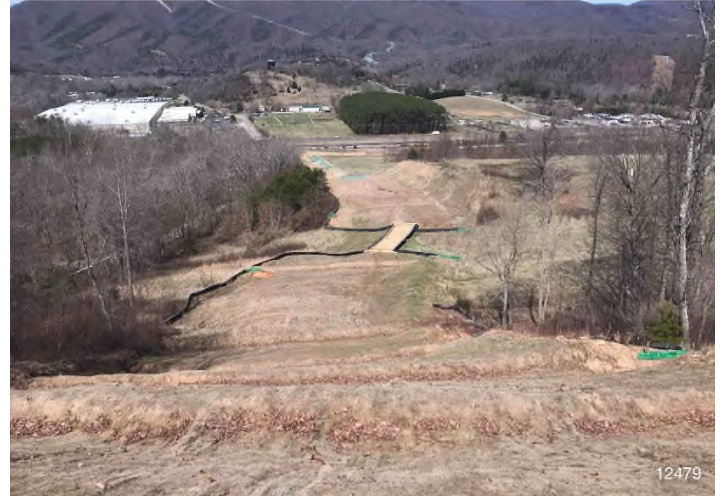
**Figure 2: STA 12479+00** – Controls in place and functioning properly. Area stabilized with erosion matting.  
BRG: 341°N (T) LAT: 37.234050 LON: -80.204574 ±541ft ALT: 1258ft

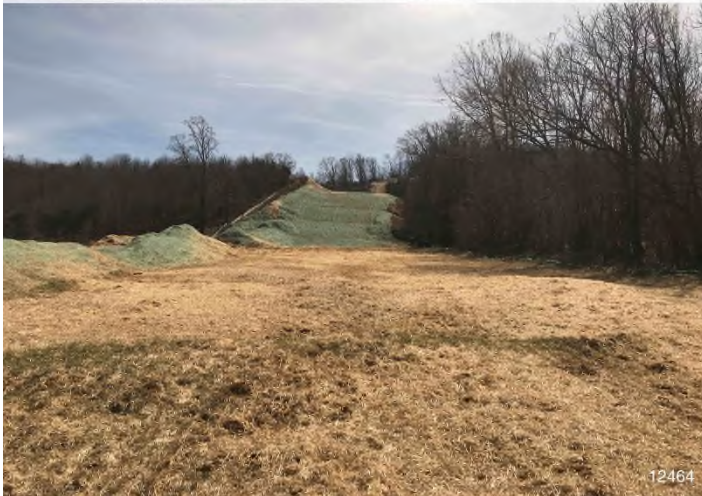
**Figure 3: STA 12464+00** – Controls in place and functioning properly. Area stabilized with straw.  
BRG: 159°S (T) LAT: 37.228214 LON: -80.203414 ±16ft ALT: 1215ft

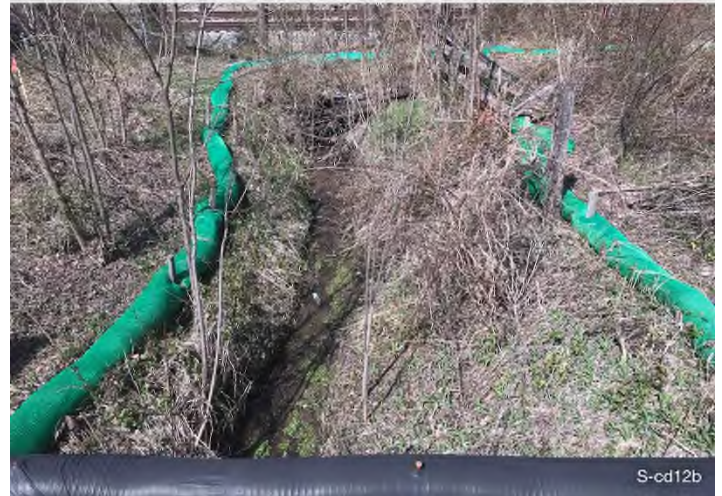
**Figure 4: Stream S-CD12b** – Controls in place and functioning properly around stream crossing.  
BRG: 360°N (T) LAT: 37.229833 LON: -80.201264 ±16ft ALT: 1203ft
