Project Name:	Mountain Valley Pipeline	Inspector:	Matthew Grant
Inspection Date:	Wednesday, April 6, 2022	Project Contact:	Brian Clauto
Spread I: Pittsylvania	St 15064-15113 ATWS 383, 383A, 382	Weather:	Dry

FIELD INSPECTION PHOTO LOG

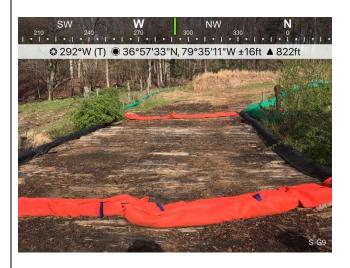
Figure 3: Designated crossing S-G9, ESC controls were in place.
