# FIELD INSPECTION REPORT

| <b>Project Name:</b> | Mountain Valley Pipeline | <b>Inspector:</b> | Matthew Grant |
| <b>Inspection Date:</b> | Wednesday, May 25, 2022 | <b>Project Contact:</b> | Brian Clauto |
| <b>Spread I:<br/>Franklin</b> | St 14455-14530<br>ATWS 358, 358A, 359, 628, 529 | <b>Weather:</b> | Wet |

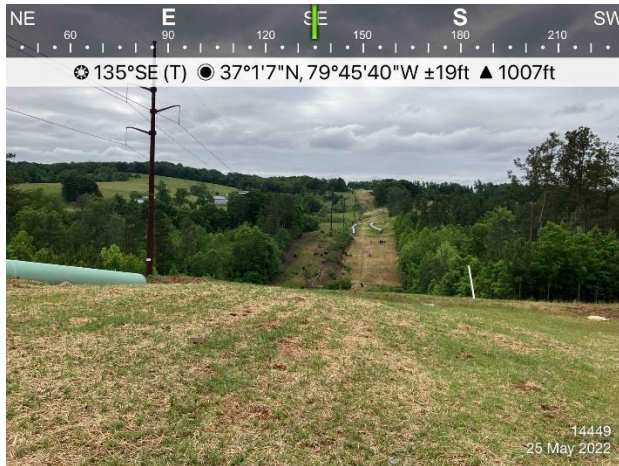
- Figure 1: St1449 ECD's remain in place and area is temporarily stabilized.

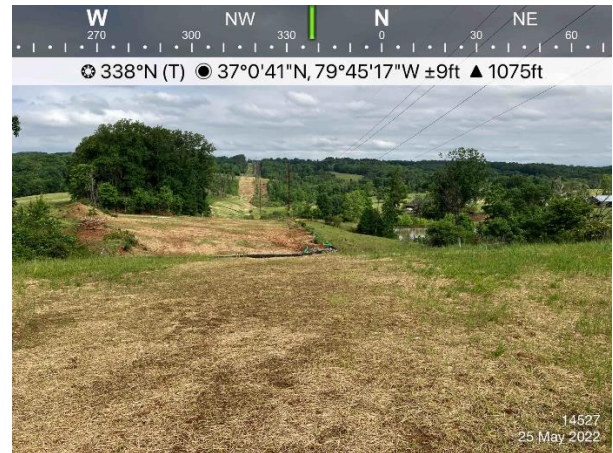
- Figure 2: St14527 ECD's remain in place and area is temporarily stabilized.

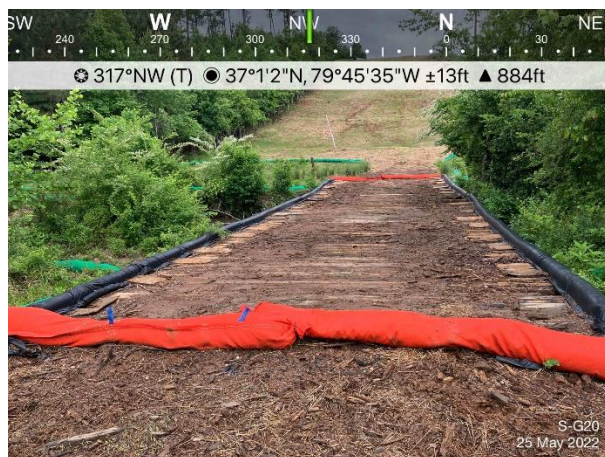
- Figure 3: Designated crossing S-G20, ESC controls were in place.

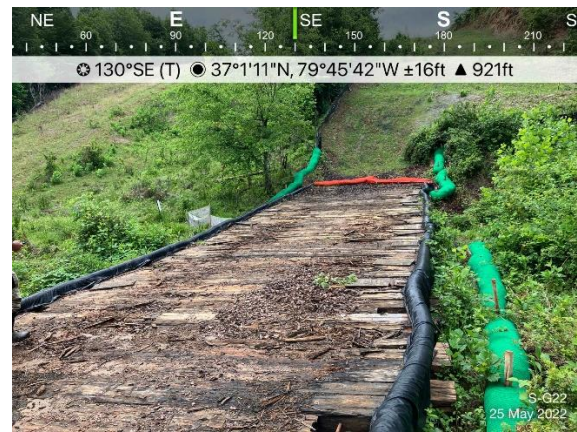
- Figure 4: Designated crossing S-G22, ESC controls were in place.
