# **Living Shoreline Sea-Level Resiliency: Performance and Adaptive Management of Existing Sites**

## **Year 3 Summary Report**

**Donna A. Milligan  
C. Scott Hardaway, Jr.  
Christine A. Wilcox  
Nick J. DiNapoli**

**Shoreline Studies Program  
Virginia Institute of Marine Science  
William & Mary**

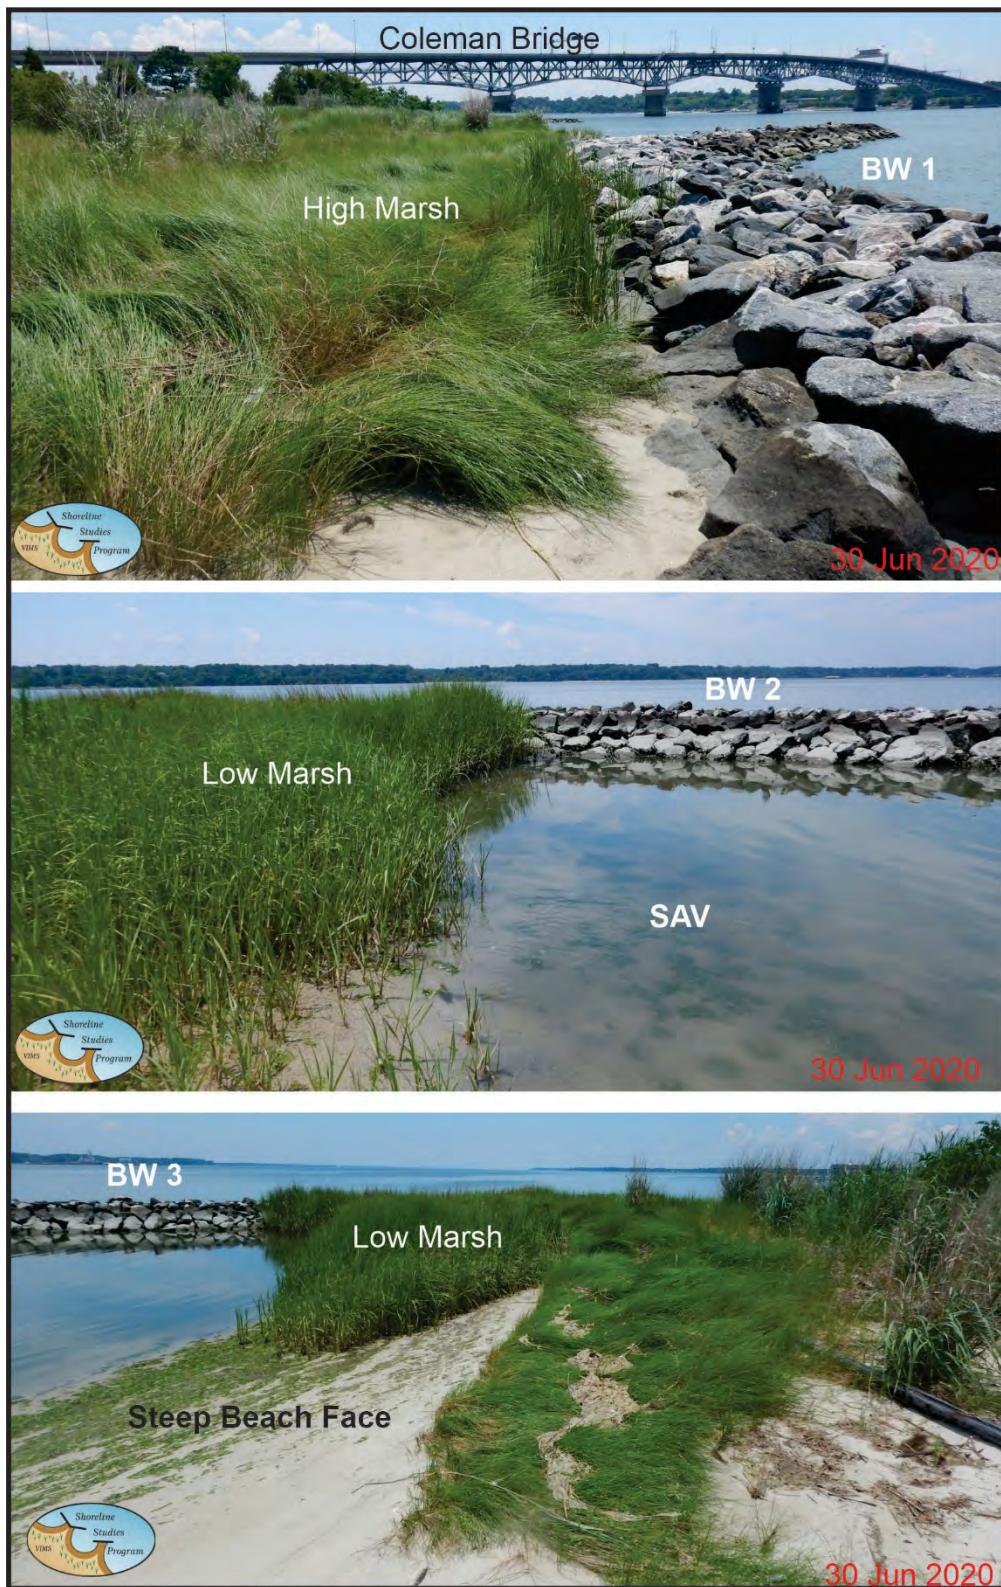
Figure 6-18. State of VIMS West in June 2020 about 9.5 years after construction. The structures are stable and the high and low marsh grasses are lush. SAV has colonized in the embayments. Photo credit: Shoreline Studies Program, VIMS.

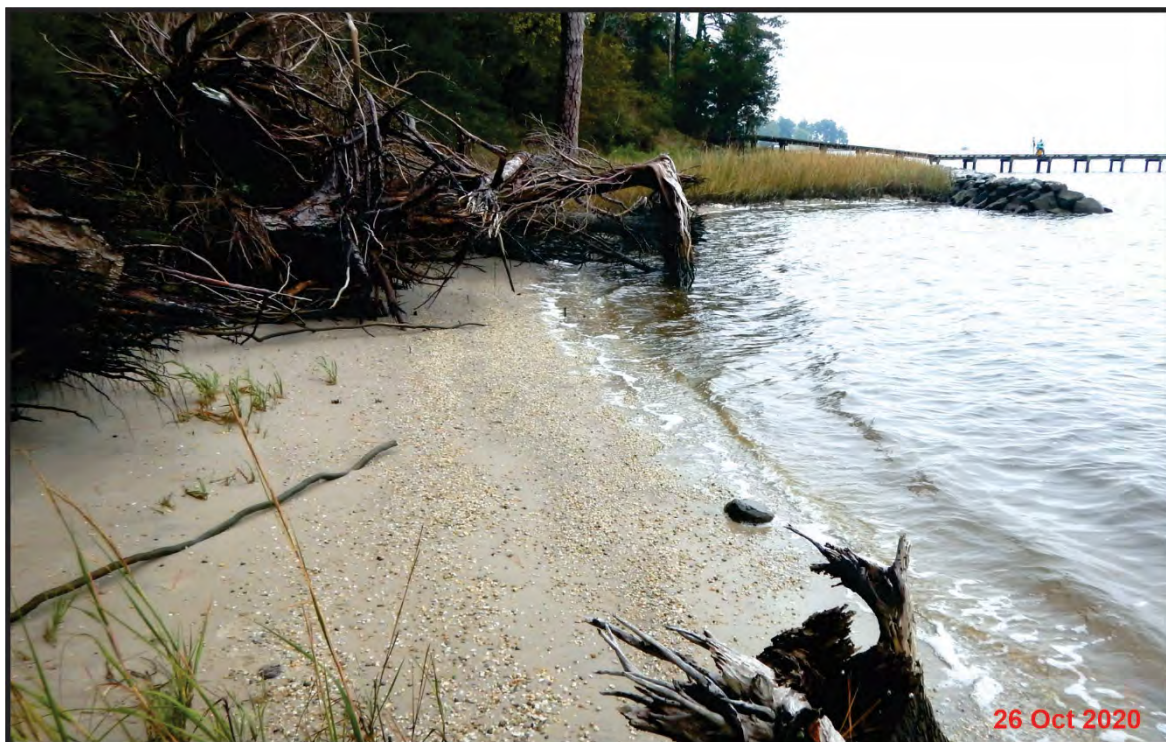
Figure 7-9. Eroding shoreline north of Sill 2. An additional structure is needed to protect the bank along this section of shoreline. Photo credit: Shoreline Studies Program, VIMS.

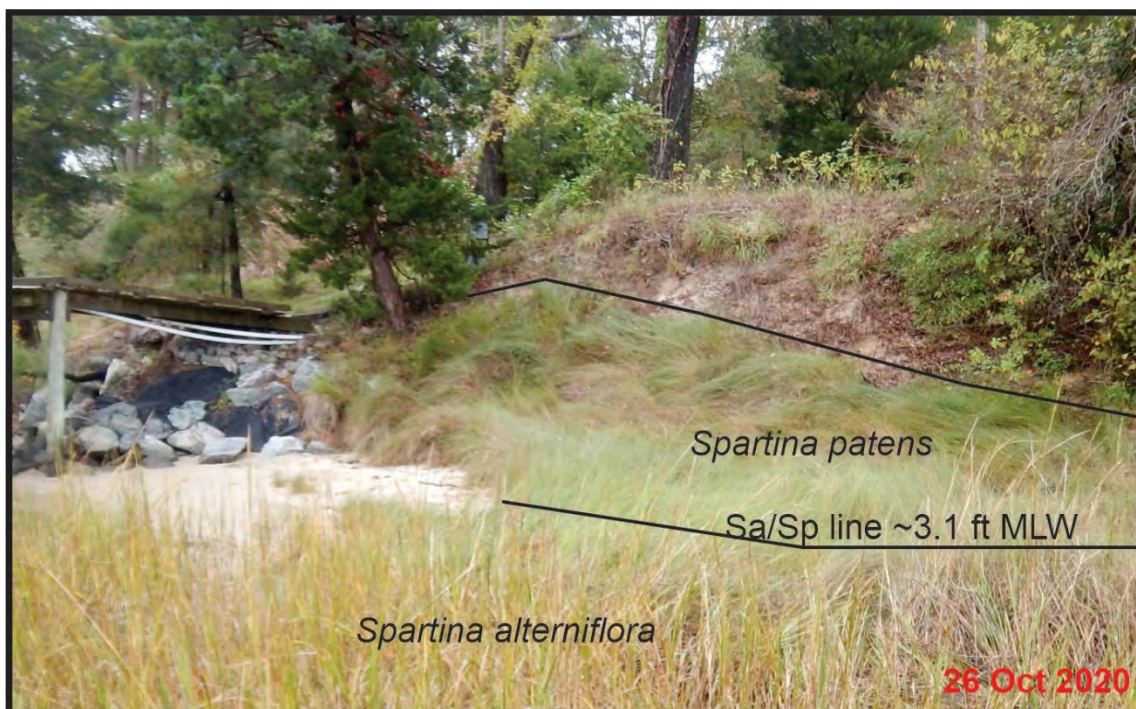
Figure 7-13. Marsh behind Sill 1 about 4.5 years after construction. The *S. alterniflora*/*S. patens* biologic benchmark is similar to what it was pre-project. Photo credit: Shoreline Studies Program, VIMS.

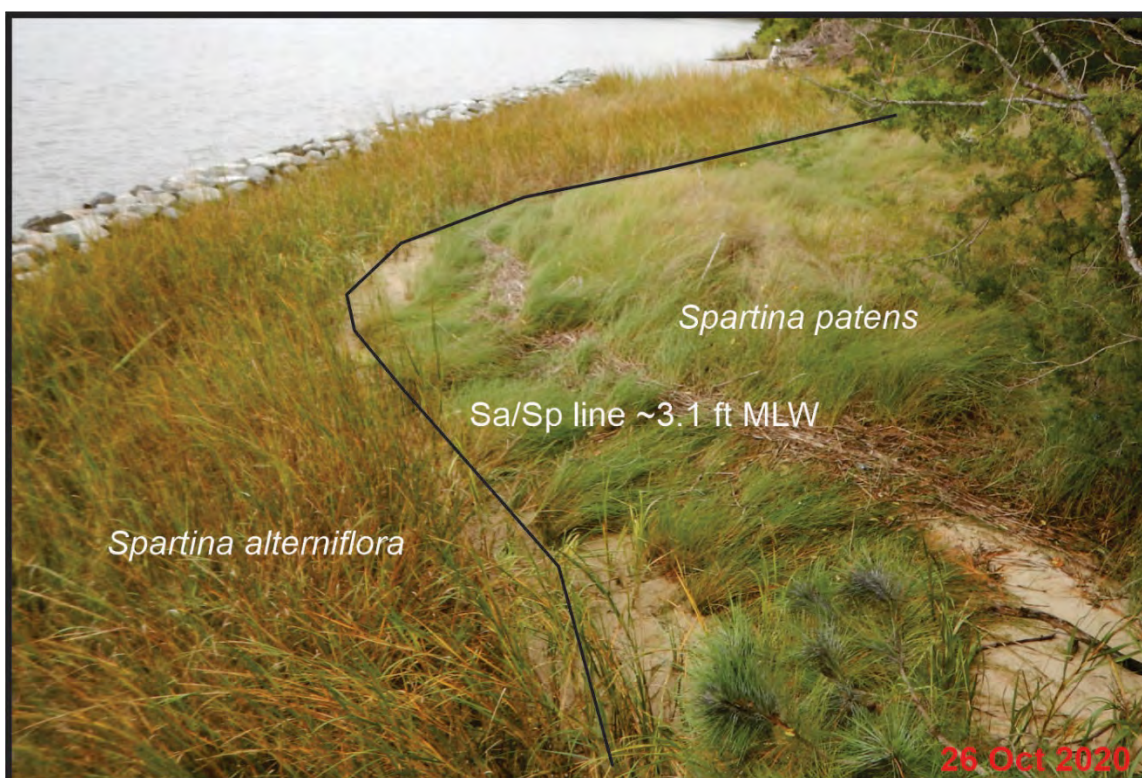
Figure 7-14. Marsh behind Sill 1 about 4.5 years after construction. The *S. alterniflora*/*S. patens* biologic benchmark is similar to what it was pre-project. Photo credit: Shoreline Studies Program, VIMS

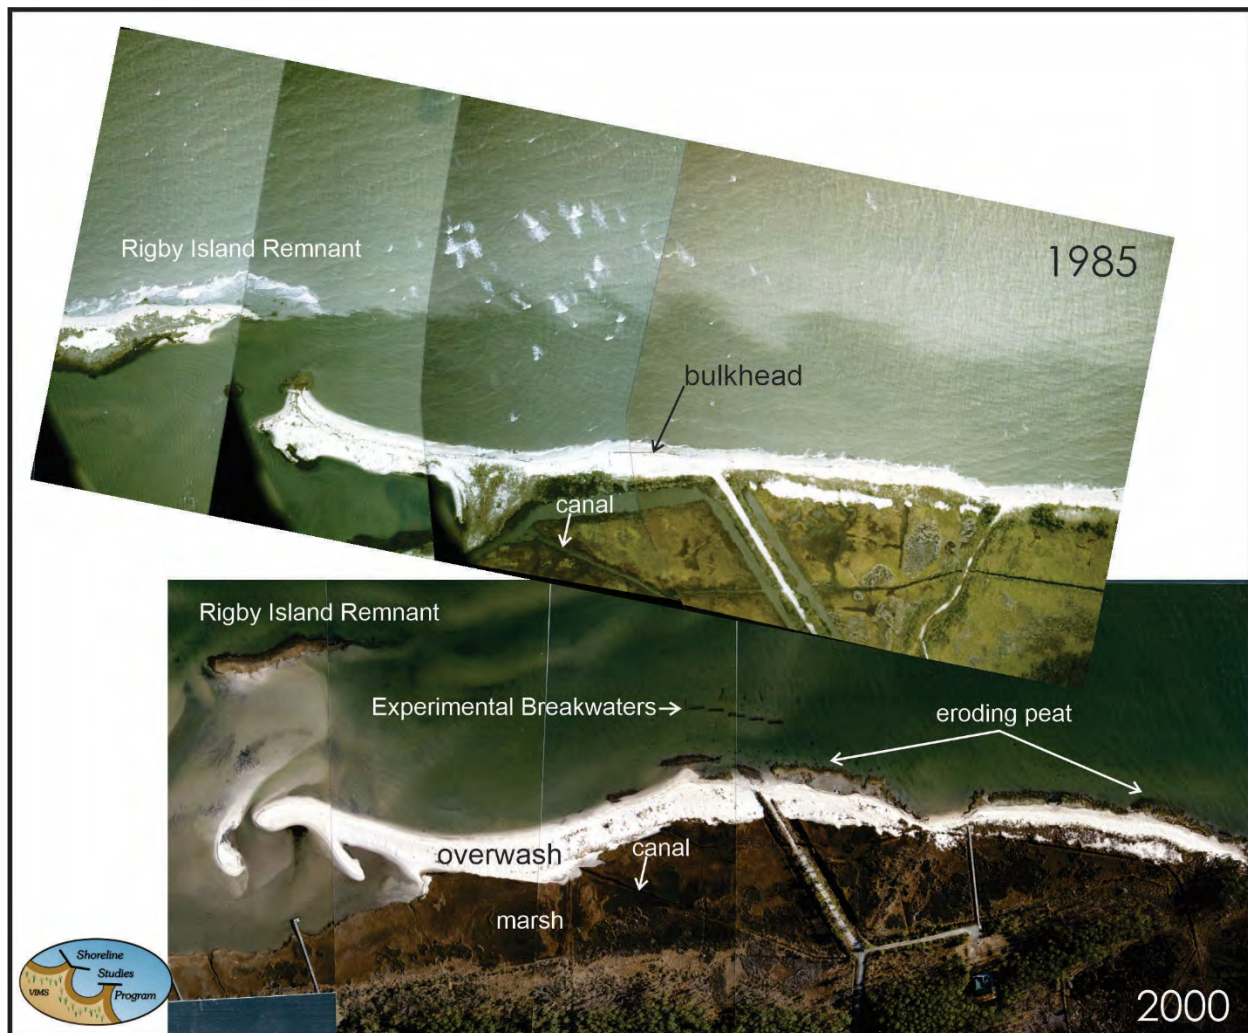
Figure 8-5. Aerial photos taken in 1985 and 2000. Previous shore protection structures such as the timber bulkhead in 1985 and the experimental breakwaters shown in 2000 failed.

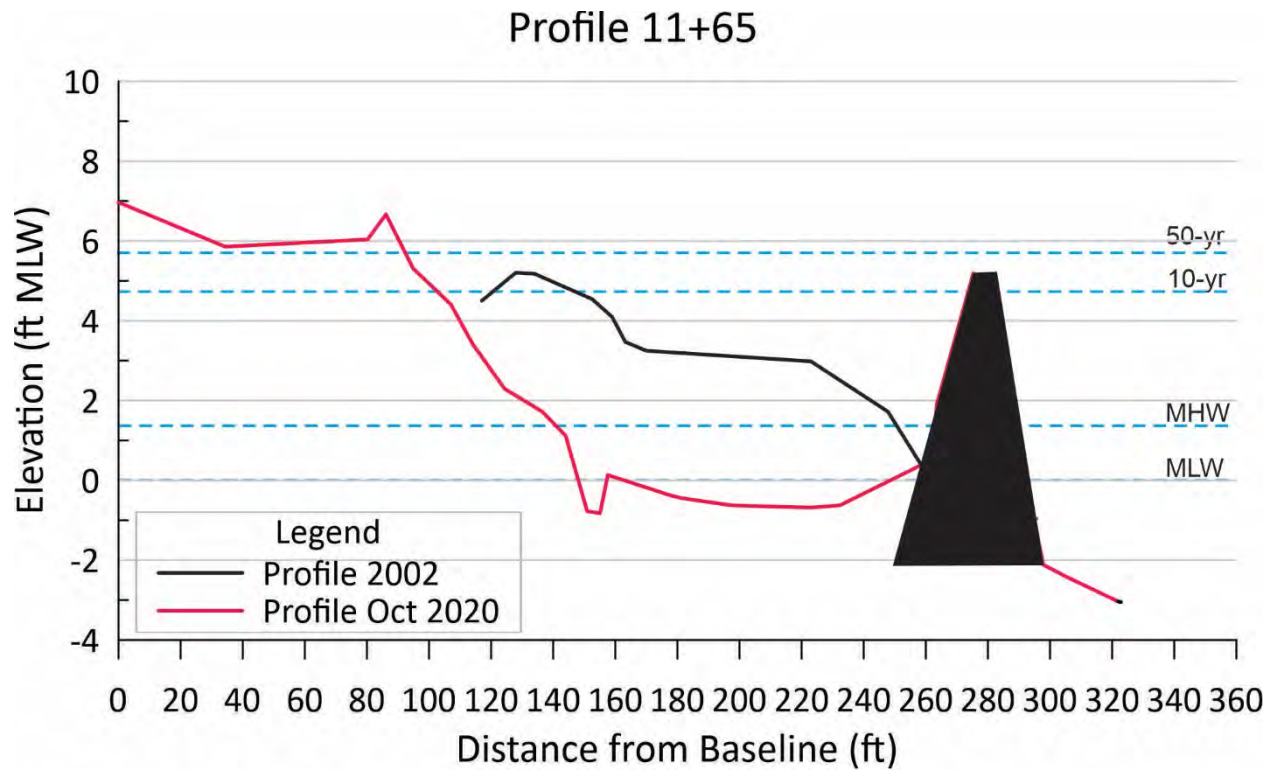
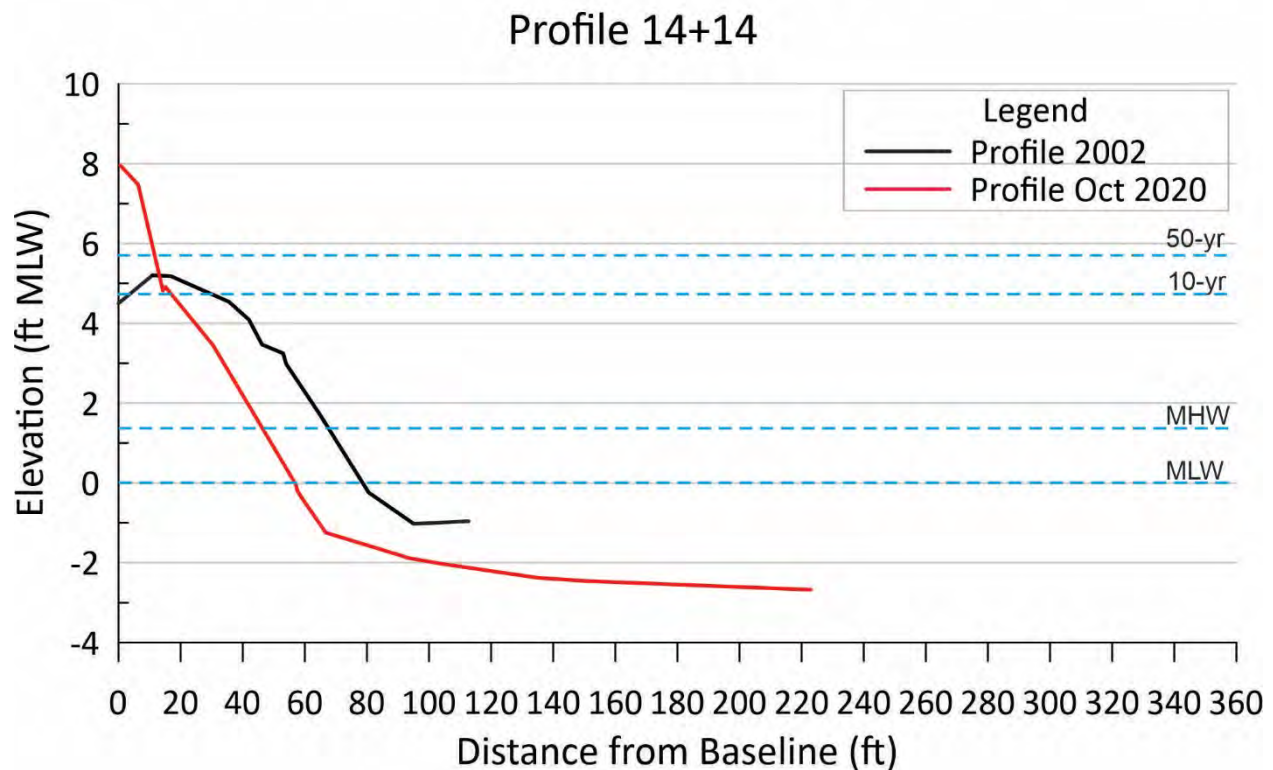
Figure 8-11. Cross-shore profiles at Haven Beach. Top: profile 11+65 crosses the small breakwater and shows the loss of the sand fill and landward migration of the shoreline after construction of the project. Bottom: profile 14+14 is just south of the small breakwater shows the change between 2002 and 2020.

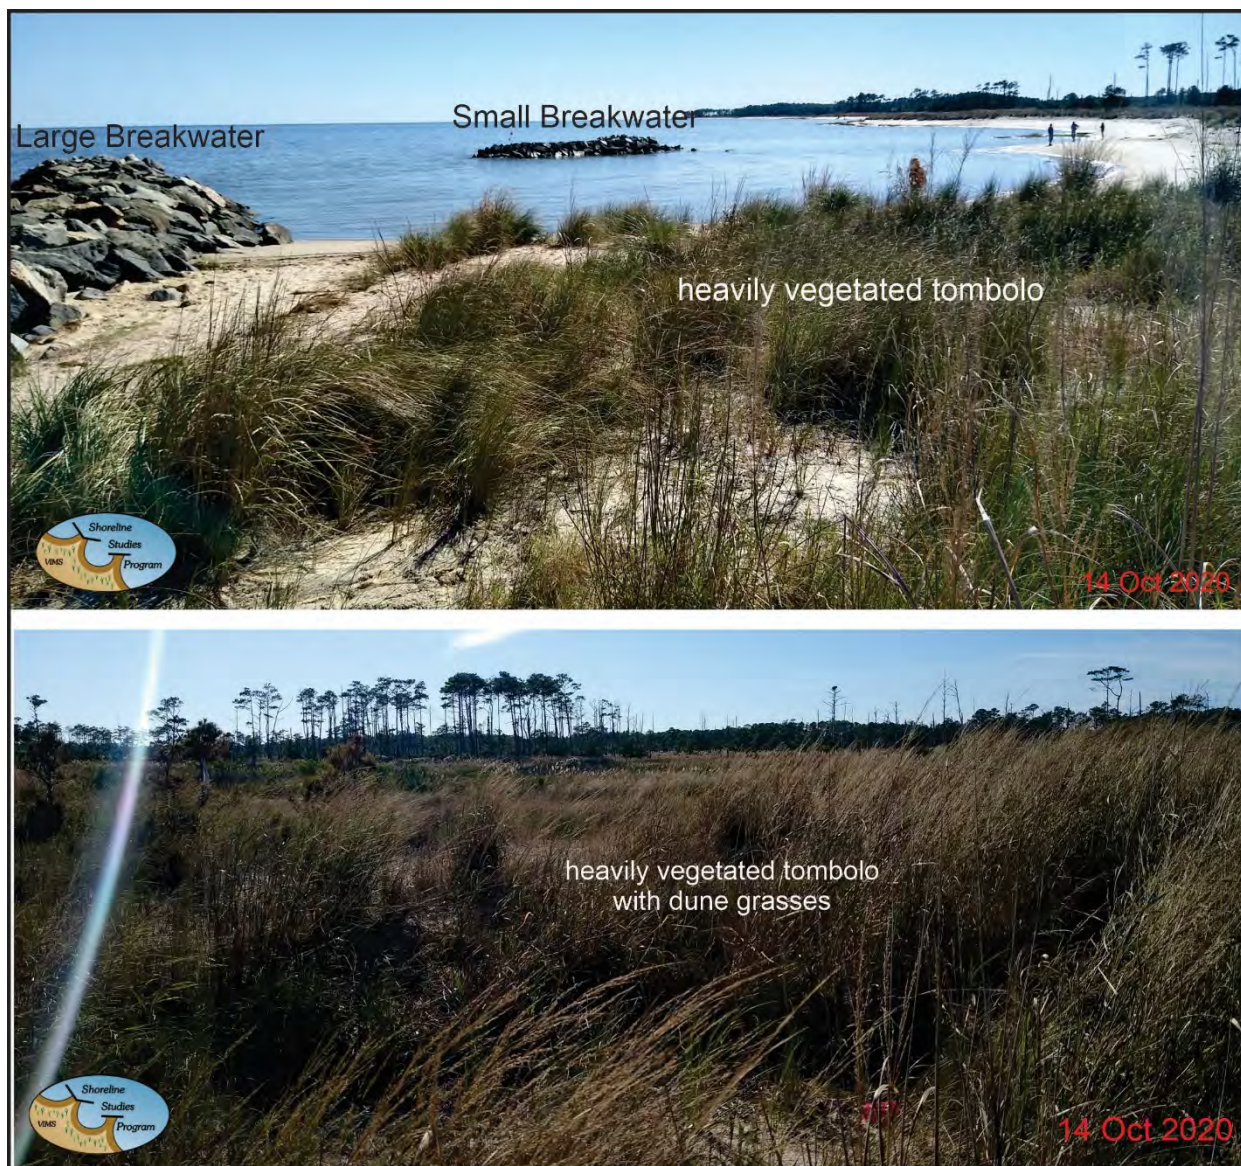
Figure 8-14. Ground photos showing the tombolo behind the large breakwater. Photo credit: Shoreline Studies Program, VIMS

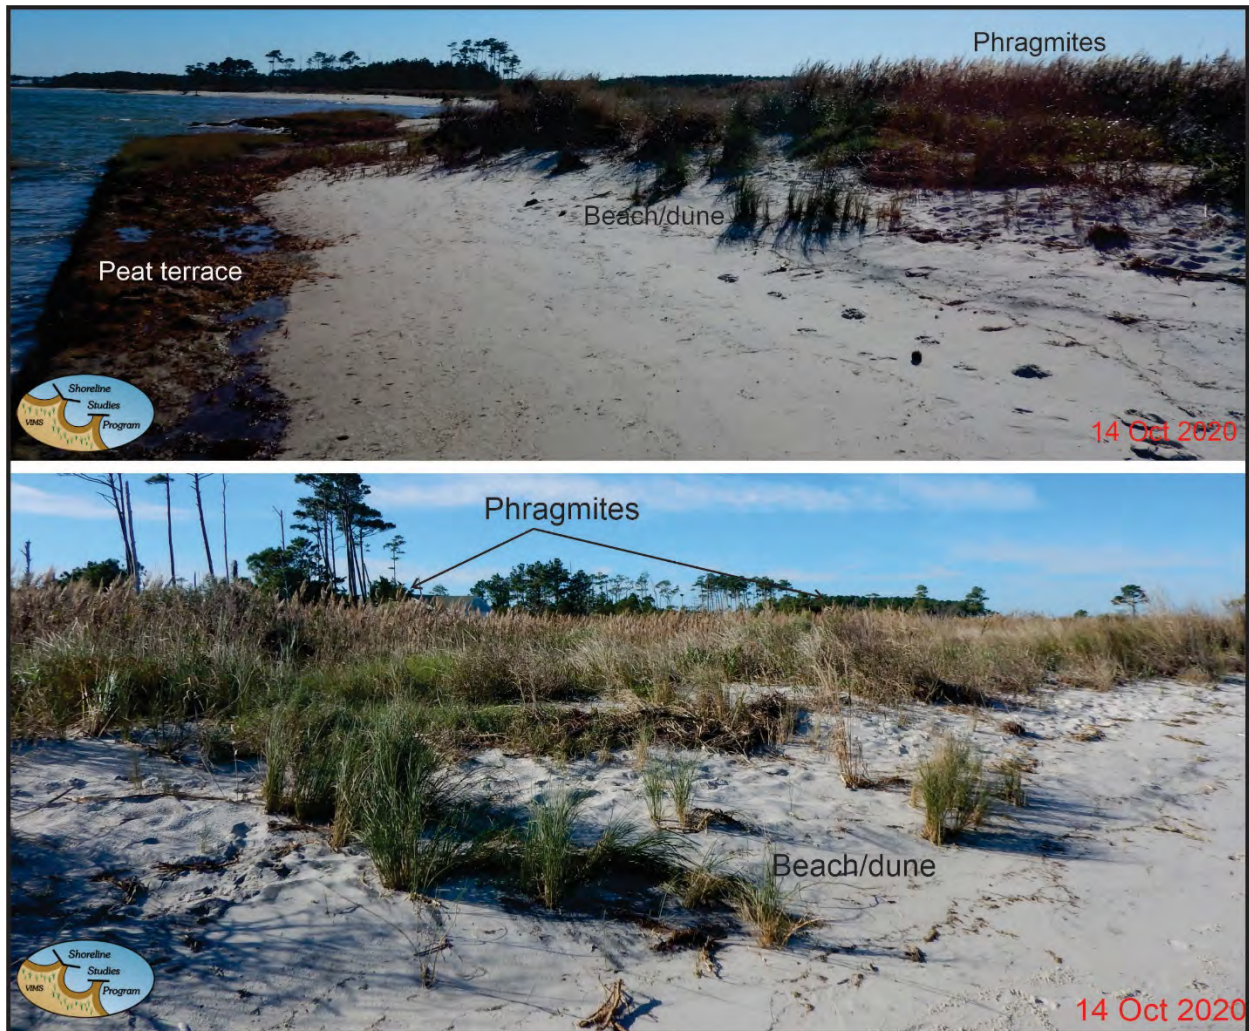
Figure 8-15. Ground photos showing the reach of shoreline south of the breakwaters. Top shows the peat terrace and the low beach/dune behind it. The bottom photo shows the low beach/dune with the *Phragmites* immediately adjacent in the marsh. Photo credit: Shoreline Studies Program, VIMS.

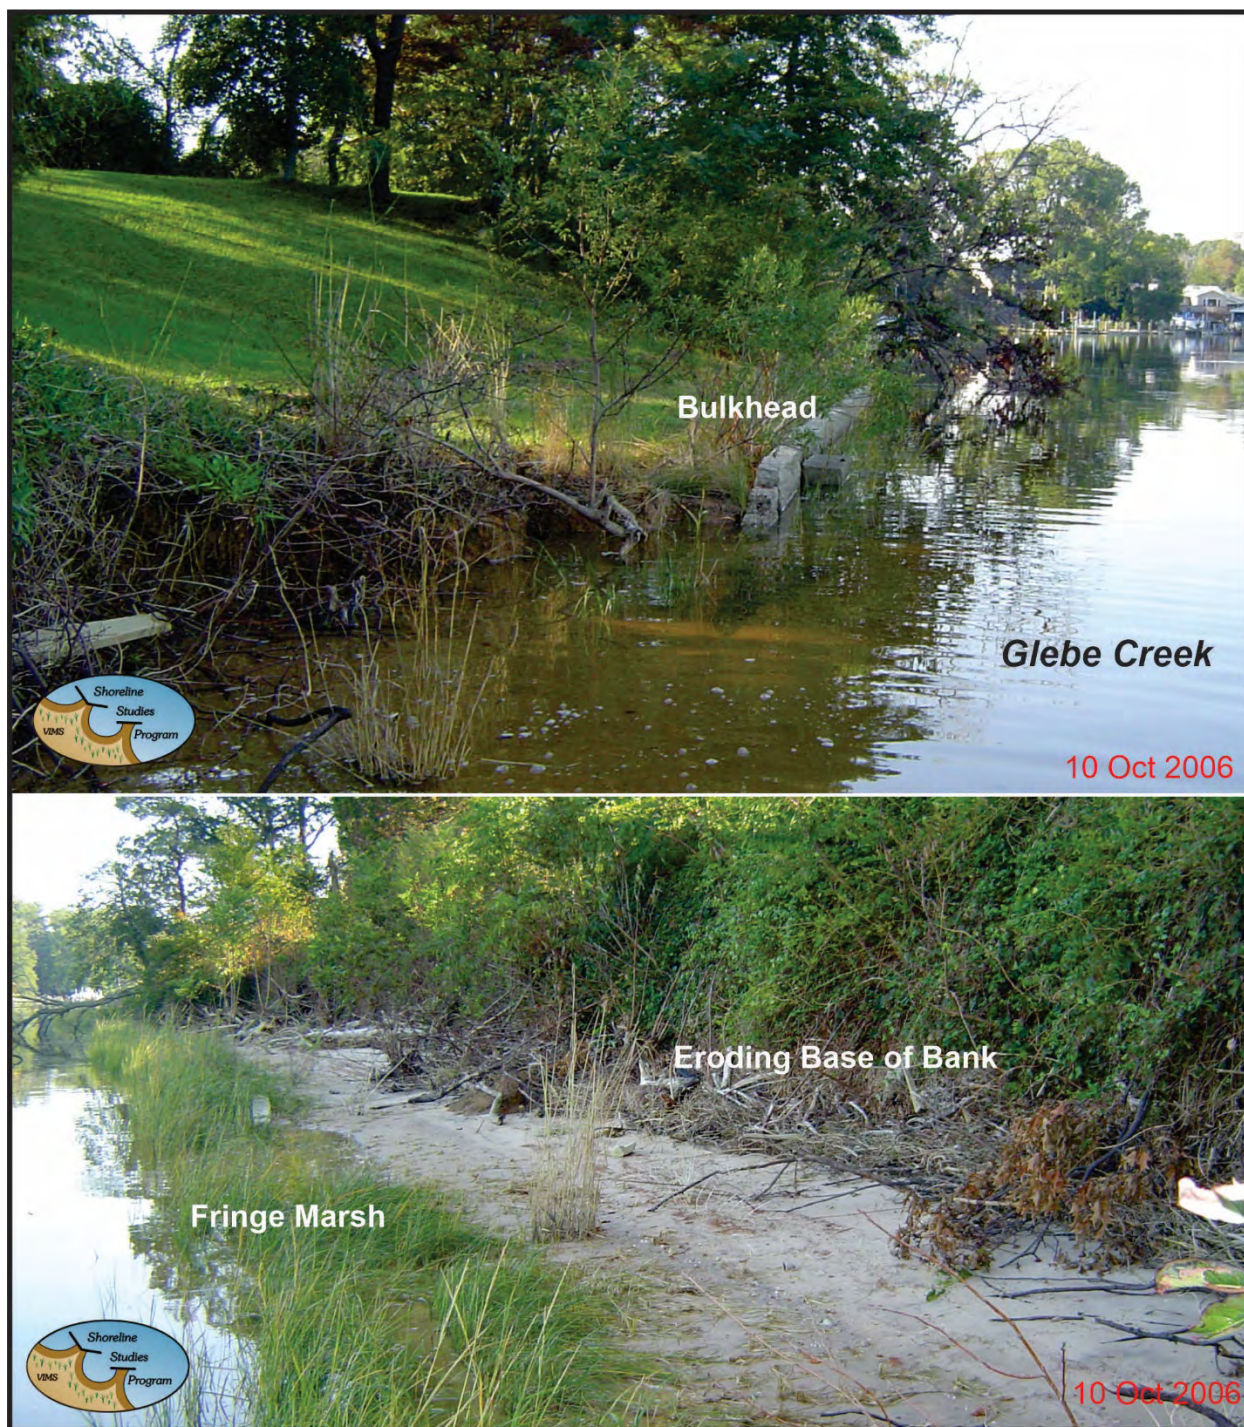
Figure 9-4. Ground photos of the Hull Springs Farm shoreline. Top: the western section of shoreline has a failing bulkhead; Bottom: Post Ernesto: the center section of the peninsula has an eroding base of bank and a fringe marsh. Photo credit: Shoreline Studies Program, VIMS.

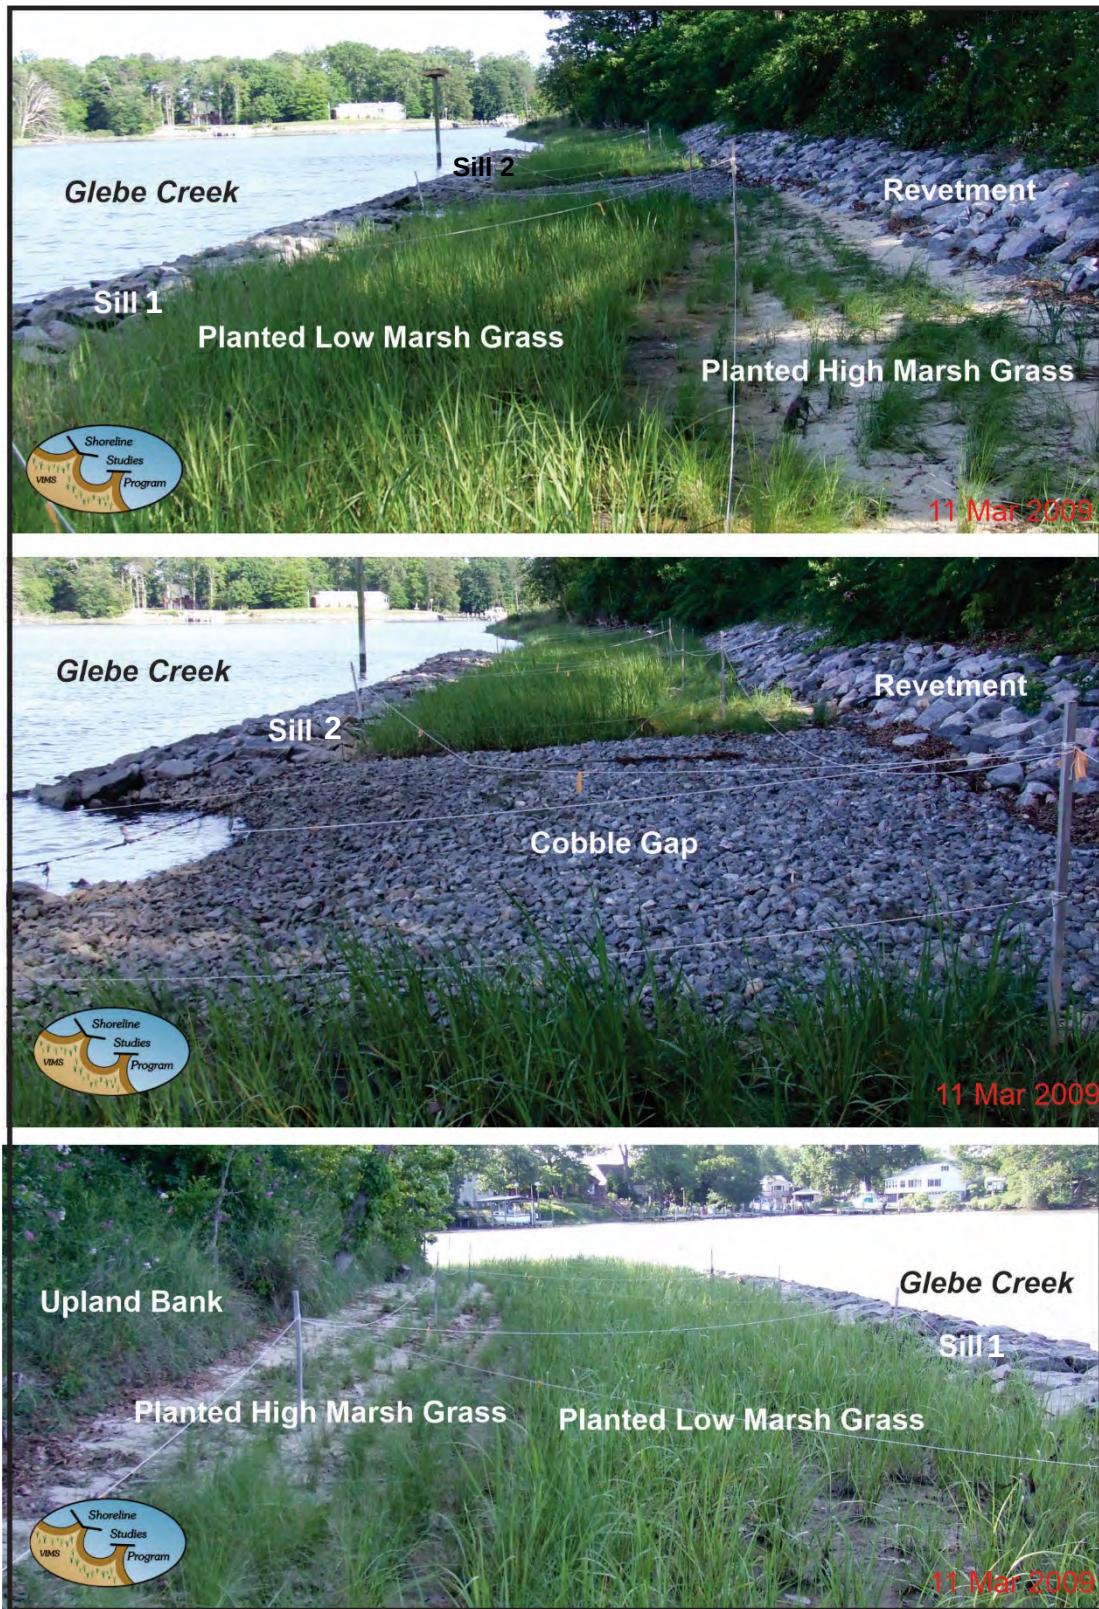
Figure 9-11. Hull Springs Farm living shoreline after about 1 year. The elements were constructed as designed, and the low marsh has filled in well. Photo credit: Shoreline Studies Program, VIMS.

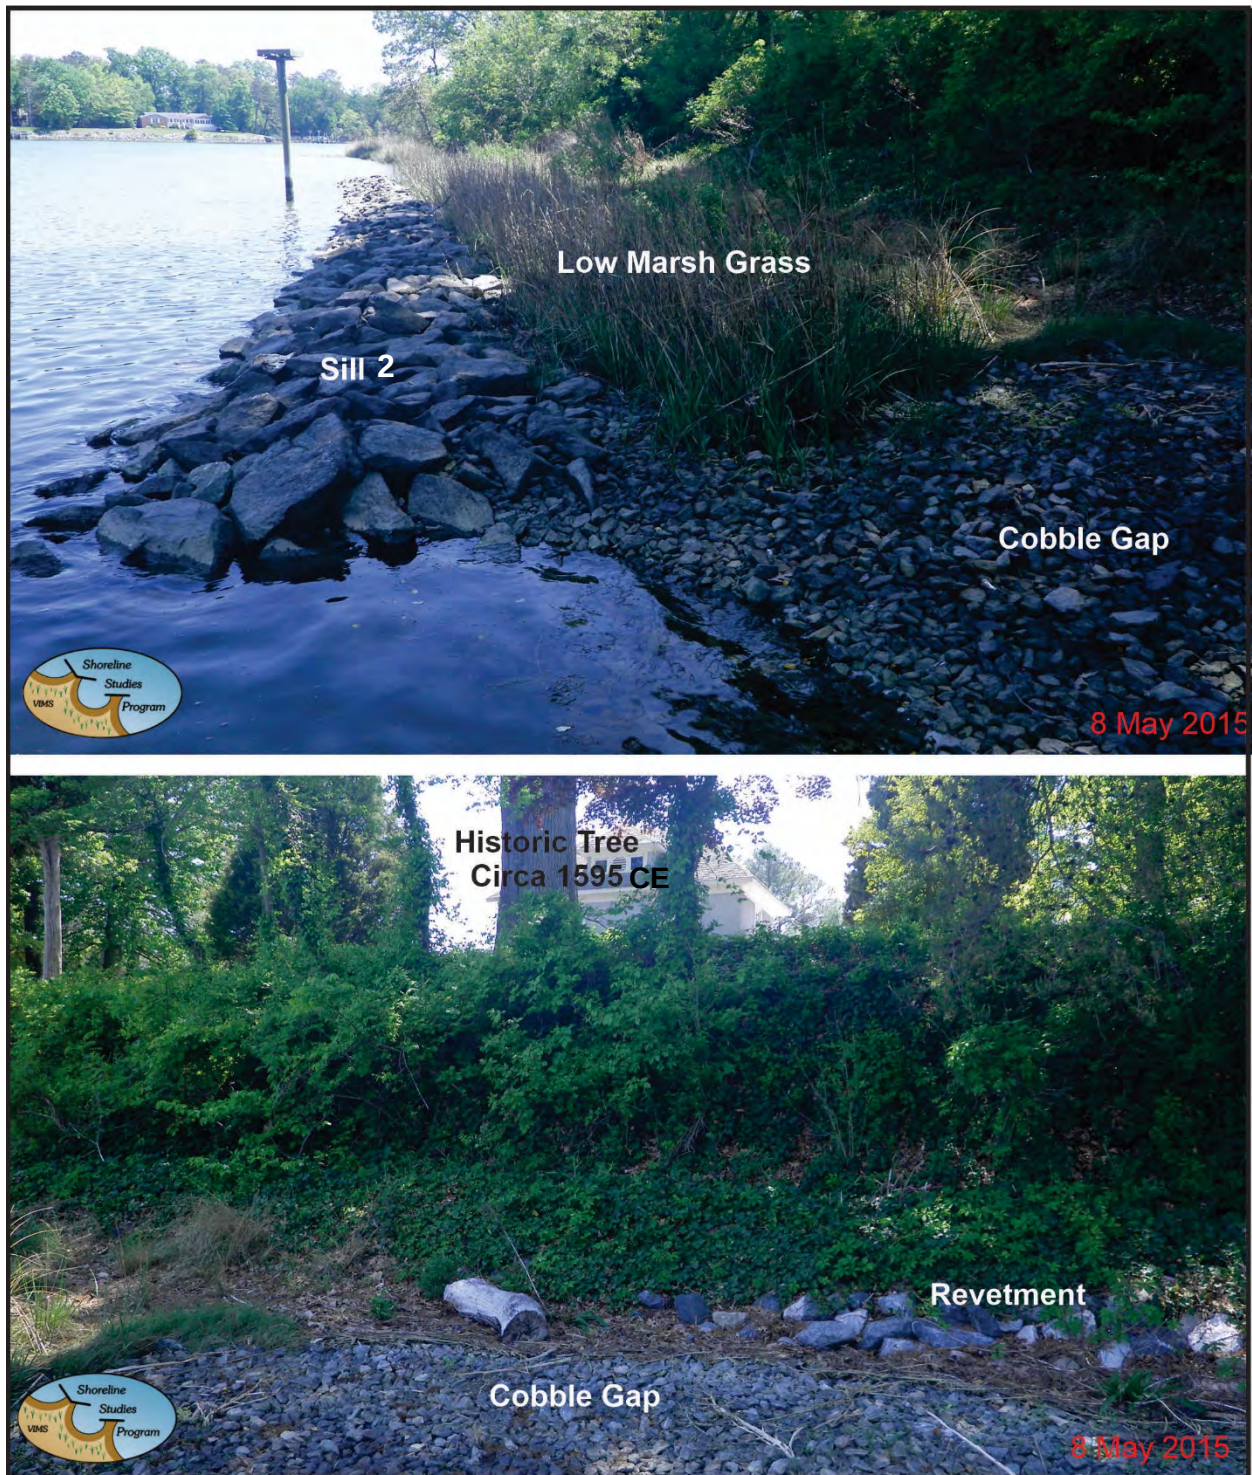
Figure 9-12. Hull Springs Farm about 6 years after construction. Top: Sill 2 has lush low marsh behind the structure, but the high marsh is not as vegetated. Bottom: The bank has slumped over the revetment. The sediment is vegetated which adds additional stability to the bank to protect the historic tree. Photo credit: Shoreline Studies Program, VIMS.

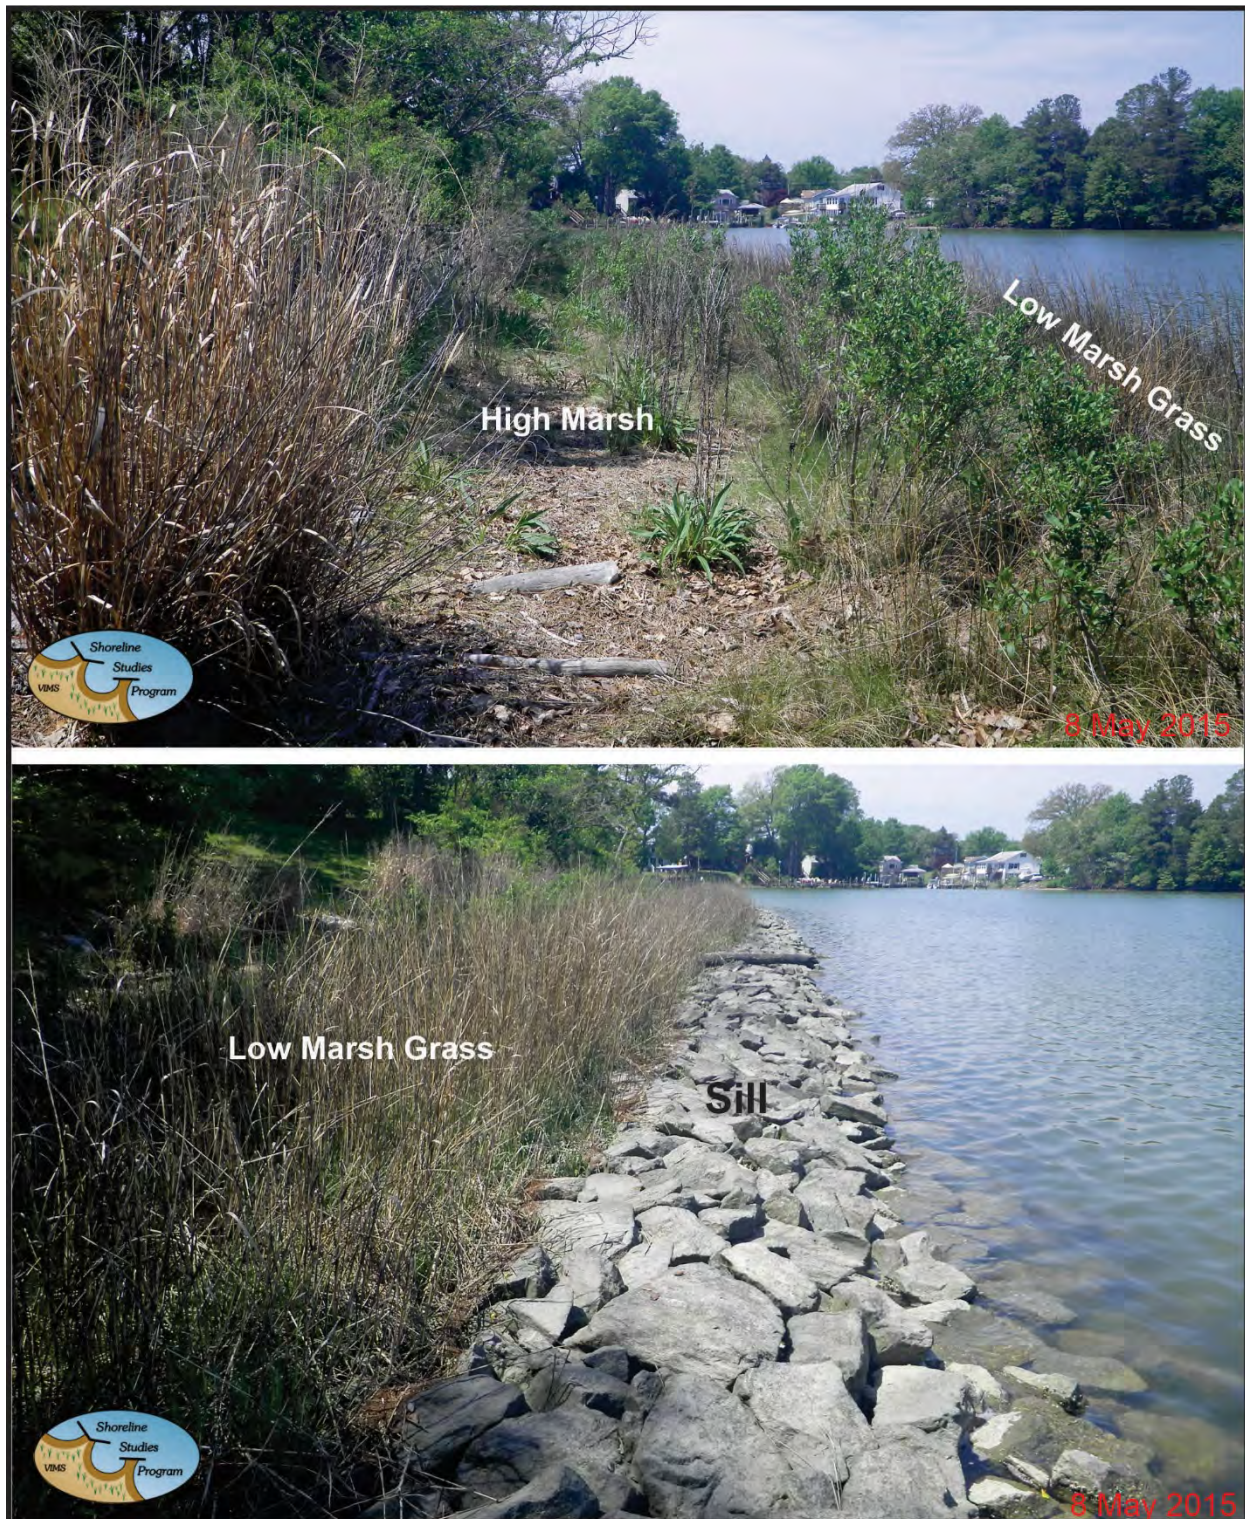
Figure 9-13. Hull Springs Farm about 6 years after construction. Top: The backshore where the upper marsh should be does not have as much grass vegetation as the low marsh. Bottom: The low marsh is doing well behind sill 1. Photo credit: Shoreline Studies Program, VIMS.
