Project Name:	Mountain Valley Pipeline	Inspector:	Matthew Grant		
Inspection Date:	Wednesday, June 15, 2022	Project Contact:	Brian Clauto		
Spread I: Franklin	St 14010-13990 ATWS 1466 AR FR306.02	Weather:	Dry

FIELD INSPECTION PHOTO LOG

Project Name: Mountain Valley Pipeline <u>Date</u>: Wednesday, June 15, 2022

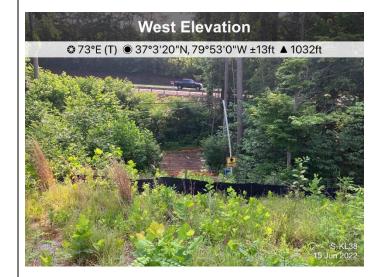
Figure 1: Designated crossing S-KL38, ESC controls were in place.

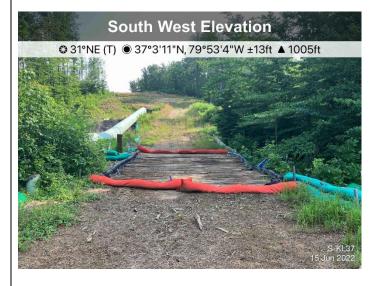
Figure 3: Designated crossing S-KL37, ESC controls were in place.

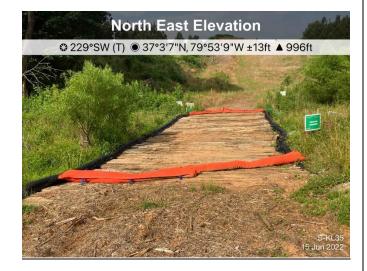
<u>Figure 4</u>: Designated crossing S-KL35, ESC controls were in place.
