Project Name:	Mountain Valley Pipeline	Inspector:	Matthew Grant
Inspection Date:	Wednesday, July 27, 2022	Project Contact:	Brian Clauto
Spread I: Franklin	St 14079-14130 ATWS 1473, 1472 AR FR309.05, 309	Weather:	Rainy

FIELD INSPECTION PHOTO LOG

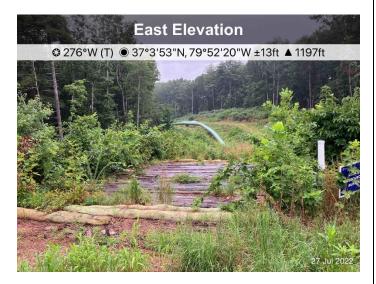
Figure 1: Designated crossing S-KL61, ESC controls were in place.

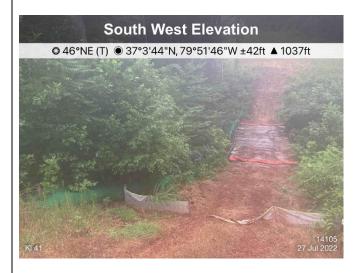
3. Areas of offsite sediment deposition observed?							\boxtimes				
■ <u>Comments:</u> Inspected the following resources: S-KL61, S-KL41											
Routine Maintenance: (<u>72-Hour Deadline</u> from Notification) - N/A											
Ineffective Controls: (<u>24-Hour Deadline</u> from Notification) - St14105, SF down near crossing S-KL41.											
Recommended Corrective Action: Maintain and install all controls per the approved PSS&S.

Figure 3: Designated crossing S-KL41, Silt fence is down at St14105.

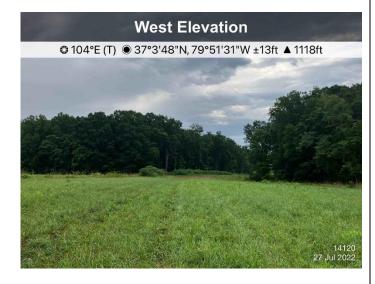
Figure 4: St14120, ECD's are in place and stabilized.
