## FIELD INSPECTION REPORT

| Project Name: | Mountain Valley Pipeline | Inspector: | Marshall Willis |
| Inspection Date: | Wednesday, April 6, 2022 | Project Contact: | Brian Clauto, Cory Chalmers |
| Spread I:<br>Pittsylvania County | STA 15063+85 – 15142+66 | Weather: | Wet |

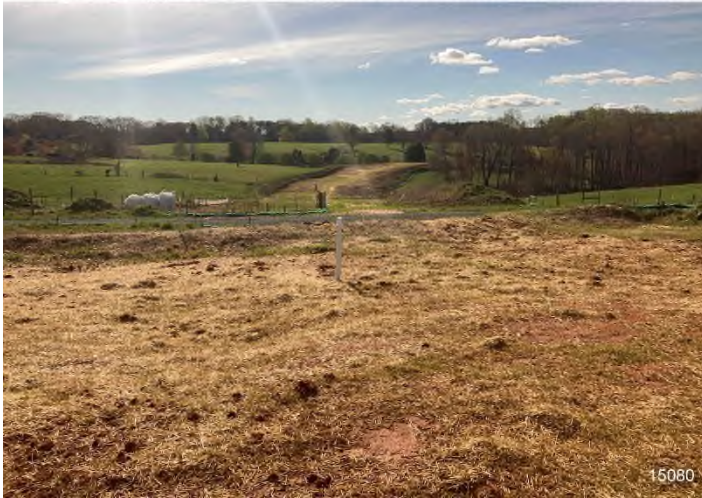
15080

**Figure 1: STA 15080+00** – Controls in place and functioning properly.

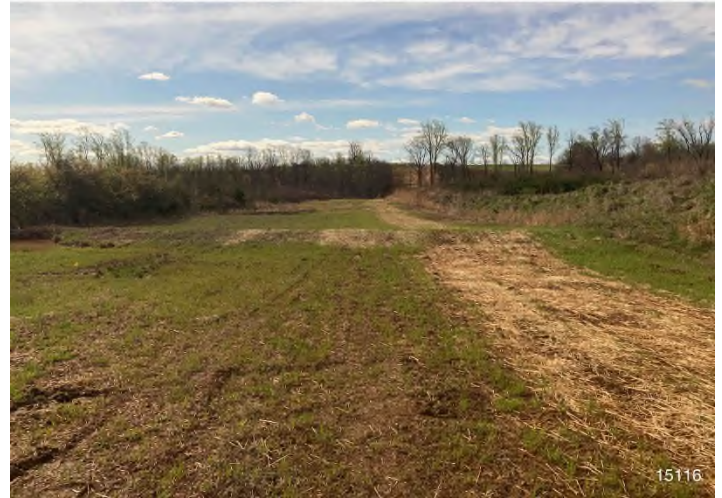
15116

**Figure 2: STA 15116+00** – Controls in place and functioning properly.

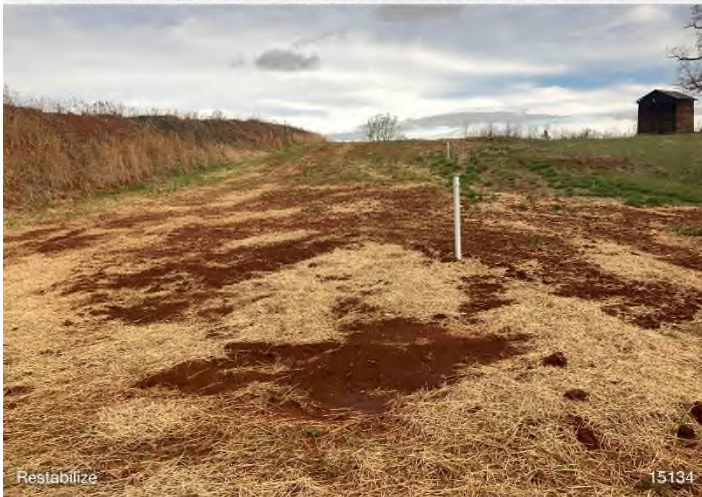
15134

- STA 15134+00: Re-stabilization needed.
- STA 15140+12: Re-stabilization needed.

**Figure 3: STA 15134+00** – Re-stabilization needed.

Restabilize

**Recommended Corrective Action:** Maintain and install all controls per the approved PSS&S.

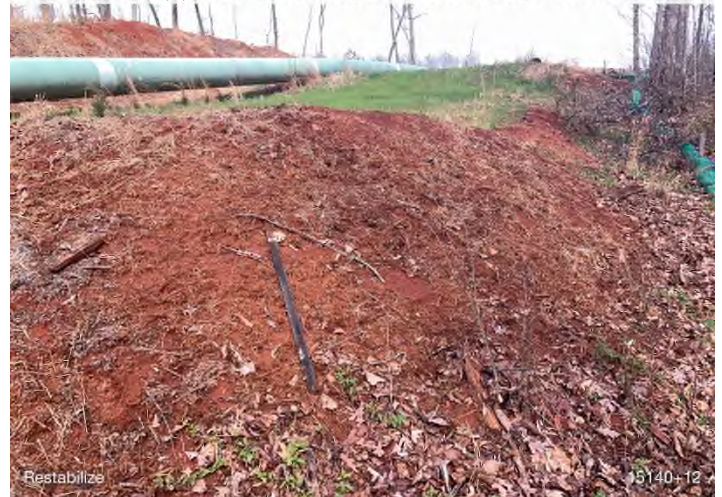
15140+12

**Figure 4: STA 15140+12** – Re-stabilization needed.

Restabilize
