## FIELD INSPECTION REPORT

| Project Name: | Mountain Valley Pipeline | Inspector: | Marshall Willis |
| Spread H:<br>Franklin County | STA 13061+44 – 13116+87<br>MVP-FR-290/291 | Weather: | Dry |

## FIELD INSPECTION PHOTO LOG

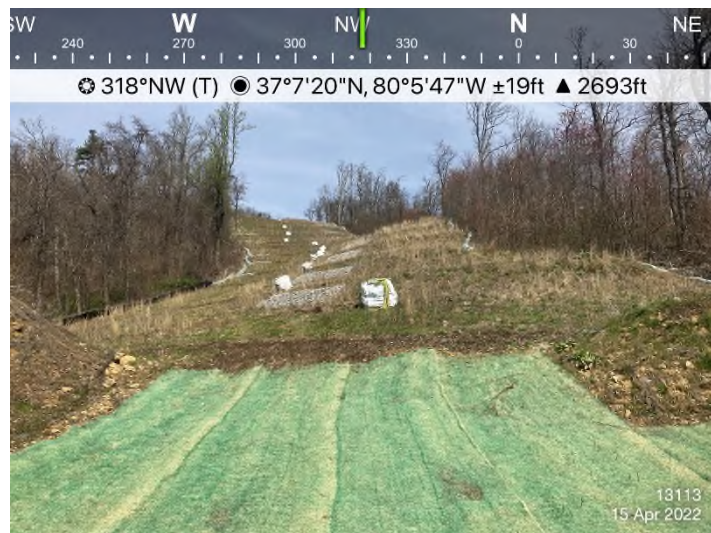
**Figure 1: STA 13113+00** – Controls in place and functioning properly.

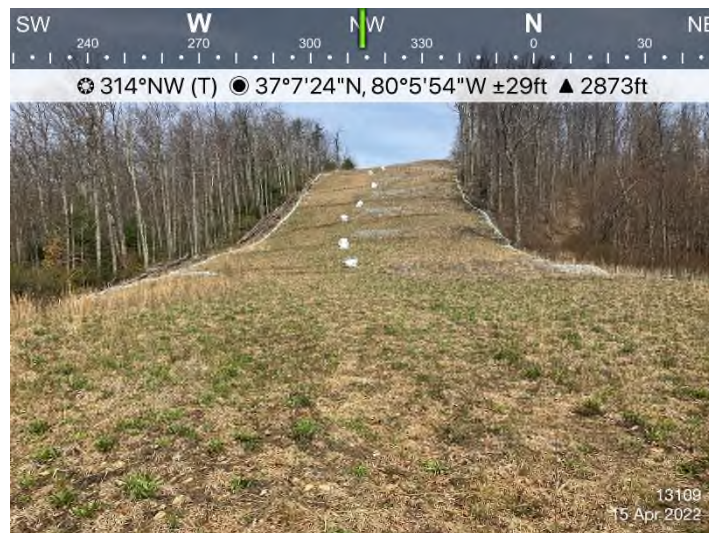
**Figure 2: STA 13109+00** – Controls in place and functioning properly.

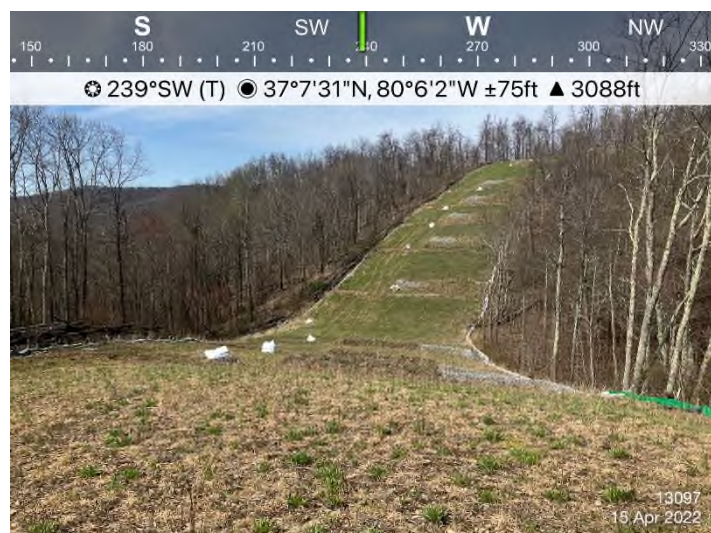
**Figure 3: STA 13097+00** – Controls in place and functioning properly.

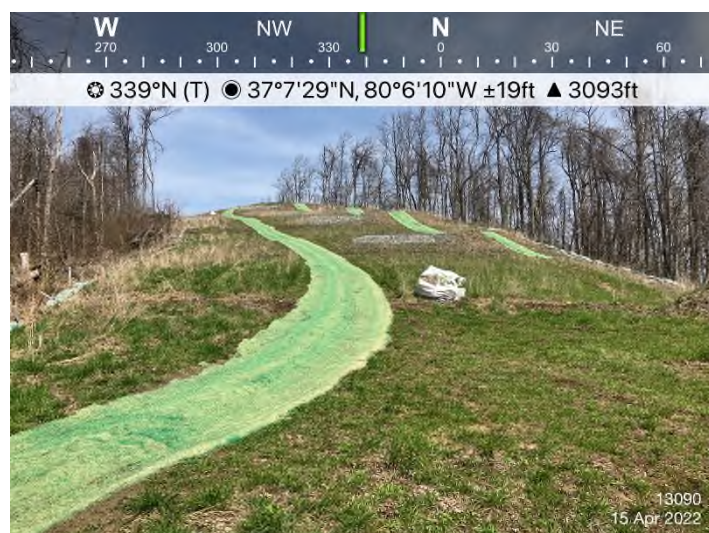
**Figure 4: STA 13090+00** – Controls in place and functioning properly.
