## FIELD INSPECTION REPORT

| Project Name: | Mountain Valley Pipeline | Inspector: | Marshall Willis |
| Inspection Date: | Wednesday, April 13, 2022 | Project Contact: | Brian Clauto, Cory Chalmers |
| Spread H:<br>Roanoke County | STA 12763+00 – 12796+00<br>MVP-RO-280 | Weather: | Dry |

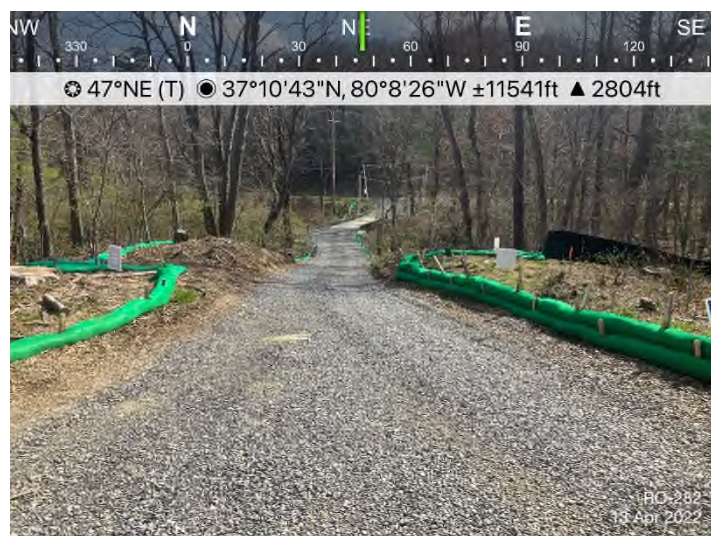
**Figure 1: MVP-RO-282** – Controls in place and functioning properly along access road.

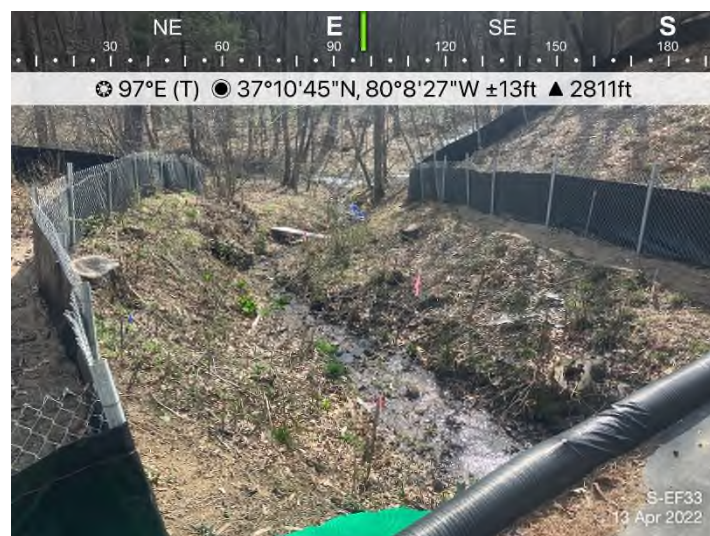
**Figure 2: Stream S-EF33** – Controls in place and functioning properly around stream S-EF33.

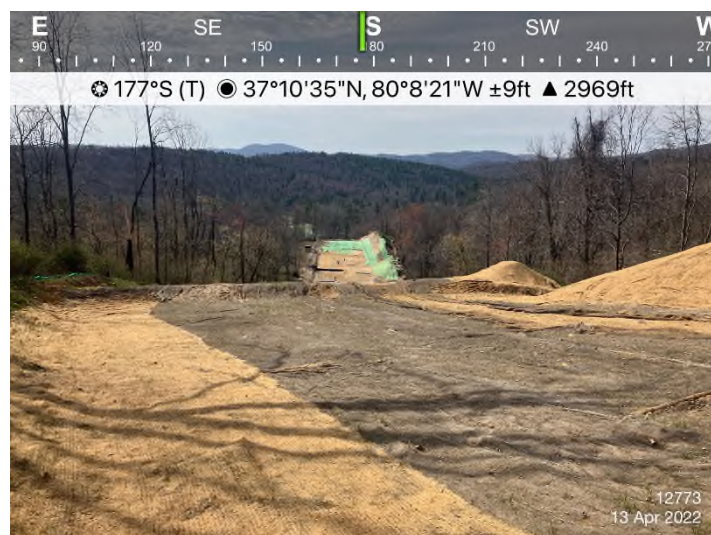
**Figure 3: STA 12773+00** – Controls in place and functioning properly. Area stabilized with erosion control matting.
