FIELD INSPECTION REPORT

Project Name:	Mountain Valley Pipeline	Inspector:	Marshall Willis
Inspection Date:	Tuesday, April 12, 2022	Project Contact:	Brian Clauto, Cory Chalmers
Spread H: Montgomery County	STA 12445+86 – 12544+27 MVP-MN-278.01	Weather:	Dry

FIELD INSPECTION PHOTO LOG

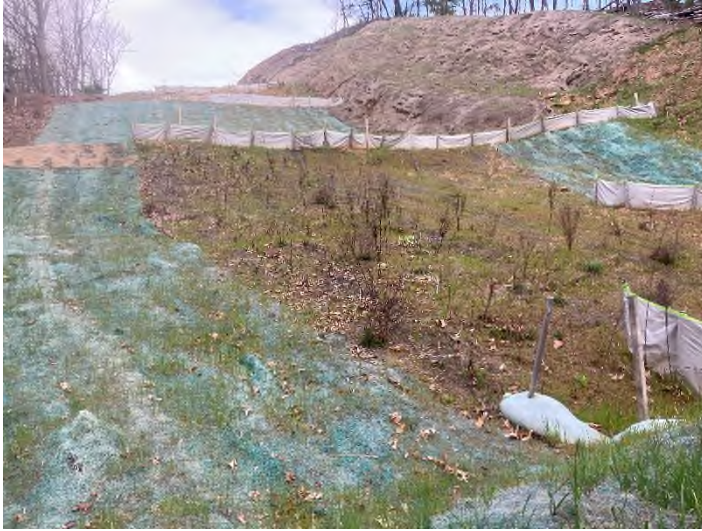
Figure 1: STA 12543+00 – Controls in place and functioning properly. Area stabilized with erosion control matting.

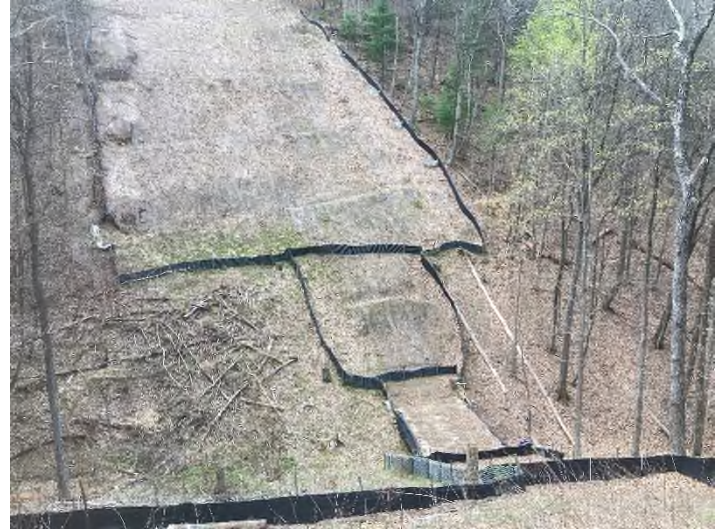
Figure 2: STA 12518+00 – Controls in place and functioning properly. Area stabilized with erosion control matting.

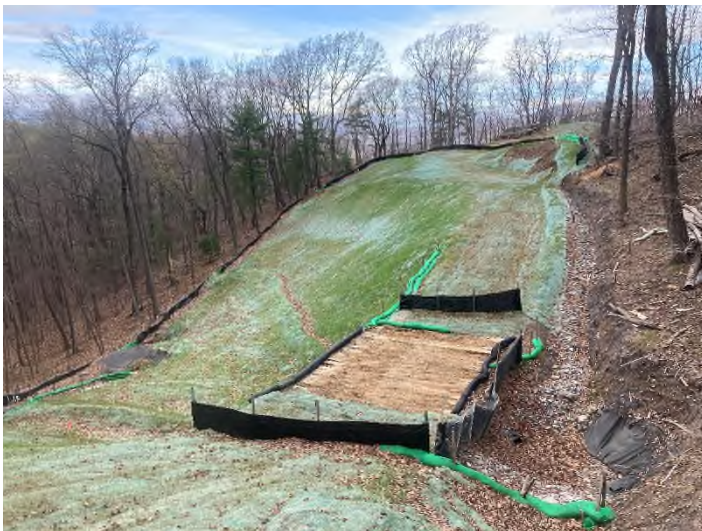
Figure 3: STA 12504+00 – Controls in place and functioning properly. Area stabilized with erosion control matting.

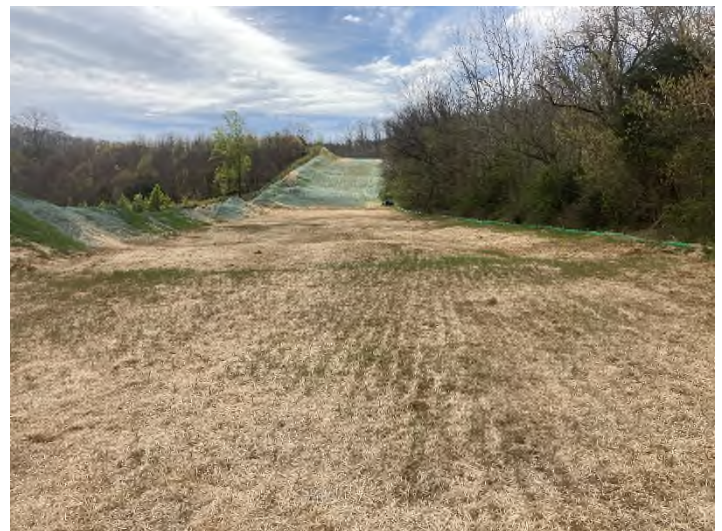
Figure 4: STA 12471+00 – Controls in place and functioning properly. Area stabilized with straw.
