FIELD INSPECTION REPORT

Project Name:	Mountain Valley Pipeline	Inspector:	Marshall Willis
Inspection Date:	Monday, April 11, 2022	Project Contact:	Brian Clauto, Cory Chalmers
Spread H: Montgomery County	STA 12373+76 - 12448+00 MVP-MN-279.02	Weather:	Dry

FIELD INSPECTION PHOTO LOG

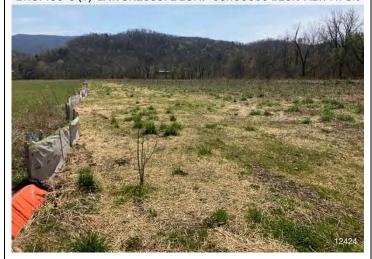
Figure 1: **STA 12424+00** – Controls in place and functioning properly.

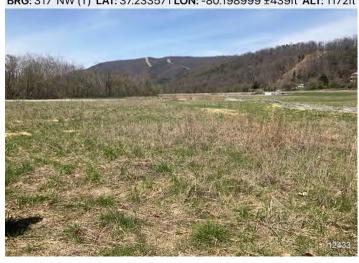
<u>Figure 2:</u> **STA 12433+00** – Controls in place and functioning properly.

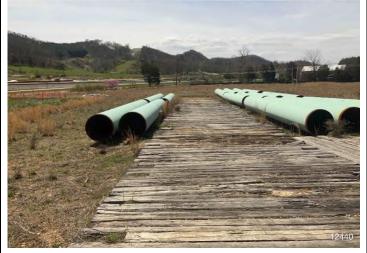
<u>Figure 3</u>: **STA 12440+00** – Controls in place and functioning properly.

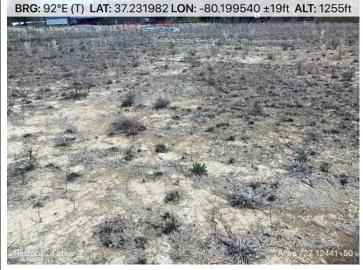
3. Areas of offsite sediment deposition observed?									\boxtimes		
 Comments: Inspected the following resources: SNN19, W-NN8 and S-NN16. Routine Maintenance: (72-Hour Deadline from Notification) STA 12441+50: Re-stabilization needed. Recommended Corrective Action: Maintain and install all controls per the approved PSS&S.

Figure 4: STA 12441+50 (ATWS 727) – Re-stabilization needed.

<u>Deadline:</u> Within 72-Hour of Notification
