## FIELD INSPECTION REPORT

| Project Name: | Mountain Valley Pipeline | Inspector: | Marshall Willis |
| Spread H:<br>Montgomery County | STA 12007+33 – 12072+84<br>MVP-MN-268.01/270 | Weather: | Dry |

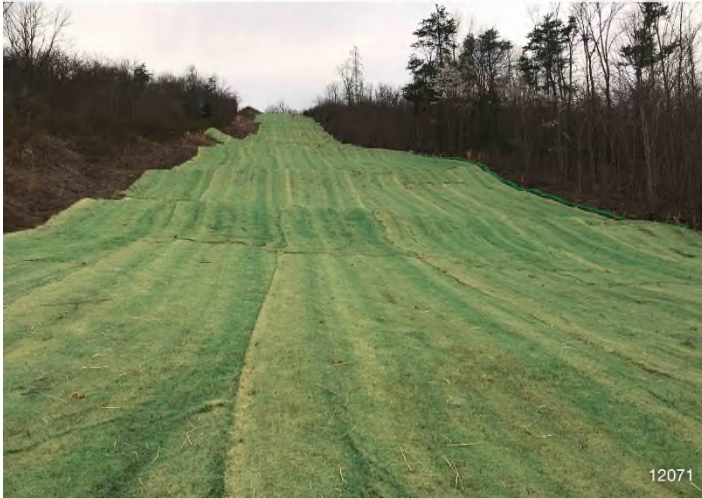
**Figure 1: STA 12071+00** – Controls in place and functioning properly.

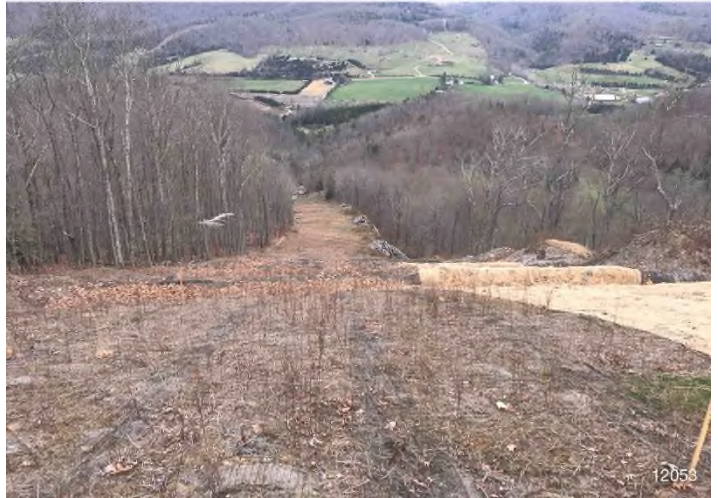
**Figure 2: STA 12053+00** – Controls in place and functioning properly.

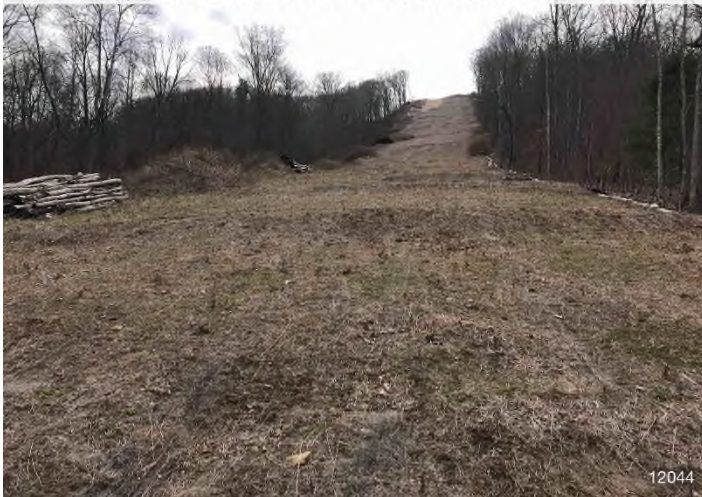
**Figure 3: STA 12044+00** – Controls in place and functioning properly.

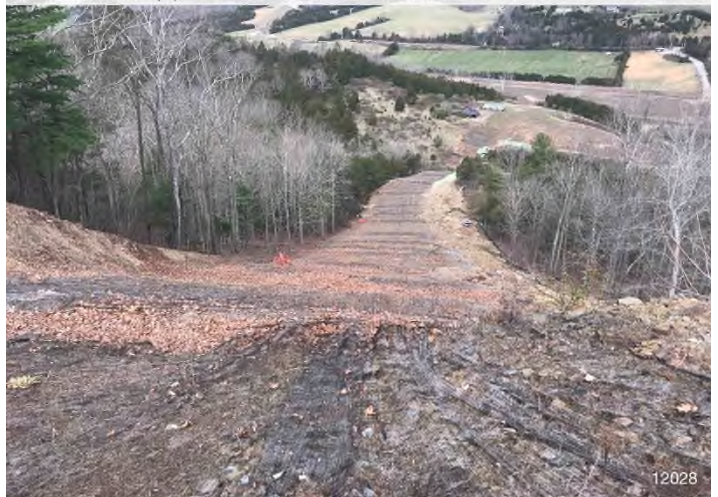
**Figure 4: STA 12028+00** – Controls in place and functioning properly.
