Project Name:	Mountain Valley Pipeline	Inspector:	Matthew Grant
Inspection Date:	Monday, July 25, 2022	Project Contact:	Brian Clauto
Spread H:		Weather:	Dry

FIELD INSPECTION PHOTO LOG

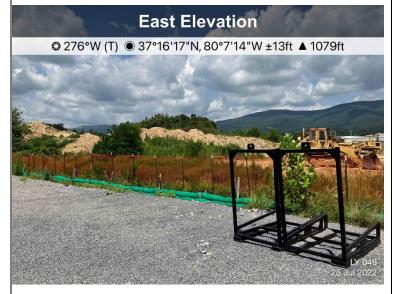
Figure 1: LY049 perimeter controls remain in place and functioning.

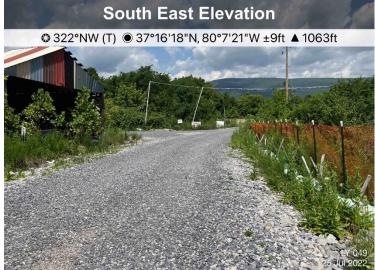
<u>Figure 2</u>: Construction road/ entrance of LY049 remains in place and functioning.

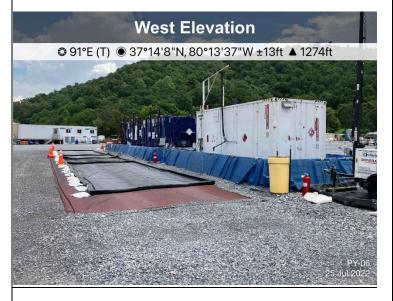
Figure 3: PY06 Fuel protection in place.

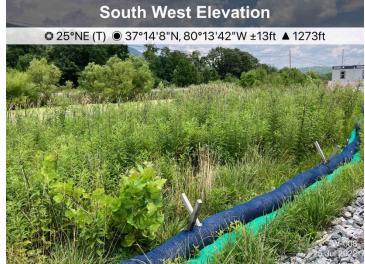
■ Figure 4: Wetland W-008 within PY06 remains protected.
